REHABILITATION NEEDS

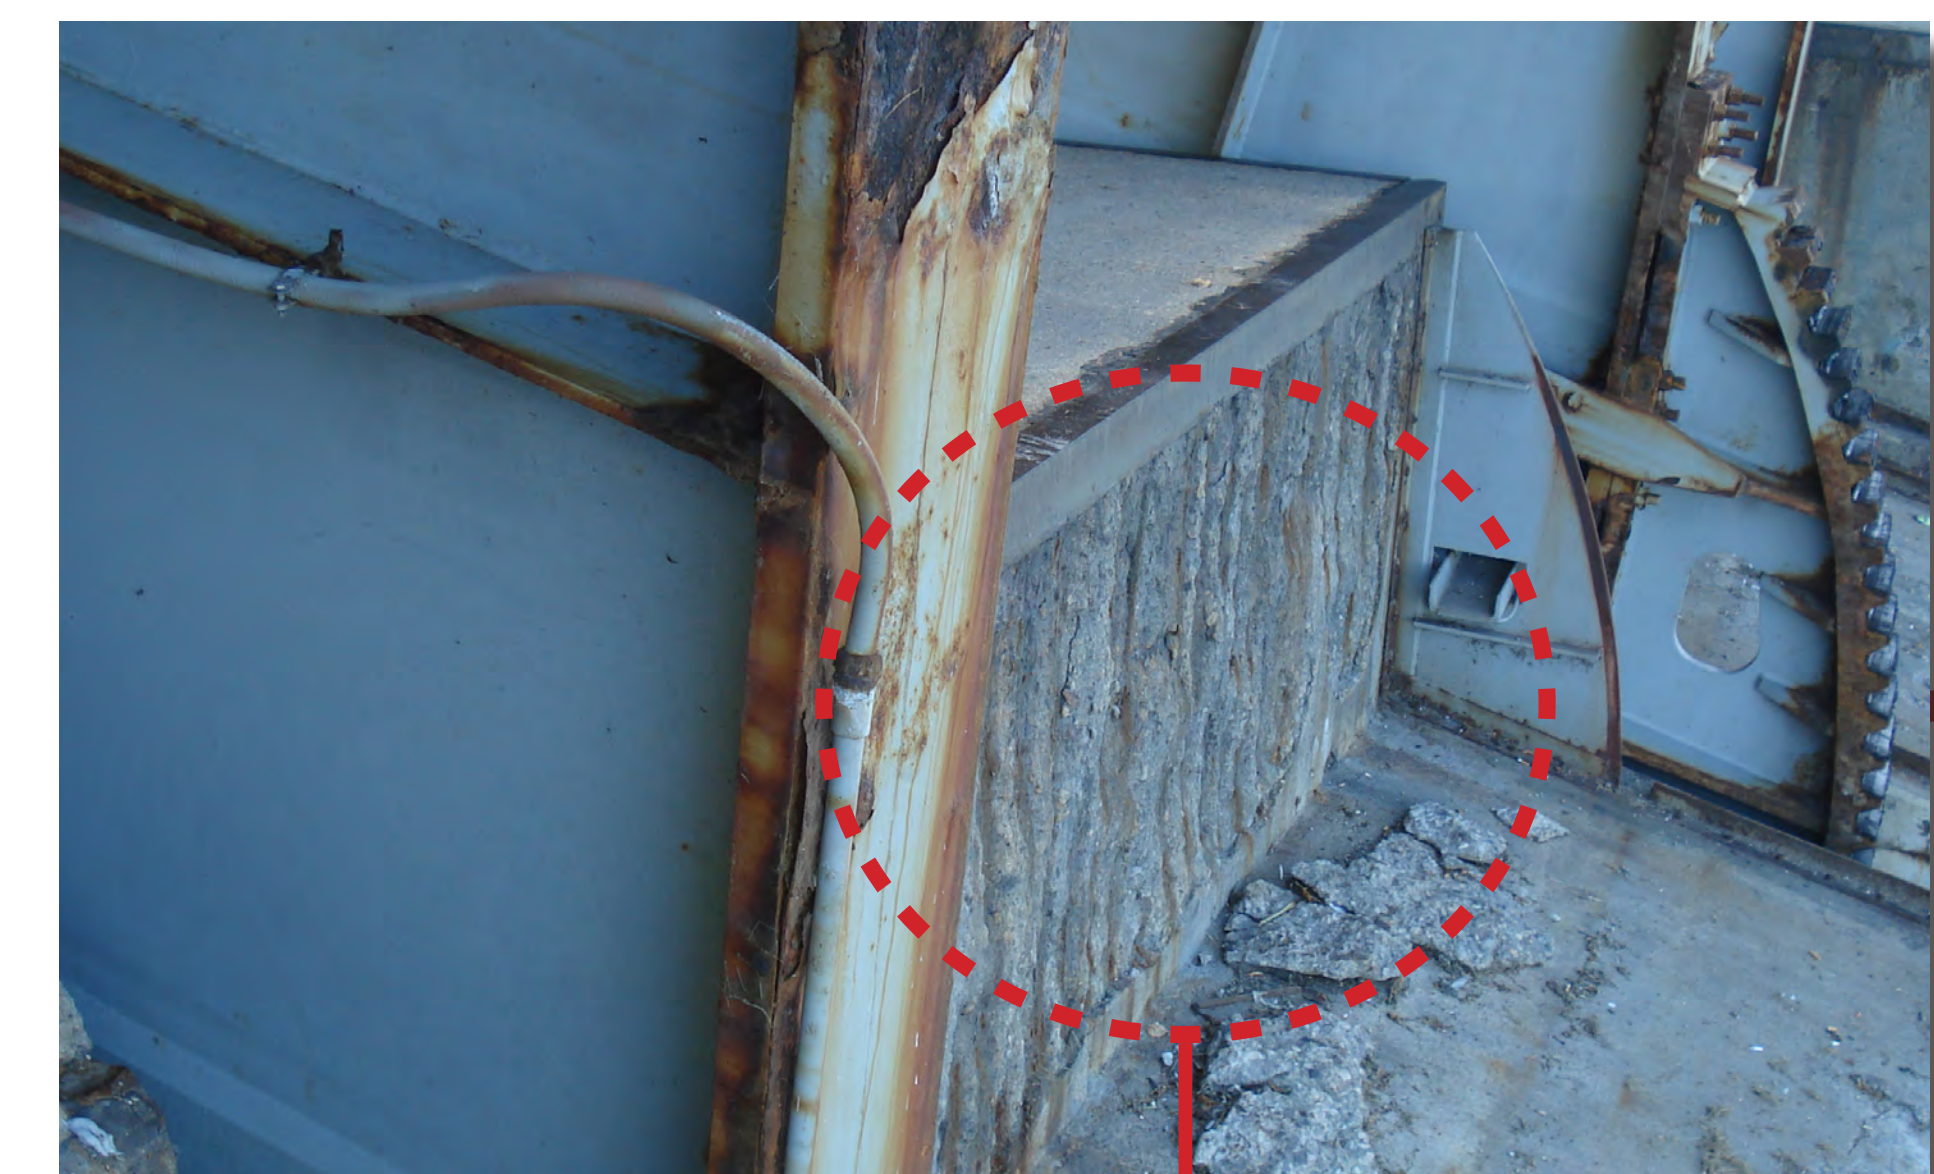
Heavy Concrete Deterioration with Exposed Rebar

Repair Pier Concrete

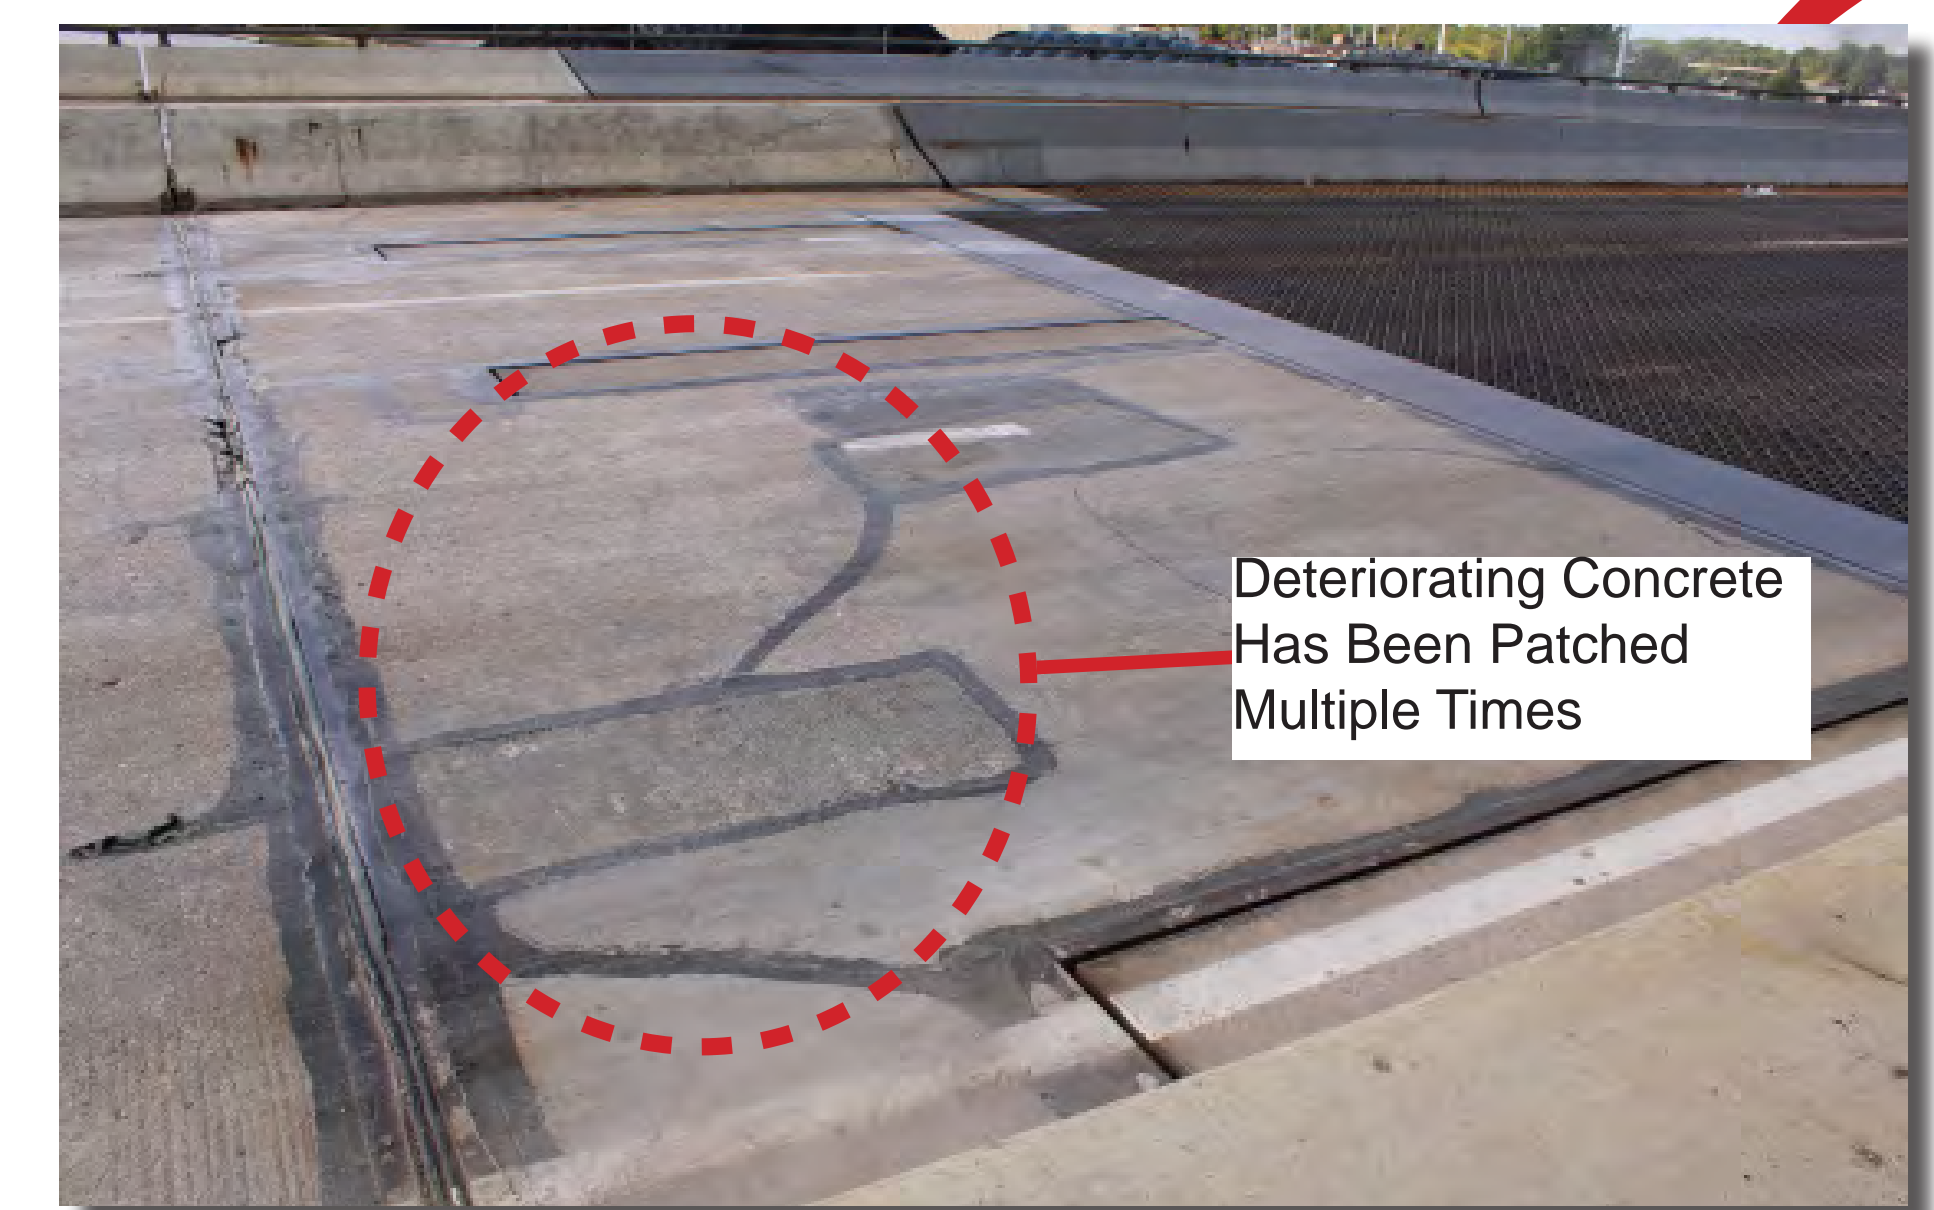
Deteriorating Concrete Has Been Patched Multiple Times

Overlay Concrete Deck over Machinery Area and Adjacent Approach Span

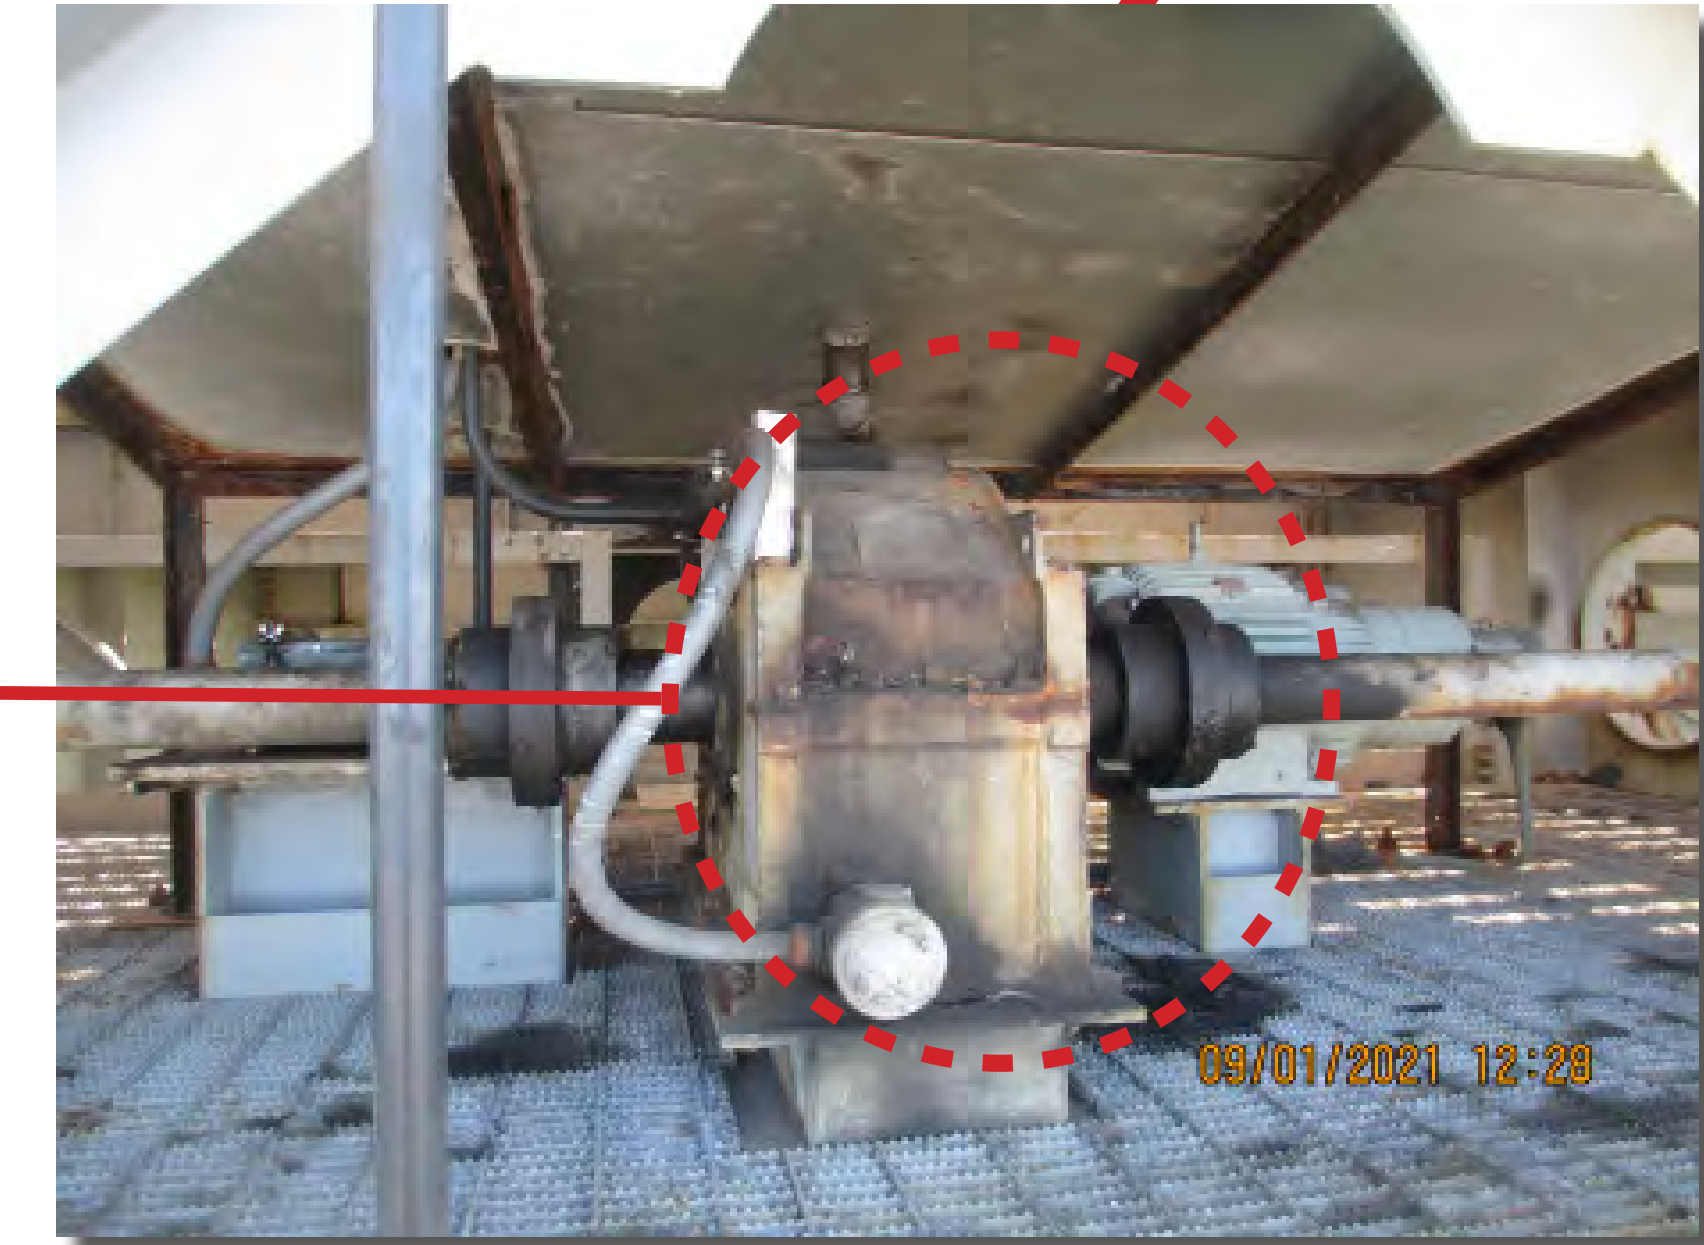
Mechanical components showing corrosion and evidence of leaking seals.

Refurbish Machinery

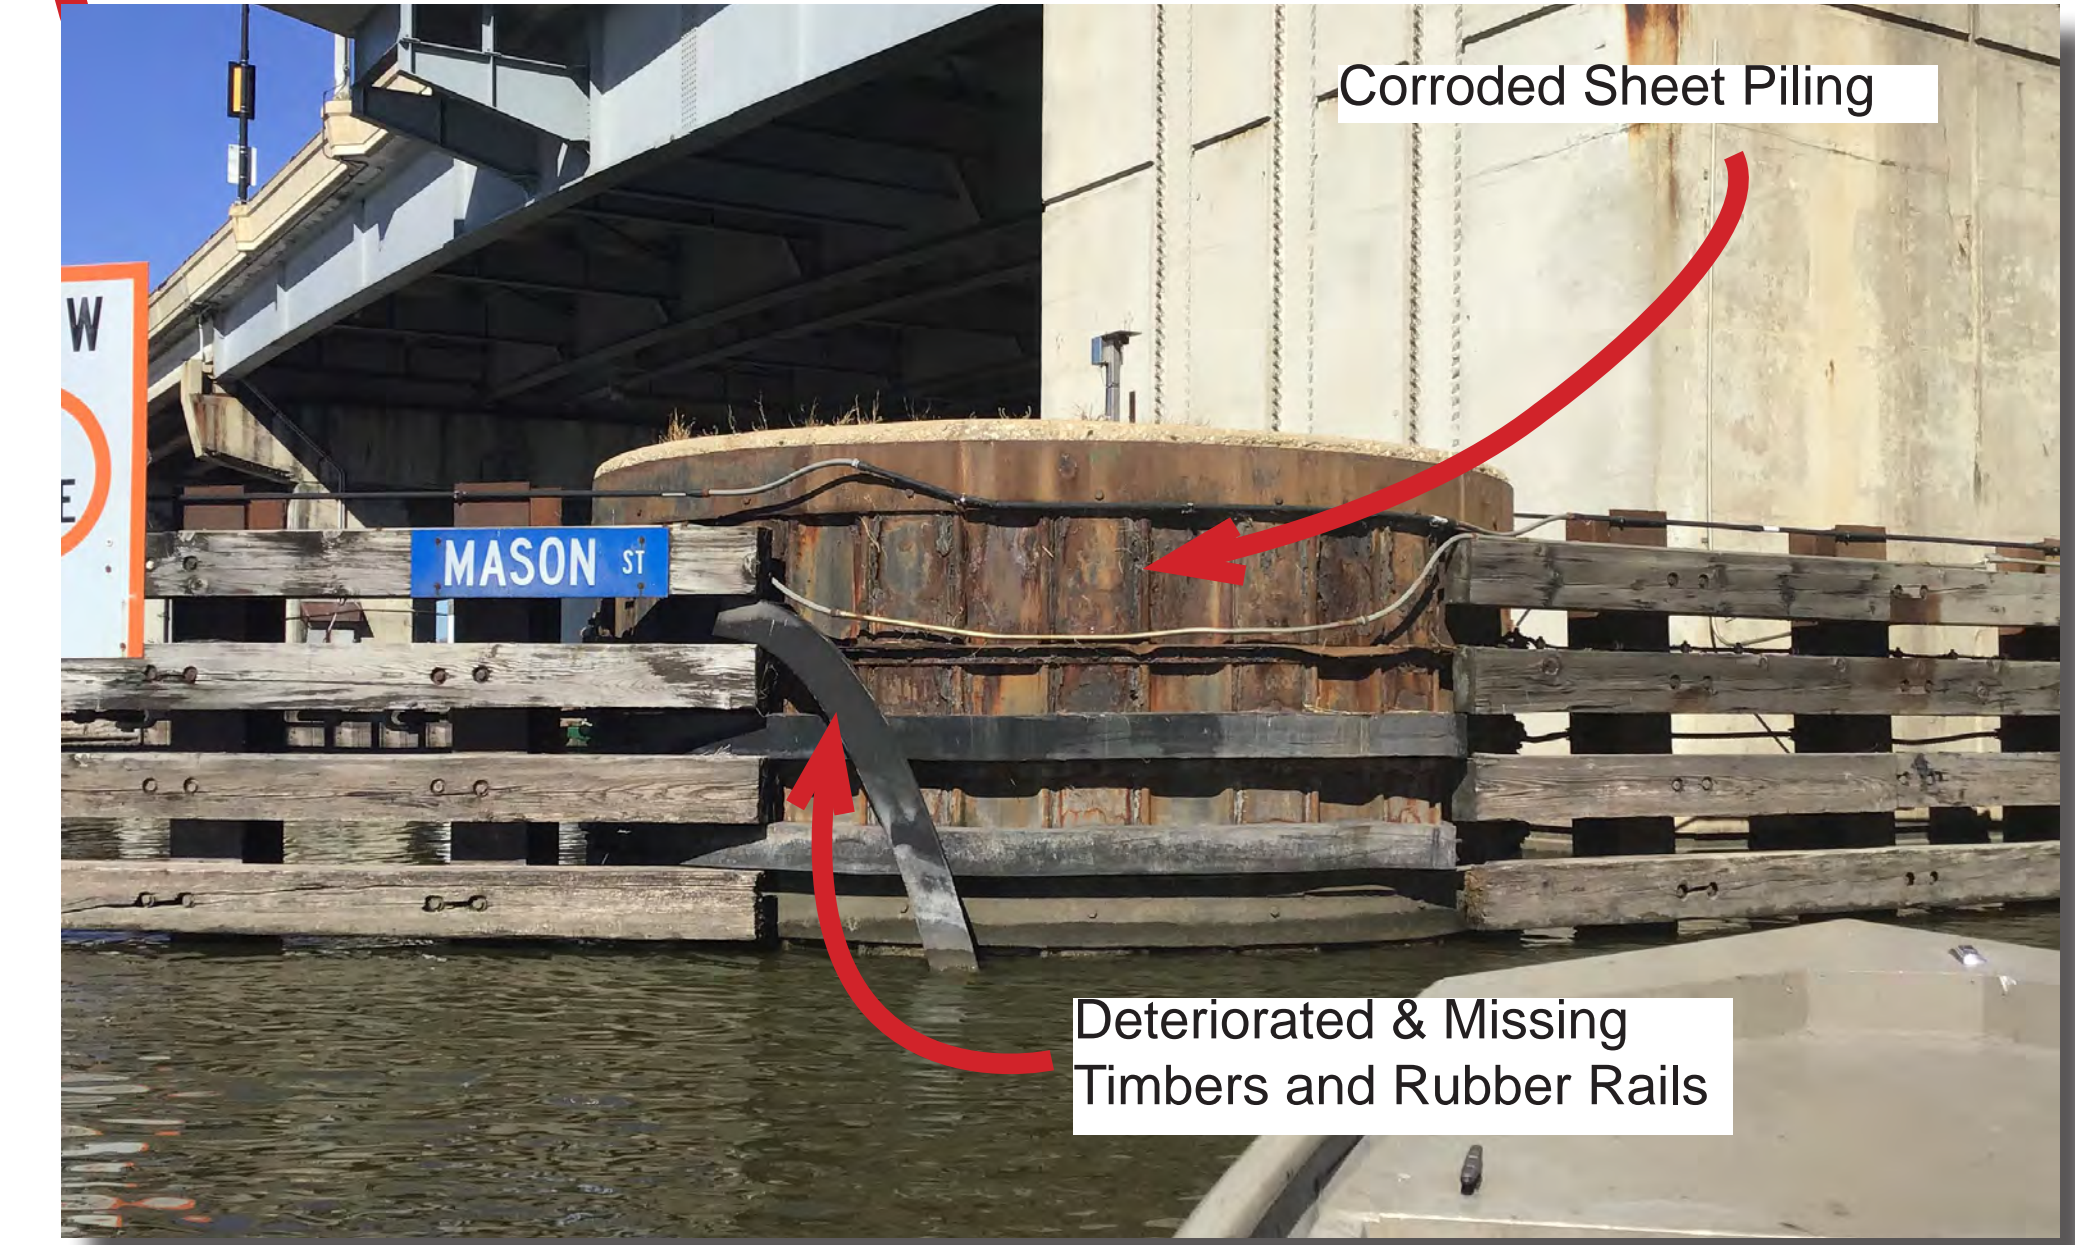
Corroded Sheet Piling

Deteriorated & Missing Timbers and Rubber Rails

Repair Fender System

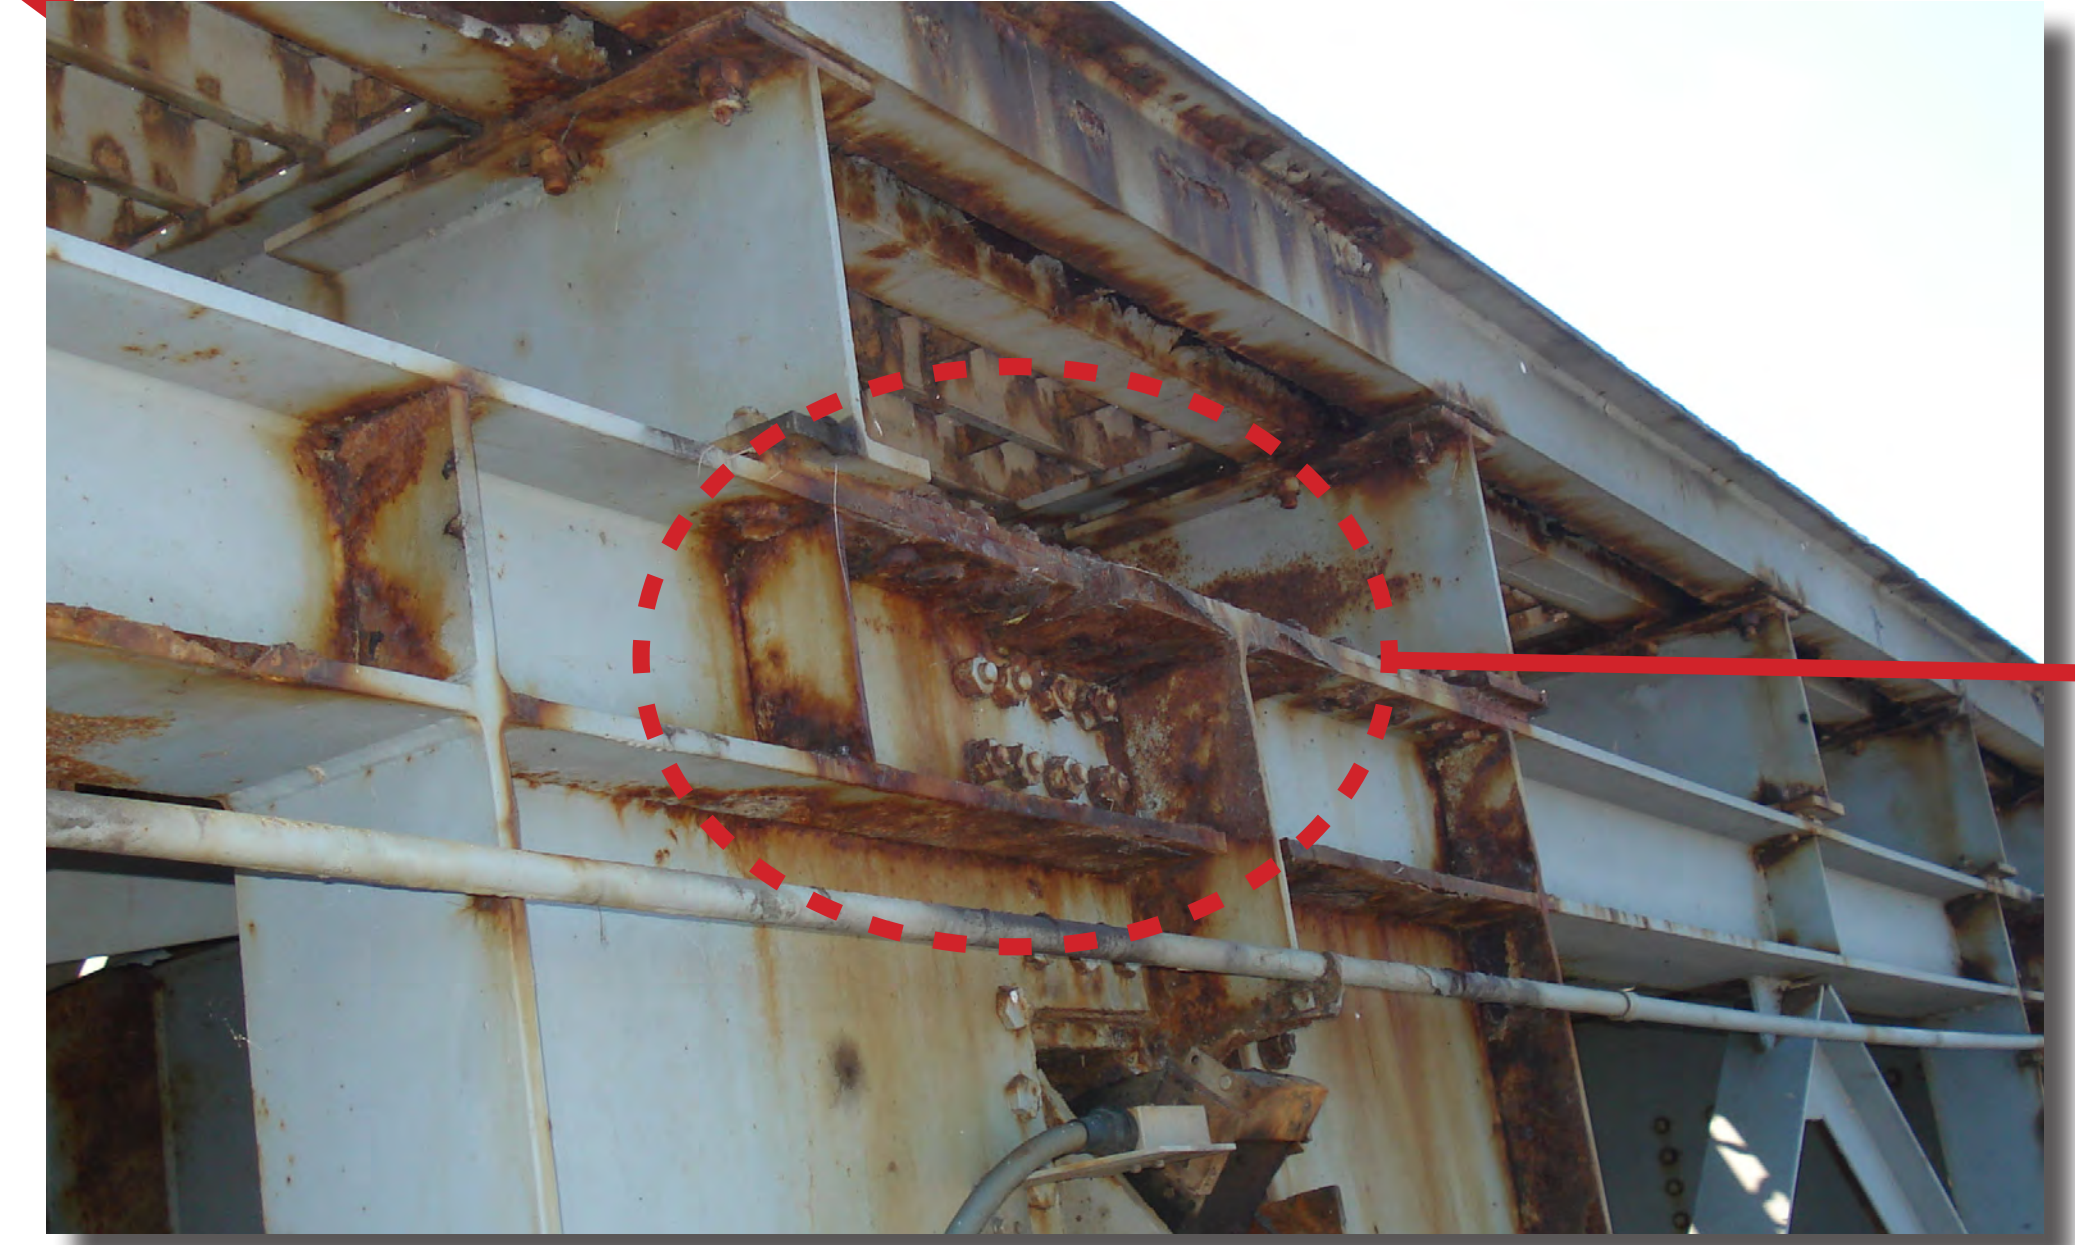
Paint System is Failing on Bascule Span

Clean & Paint Structural Steel

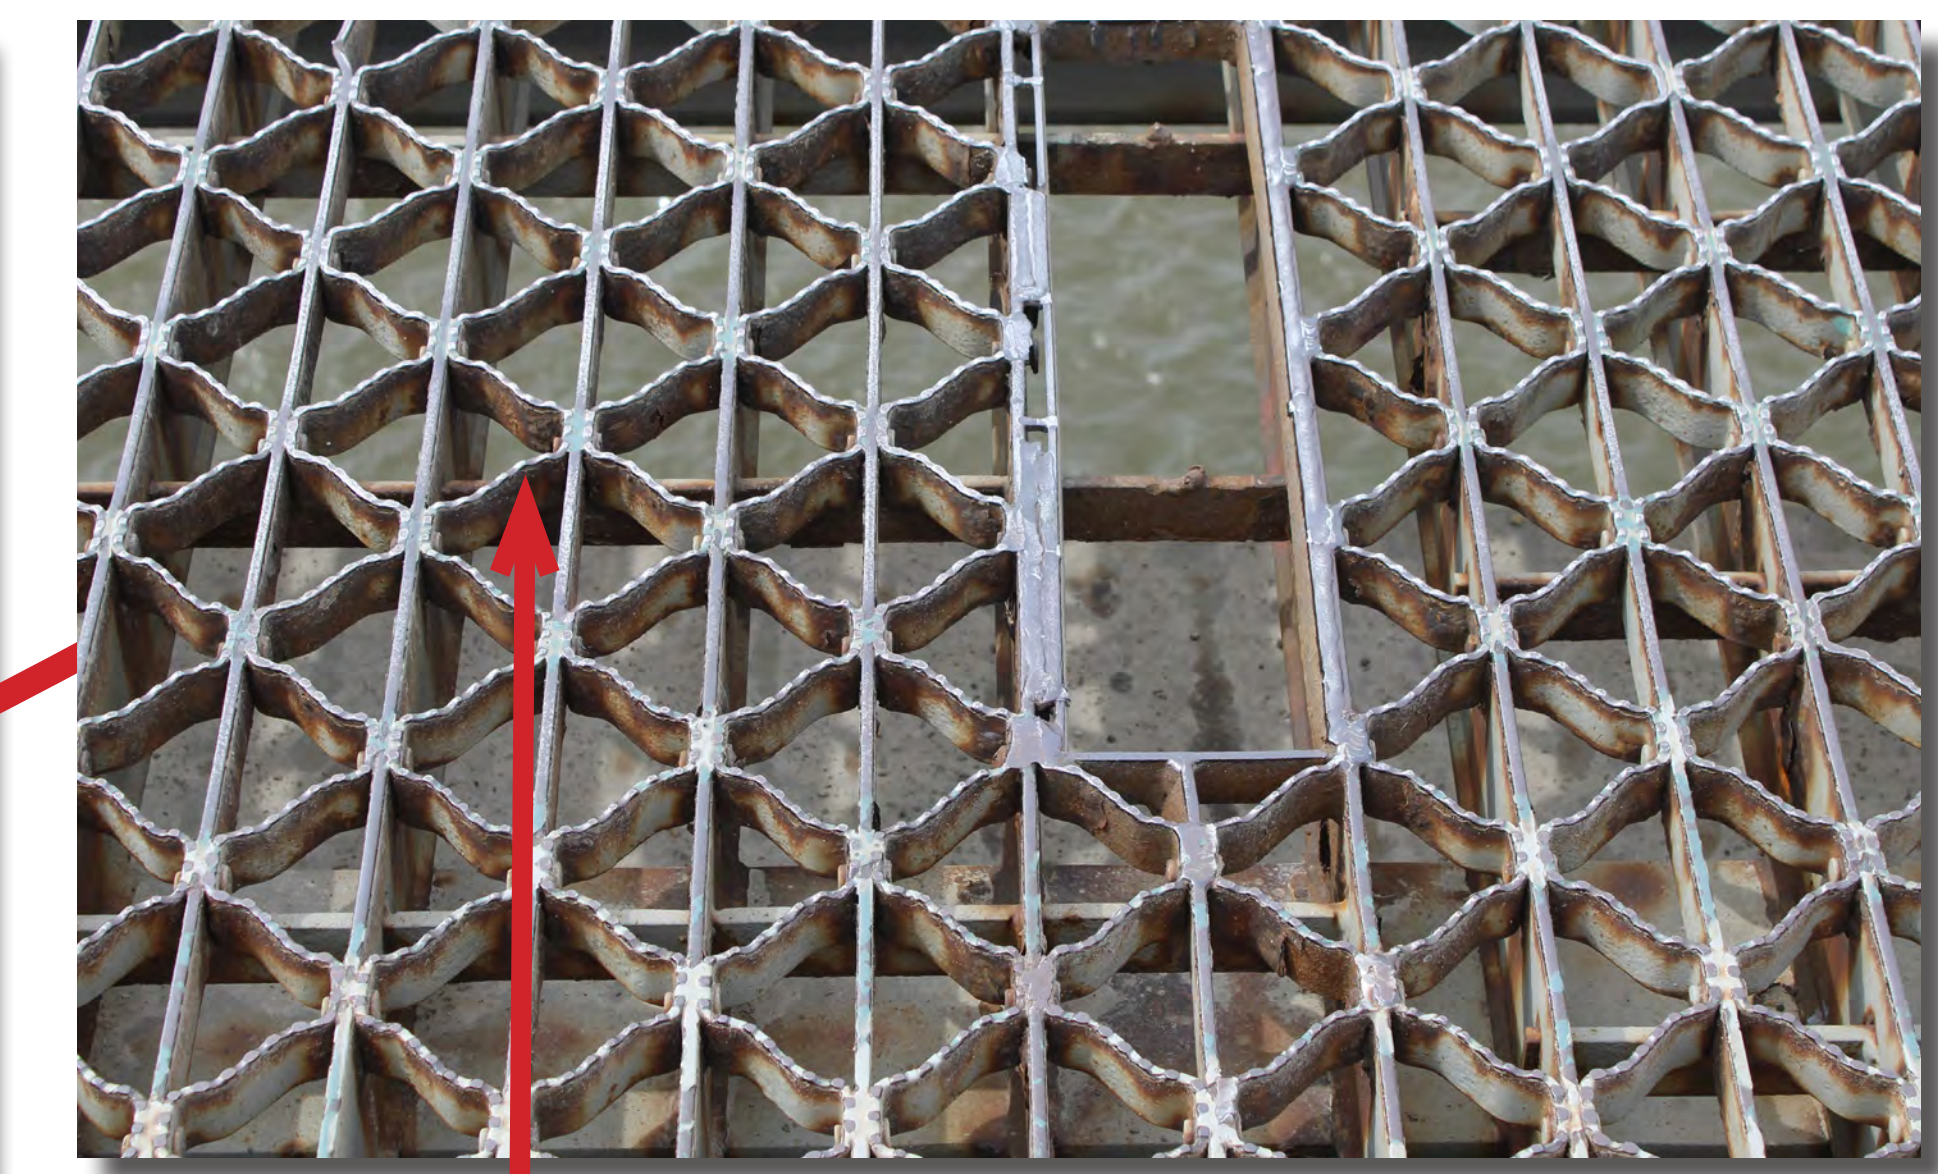
Numerous weld repairs on broken/missing bars. Grid Deck requires continuous repairs.

Replace Steel Grid Deck

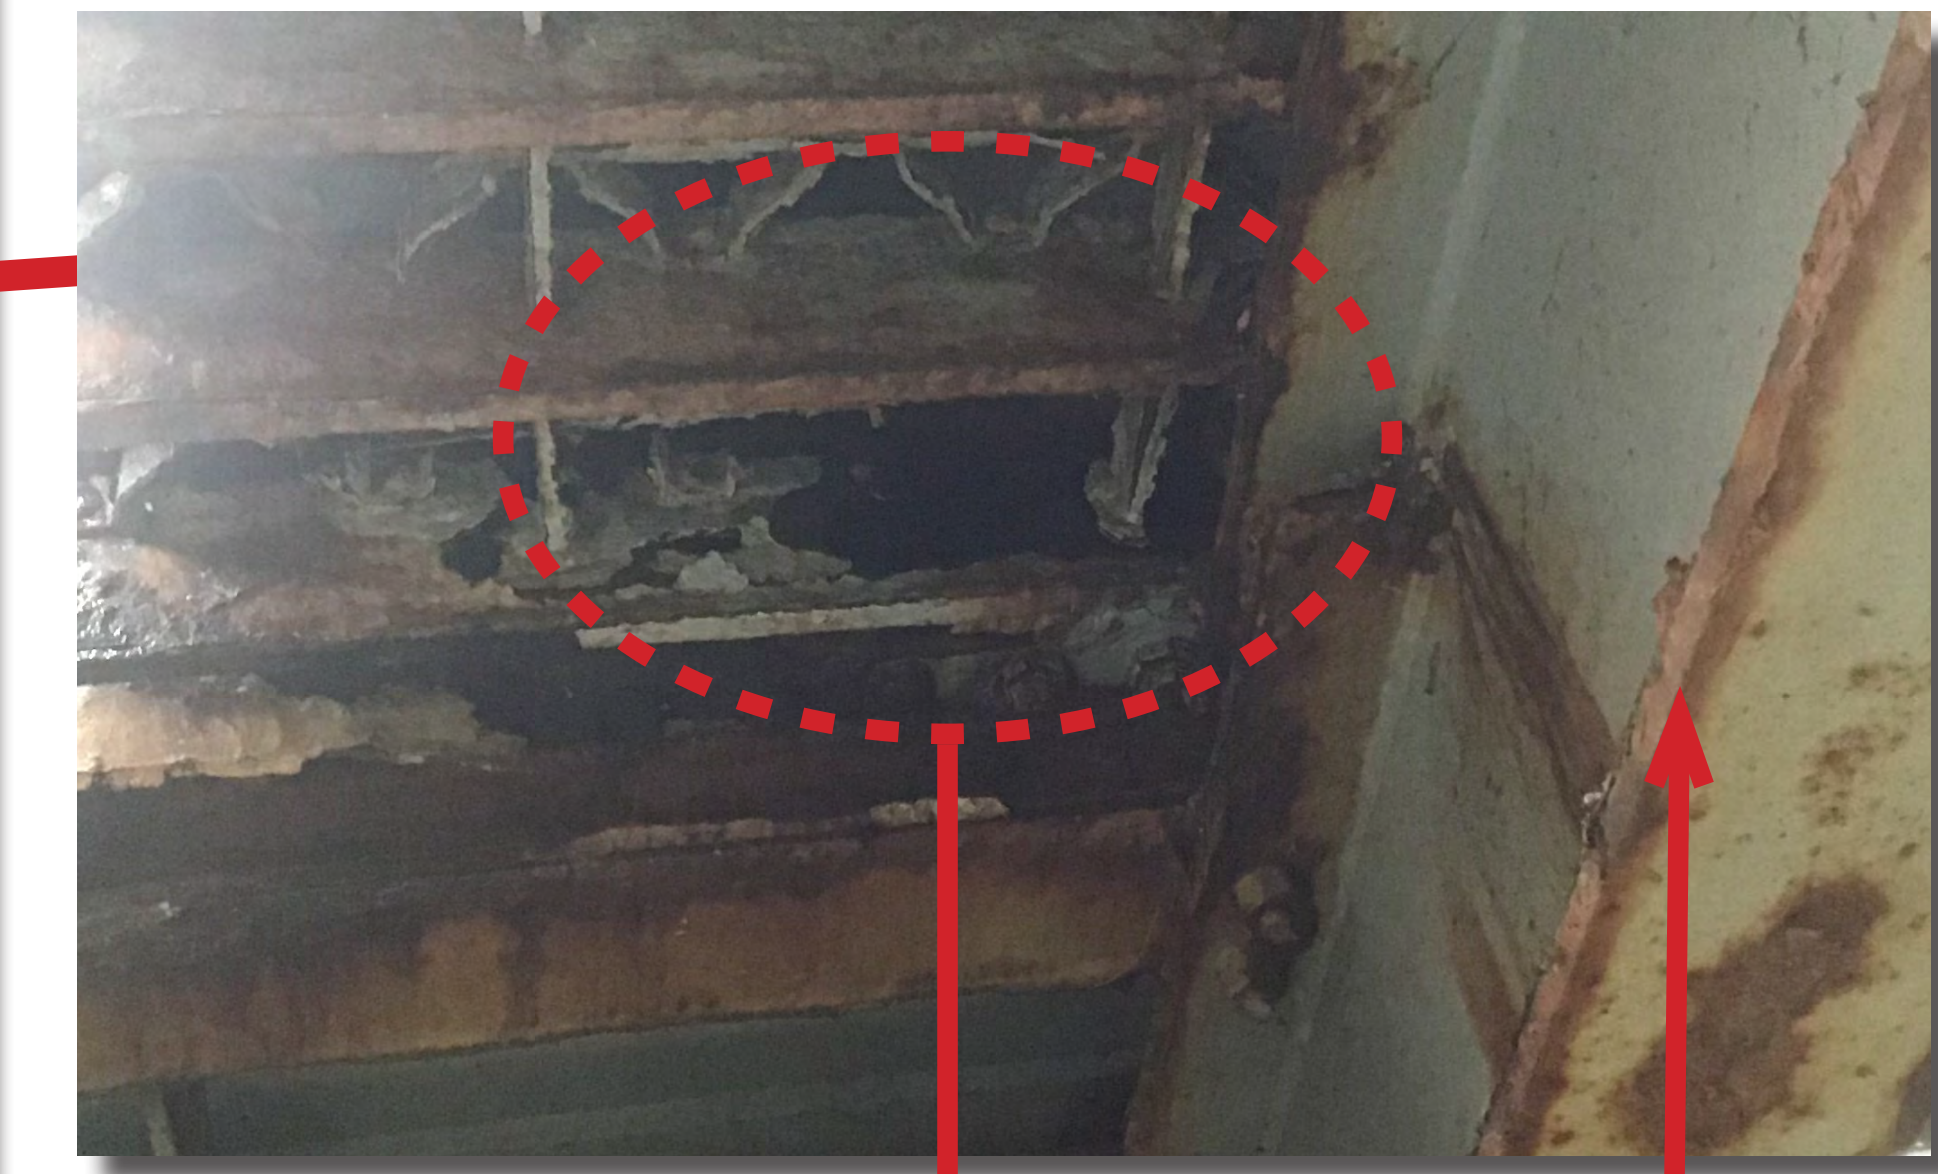
Severe Deterioration under Median Barrier

Corroded Stringer

Replace Median Barrier and Stringers
