# Bridge Deck Thermography Verification and Policy

**Brady Seston, P.E.**  
NDE Department Manager, AECOM

WisDOT ID no. 0092-23-04

September 2024

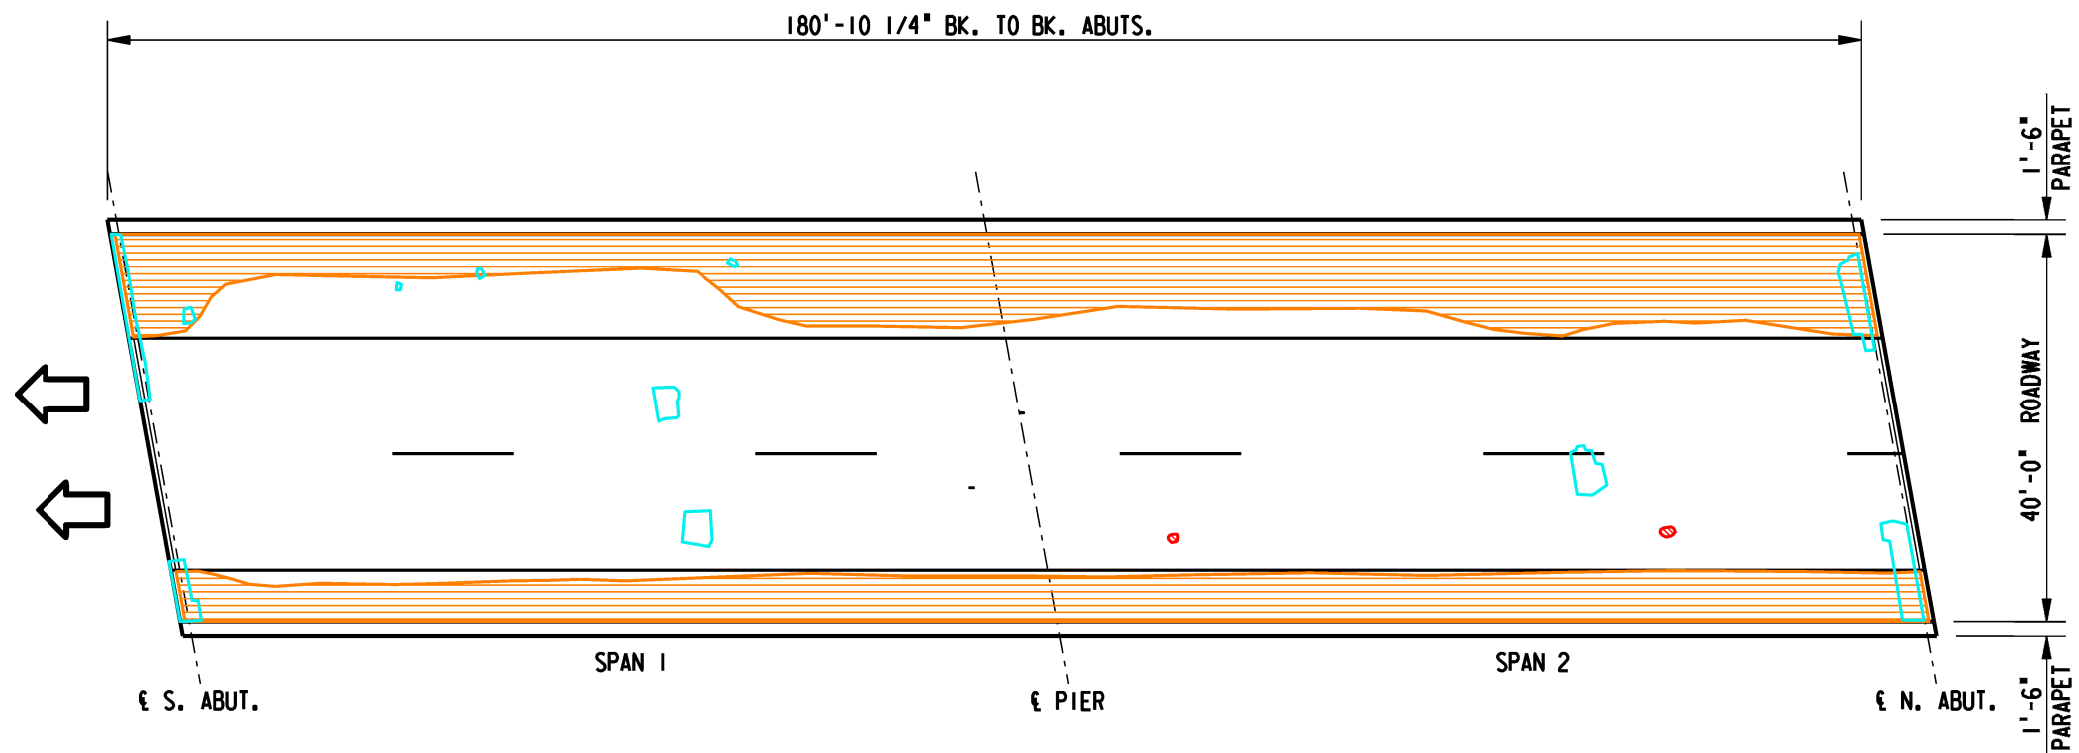
**PLAN**  
**B-5-202**

DEFECT-REHAB COMPARISON		STRUCTURE NO. B-5-202	
ITEM	UNIT	QUANT.	%
TOTAL AREA	ft <sup>2</sup>	7188	
TOTAL DEFECTS*	ft <sup>2</sup>	2	<0.1
TOTAL TYPE-1 REHAB	ft <sup>2</sup>	104	1.5
DEFECTS/REHAB OVERLAP	ft <sup>2</sup>	0	0
IR FALSE POSITIVES	ft <sup>2</sup>	2	<0.1
REHAB NOT DETECTED BY IR	ft <sup>2</sup>	104	1.5

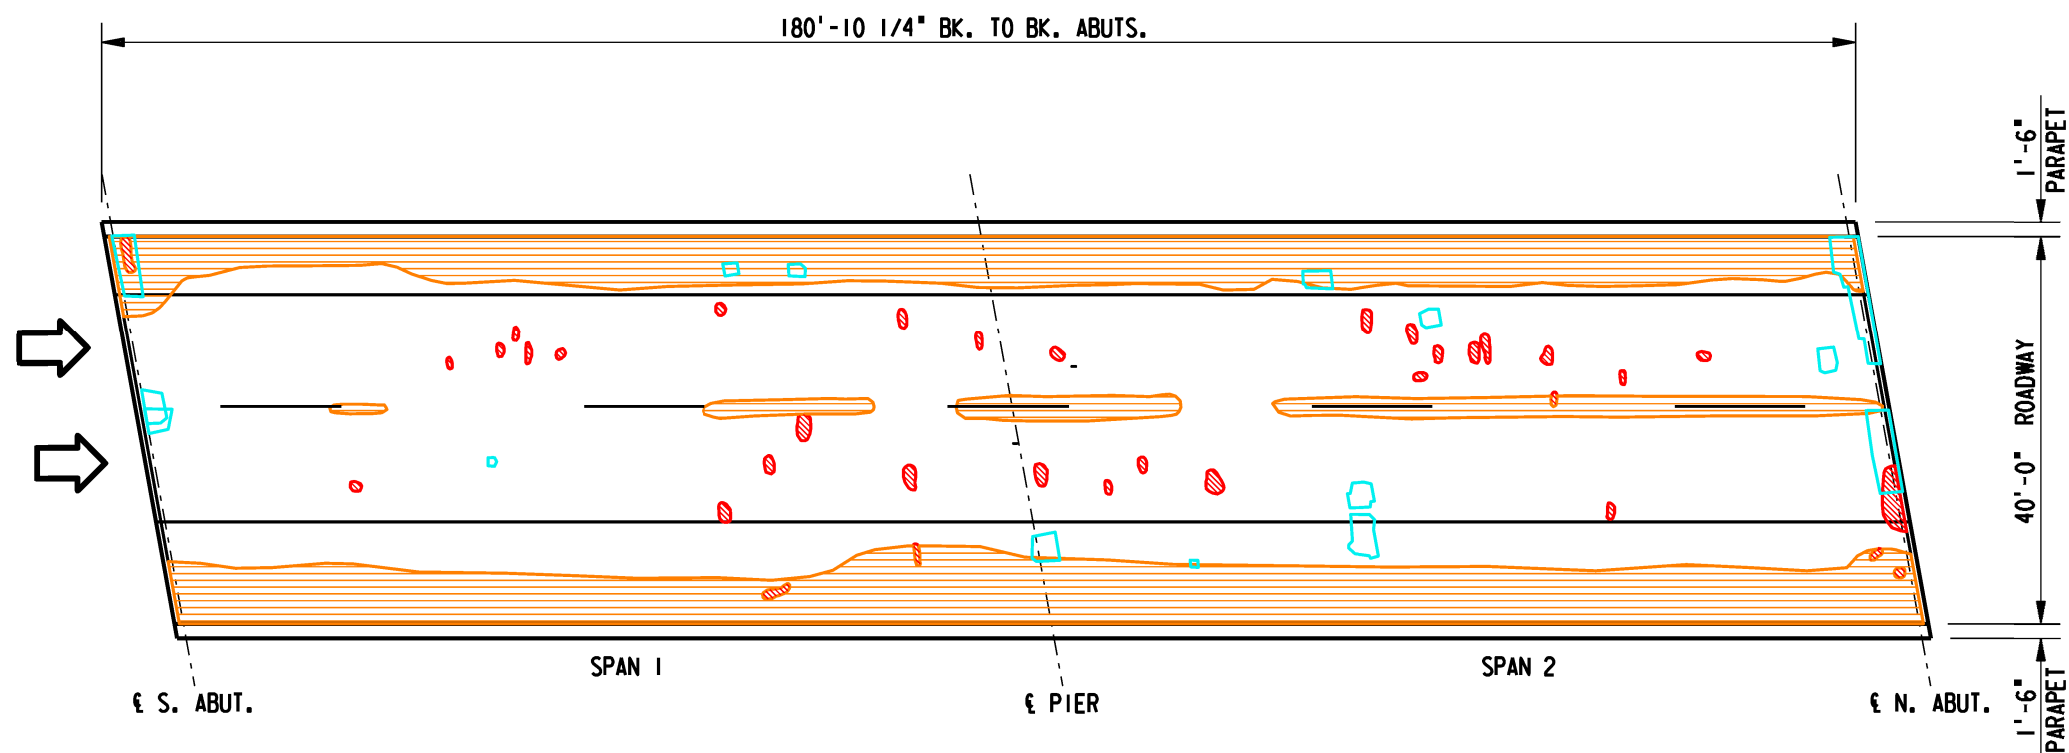
**PLAN**  
**B-5-203**

DEFECT-REHAB COMPARISON		STRUCTURE NO. B-5-203	
ITEM	UNIT	QUANT.	%
TOTAL AREA	ft <sup>2</sup>	7188	
TOTAL DEFECTS*	ft <sup>2</sup>	61	0.8
TOTAL TYPE-1 REHAB	ft <sup>2</sup>	113	1.6
DEFECTS/REHAB OVERLAP	ft <sup>2</sup>	7	0.1
IR FALSE POSITIVES	ft <sup>2</sup>	54	0.8
REHAB NOT DETECTED BY IR	ft <sup>2</sup>	106	1.5

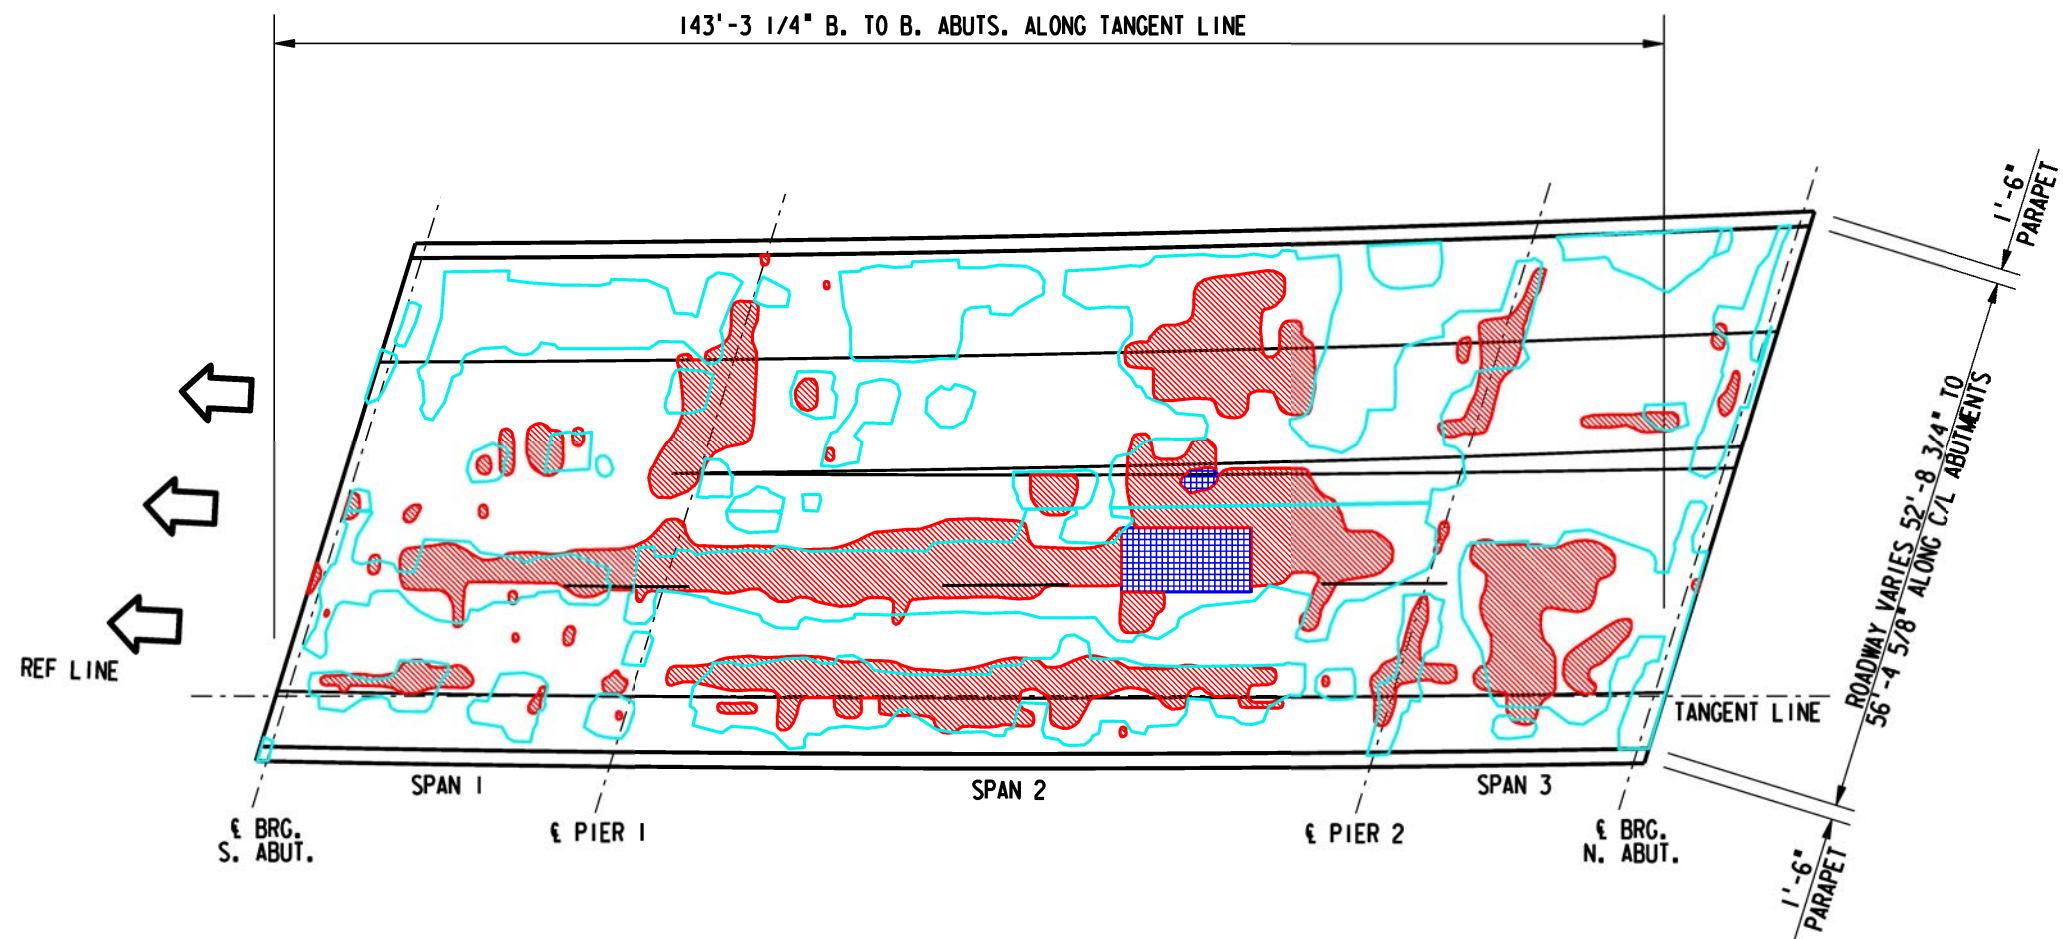
PLAN  
B-5-208

DEFECT-REHAB COMPARISON		STRUCTURE NO. B-5-208	
ITEM	UNIT	QUANT.	%
TOTAL AREA	ft <sup>2</sup>	7454	
TOTAL DEFECTS*	ft <sup>2</sup>	1684	22.6
TOTAL TYPE-1 REHAB	ft <sup>2</sup>	3318	44.5
DEFECTS/REHAB OVERLAP	ft <sup>2</sup>	1377	18.5
IR FALSE POSITIVES	ft <sup>2</sup>	307	4.1
REHAB NOT DETECTED BY IR	ft <sup>2</sup>	1941	26.0

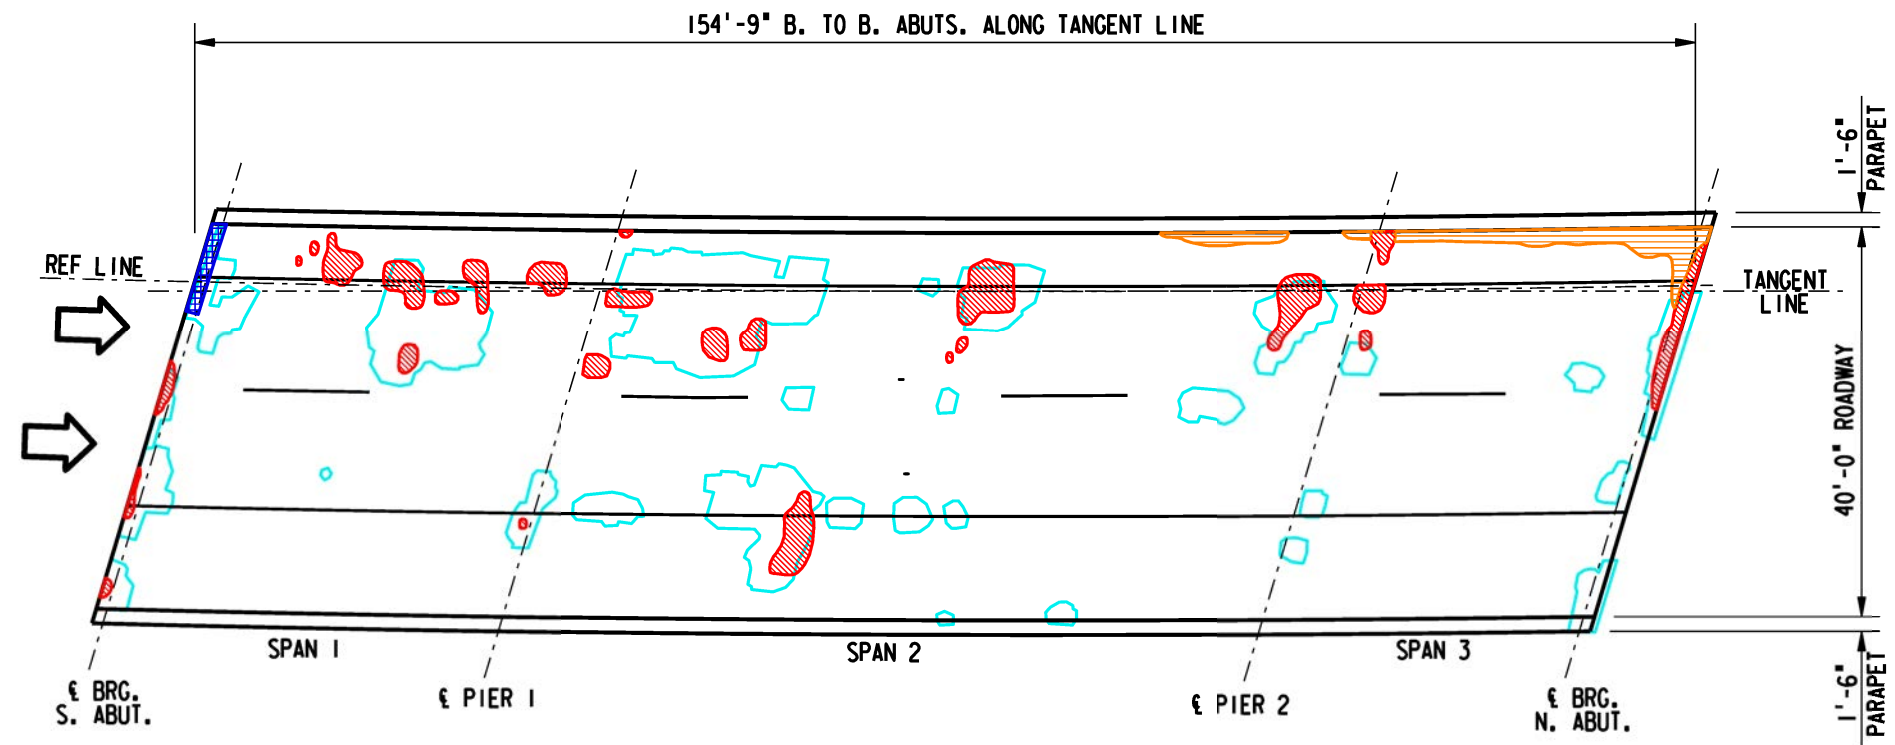
**PLAN**  
**B-5-209**

DEFECT-REHAB COMPARISON		STRUCTURE NO. B-5-209	
ITEM	UNIT	QUANT.	%
TOTAL AREA	ft <sup>2</sup>	6188	
TOTAL DEFECTS*	ft <sup>2</sup>	214	3.5
TOTAL TYPE-1 REHAB	ft <sup>2</sup>	800	12.9
DEFECTS/REHAB OVERLAP	ft <sup>2</sup>	132	2.1
IR FALSE POSITIVES	ft <sup>2</sup>	82	1.3
REHAB NOT DETECTED BY IR	ft <sup>2</sup>	668	10.8

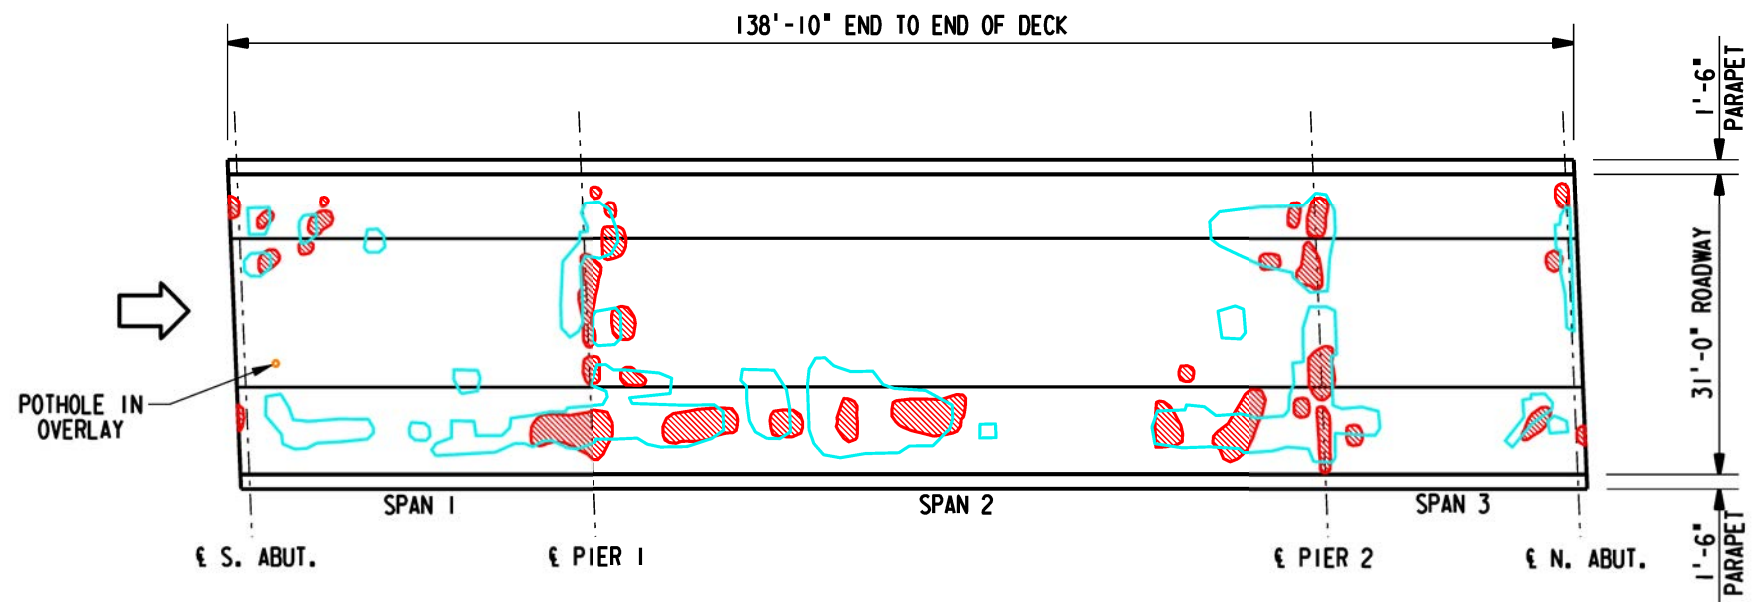
**PLAN**  
**B-5-210**

DEFECT-REHAB COMPARISON		STRUCTURE NO. B-5-210	
ITEM	UNIT	QUANT.	%
TOTAL AREA	ft <sup>2</sup>	4303	
TOTAL DEFECTS*	ft <sup>2</sup>	236	5.5
TOTAL TYPE-1 REHAB	ft <sup>2</sup>	598	13.9
DEFECTS/REHAB OVERLAP	ft <sup>2</sup>	158	3.7
IR FALSE POSITIVES	ft <sup>2</sup>	79	1.8
REHAB NOT DETECTED BY IR	ft <sup>2</sup>	441	10.2

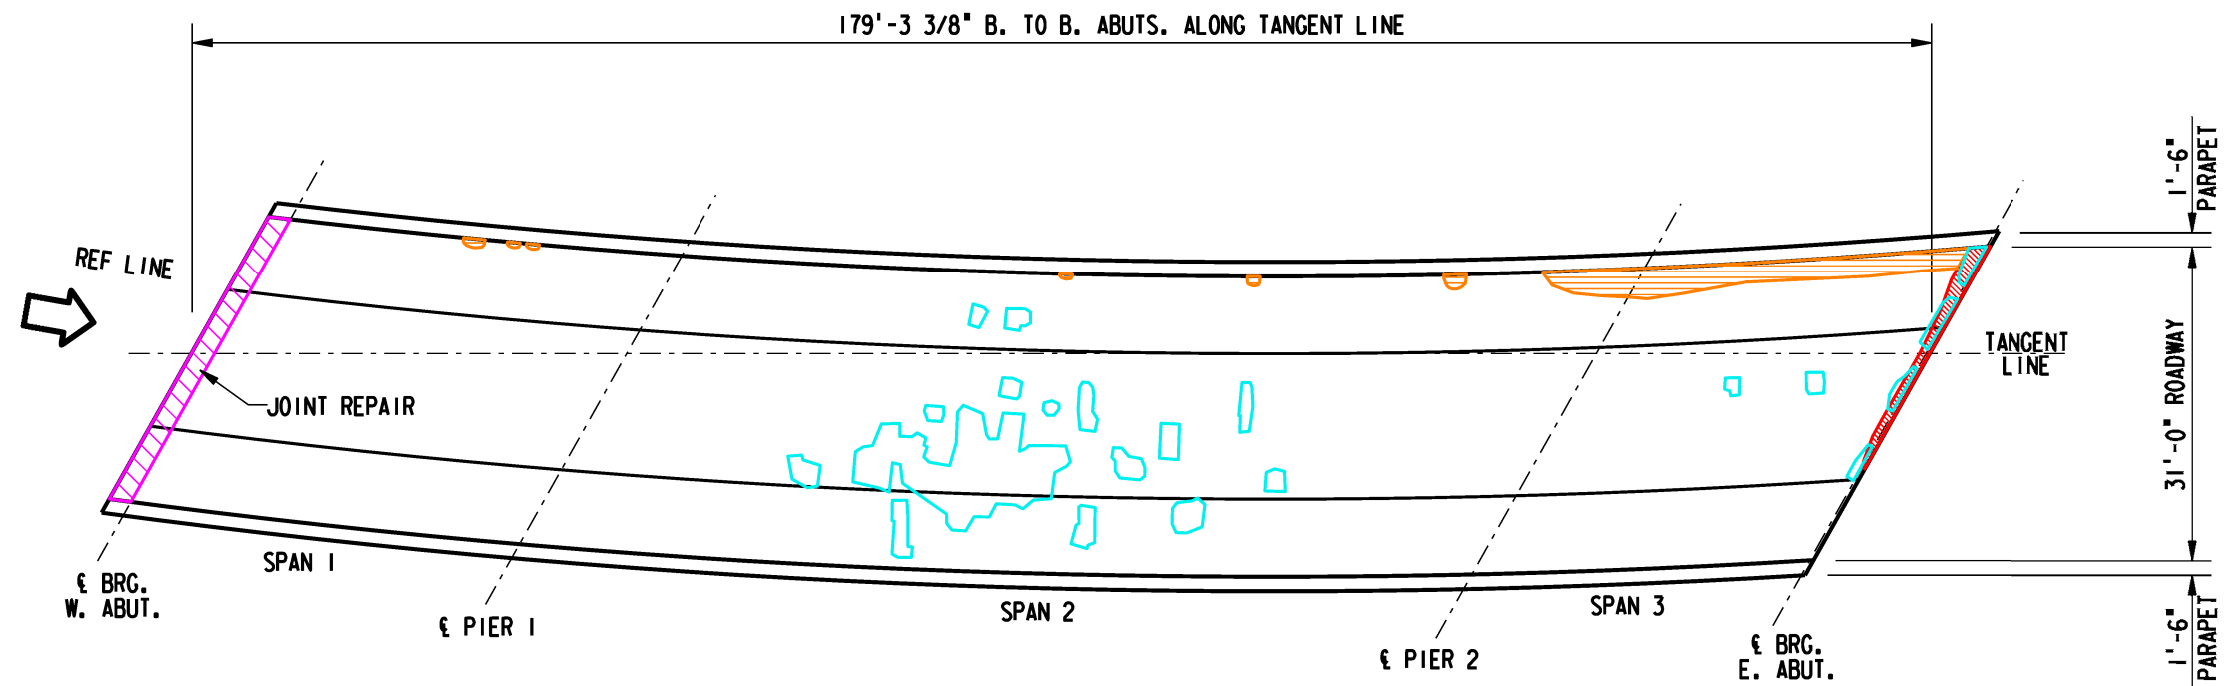
**PLAN**  
**B-5-211**

DEFECT-REHAB COMPARISON		STRUCTURE NO. B-5-211	
ITEM	UNIT	QUANT.	%
TOTAL AREA	ft <sup>2</sup>	5530	
TOTAL DEFECTS*	ft <sup>2</sup>	30	0.5
TOTAL TYPE-1 REHAB	ft <sup>2</sup>	252	4.5
DEFECTS/REHAB OVERLAP	ft <sup>2</sup>	13	0.2
IR FALSE POSITIVES	ft <sup>2</sup>	17	0.3
REHAB NOT DETECTED BY IR	ft <sup>2</sup>	239	4.3

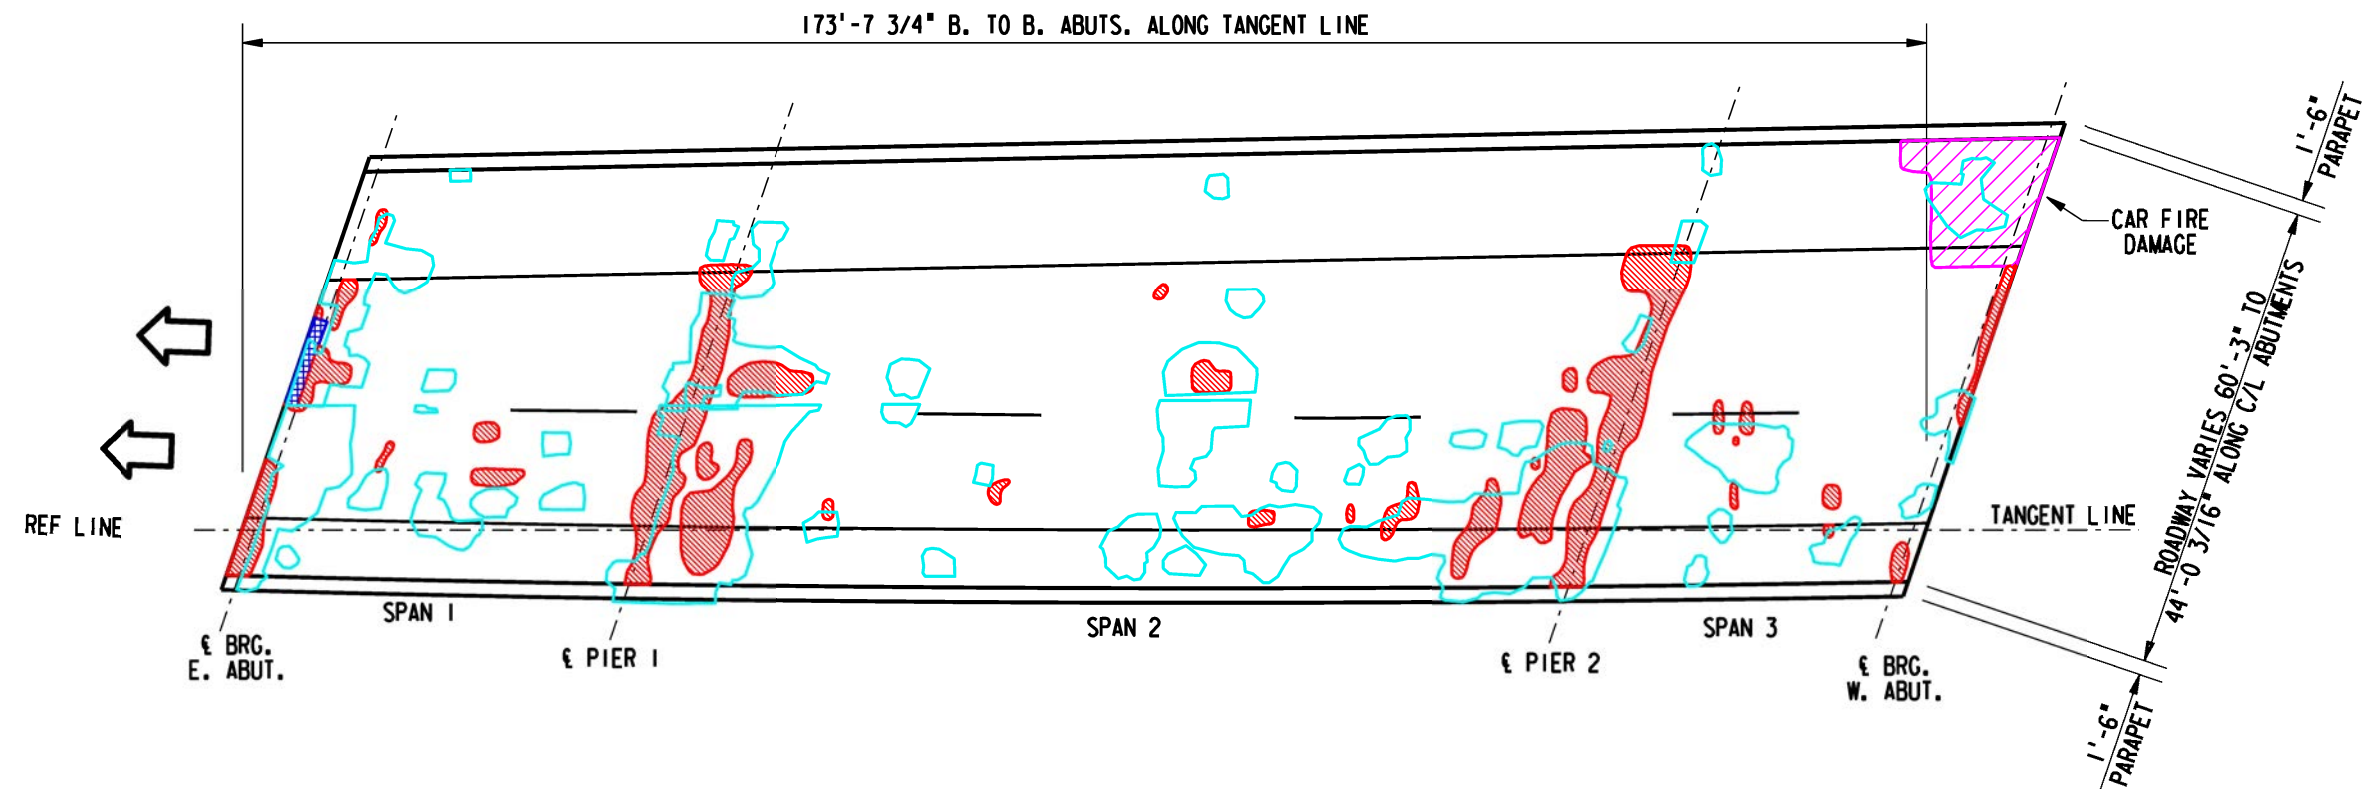
PLAN  
B-5-212

DEFECT-REHAB COMPARISON		STRUCTURE NO. B-5-212	
ITEM	UNIT	QUANT.	%
TOTAL AREA	ft <sup>2</sup>	7578	
TOTAL DEFECTS*	ft <sup>2</sup>	531	7.0
TOTAL TYPE-1 REHAB	ft <sup>2</sup>	1359	17.9
DEFECTS/REHAB OVERLAP	ft <sup>2</sup>	292	3.9
IR FALSE POSITIVES	ft <sup>2</sup>	239	3.2
REHAB NOT DETECTED BY IR	ft <sup>2</sup>	1067	14.1

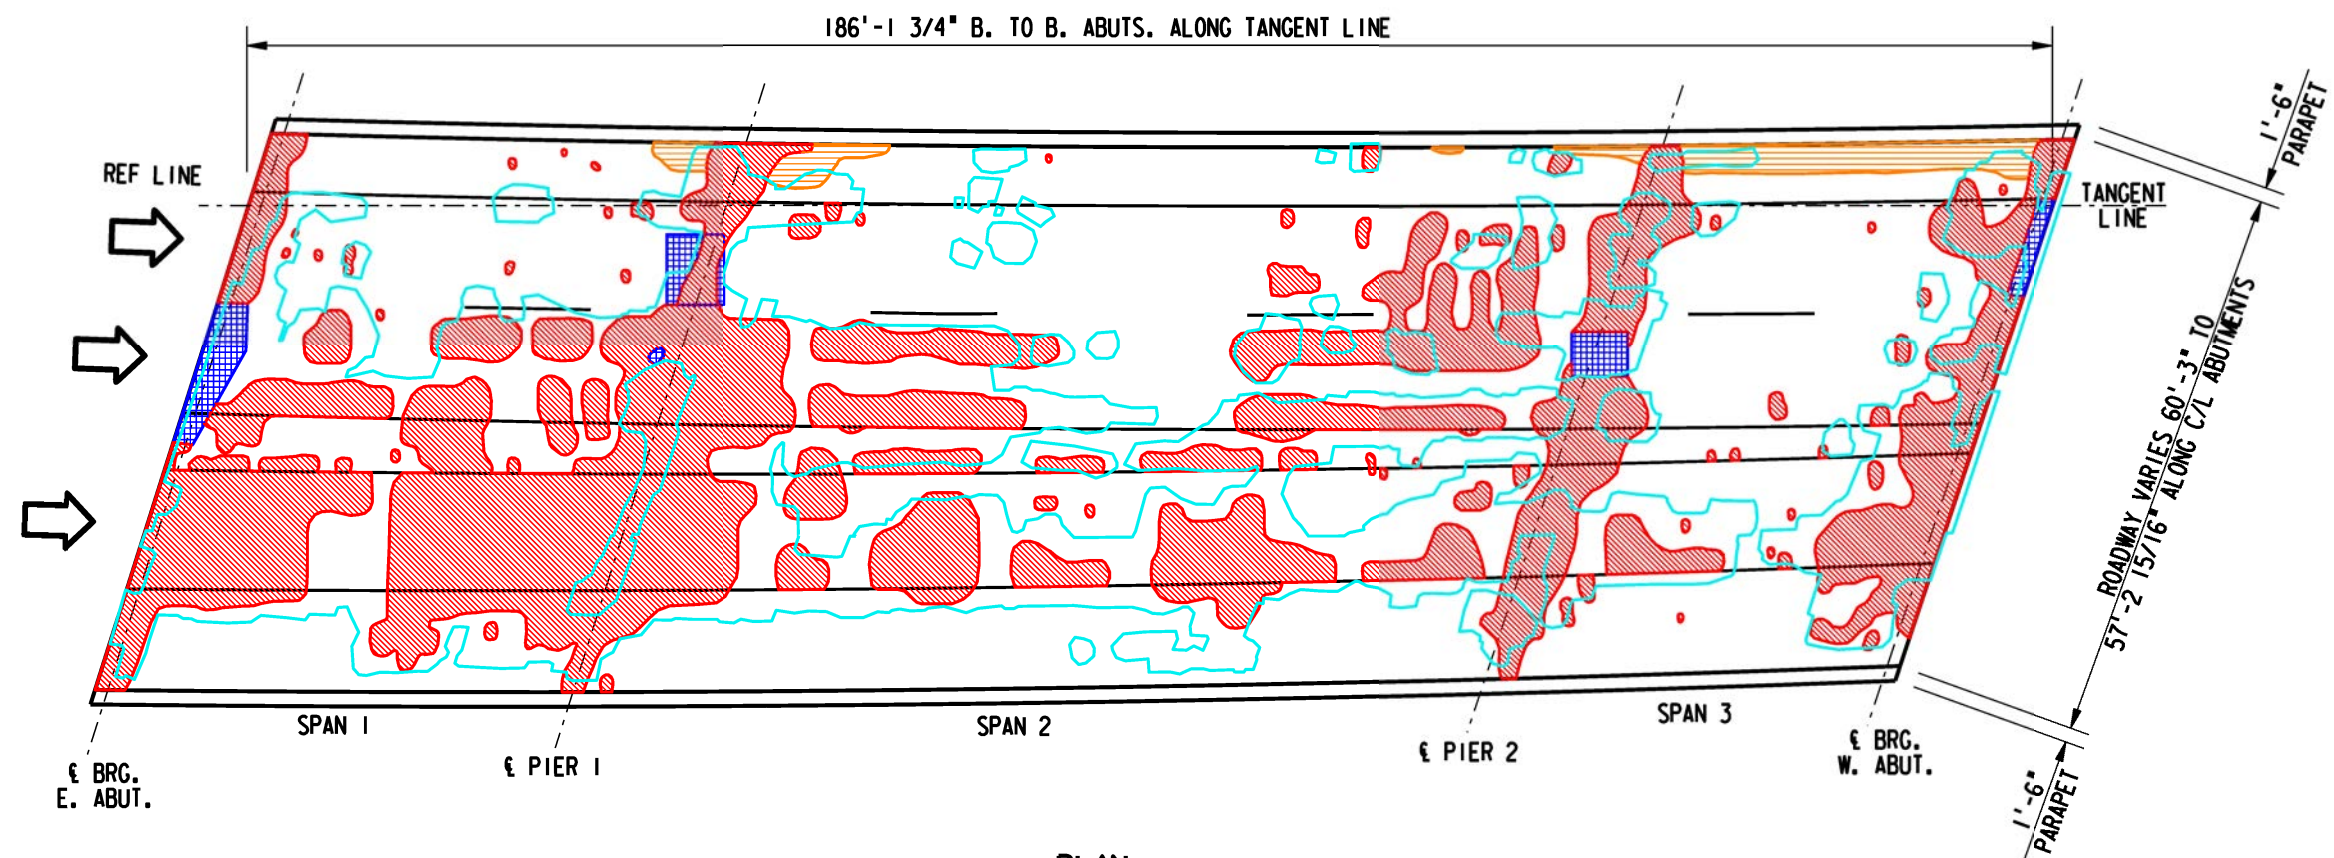
PLAN  
B-5-213

DEFECT-REHAB COMPARISON		STRUCTURE NO. B-5-213	
ITEM	UNIT	QUANT.	%
TOTAL AREA	ft <sup>2</sup>	10364	
TOTAL DEFECTS*	ft <sup>2</sup>	3470	33.5
TOTAL TYPE-1 REHAB	ft <sup>2</sup>	4850	46.8
DEFECTS/REHAB OVERLAP	ft <sup>2</sup>	2732	26.4
IR FALSE POSITIVES	ft <sup>2</sup>	738	7.1
REHAB NOT DETECTED BY IR	ft <sup>2</sup>	2118	20.4

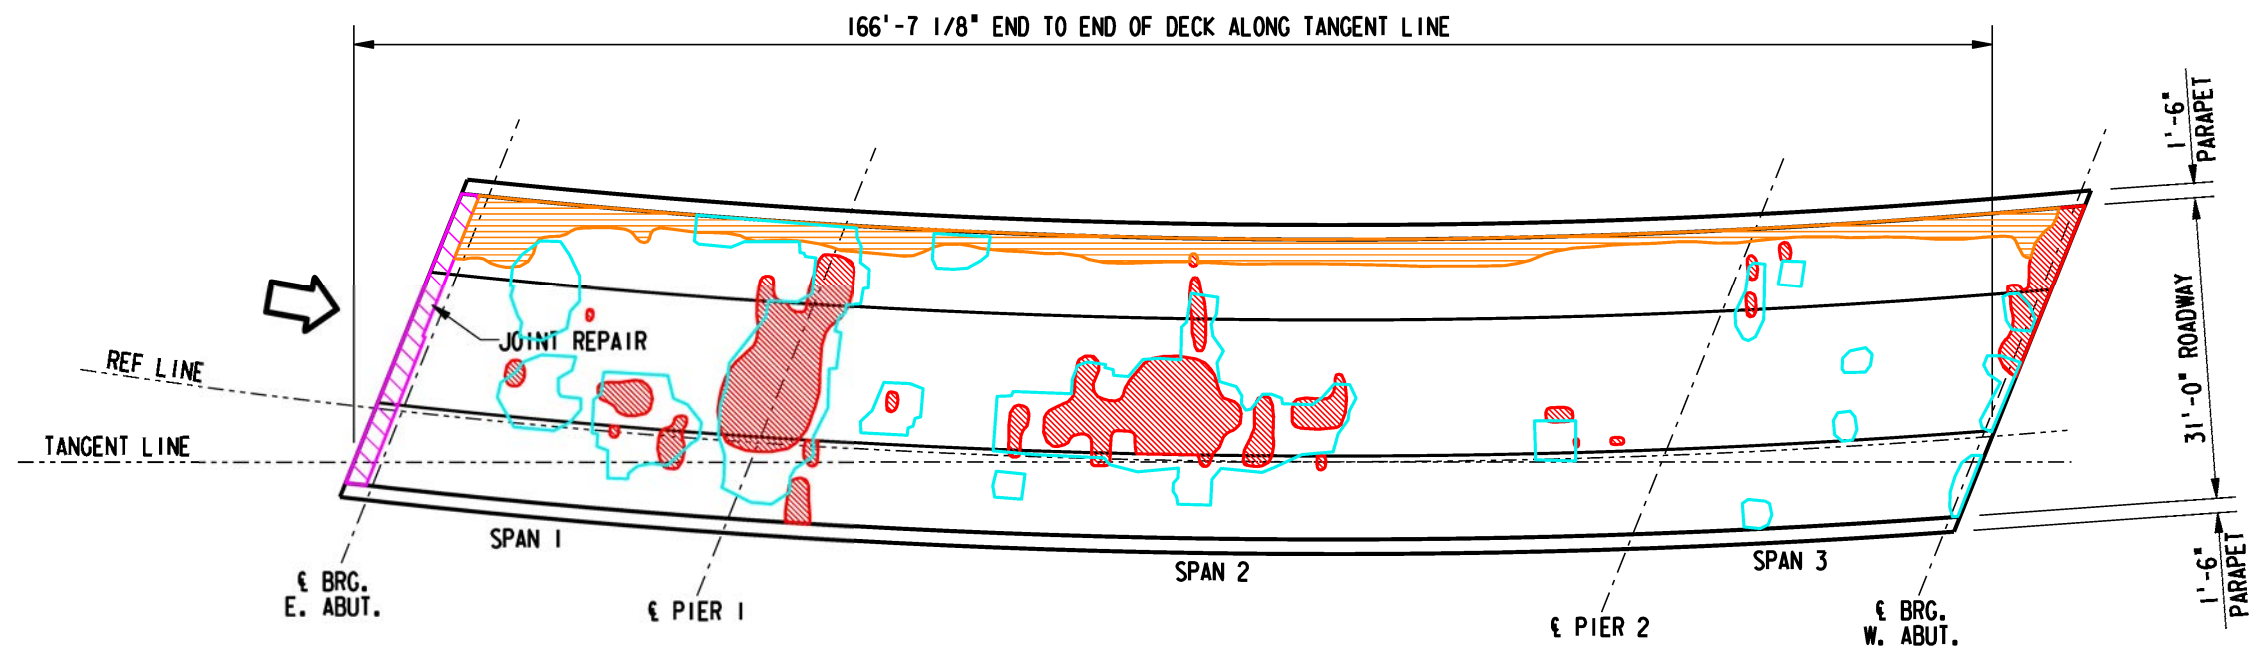
**PLAN**  
**B-5-214**

DEFECT-REHAB COMPARISON		STRUCTURE NO. B-5-214	
ITEM	UNIT	QUANT.	%
TOTAL AREA	ft <sup>2</sup>	5137	
TOTAL DEFECTS*	ft <sup>2</sup>	459	8.9
TOTAL TYPE-1 REHAB	ft <sup>2</sup>	929	18.1
DEFECTS/REHAB OVERLAP	ft <sup>2</sup>	378	7.4
IR FALSE POSITIVES	ft <sup>2</sup>	82	1.6
REHAB NOT DETECTED BY IR	ft <sup>2</sup>	552	10.7

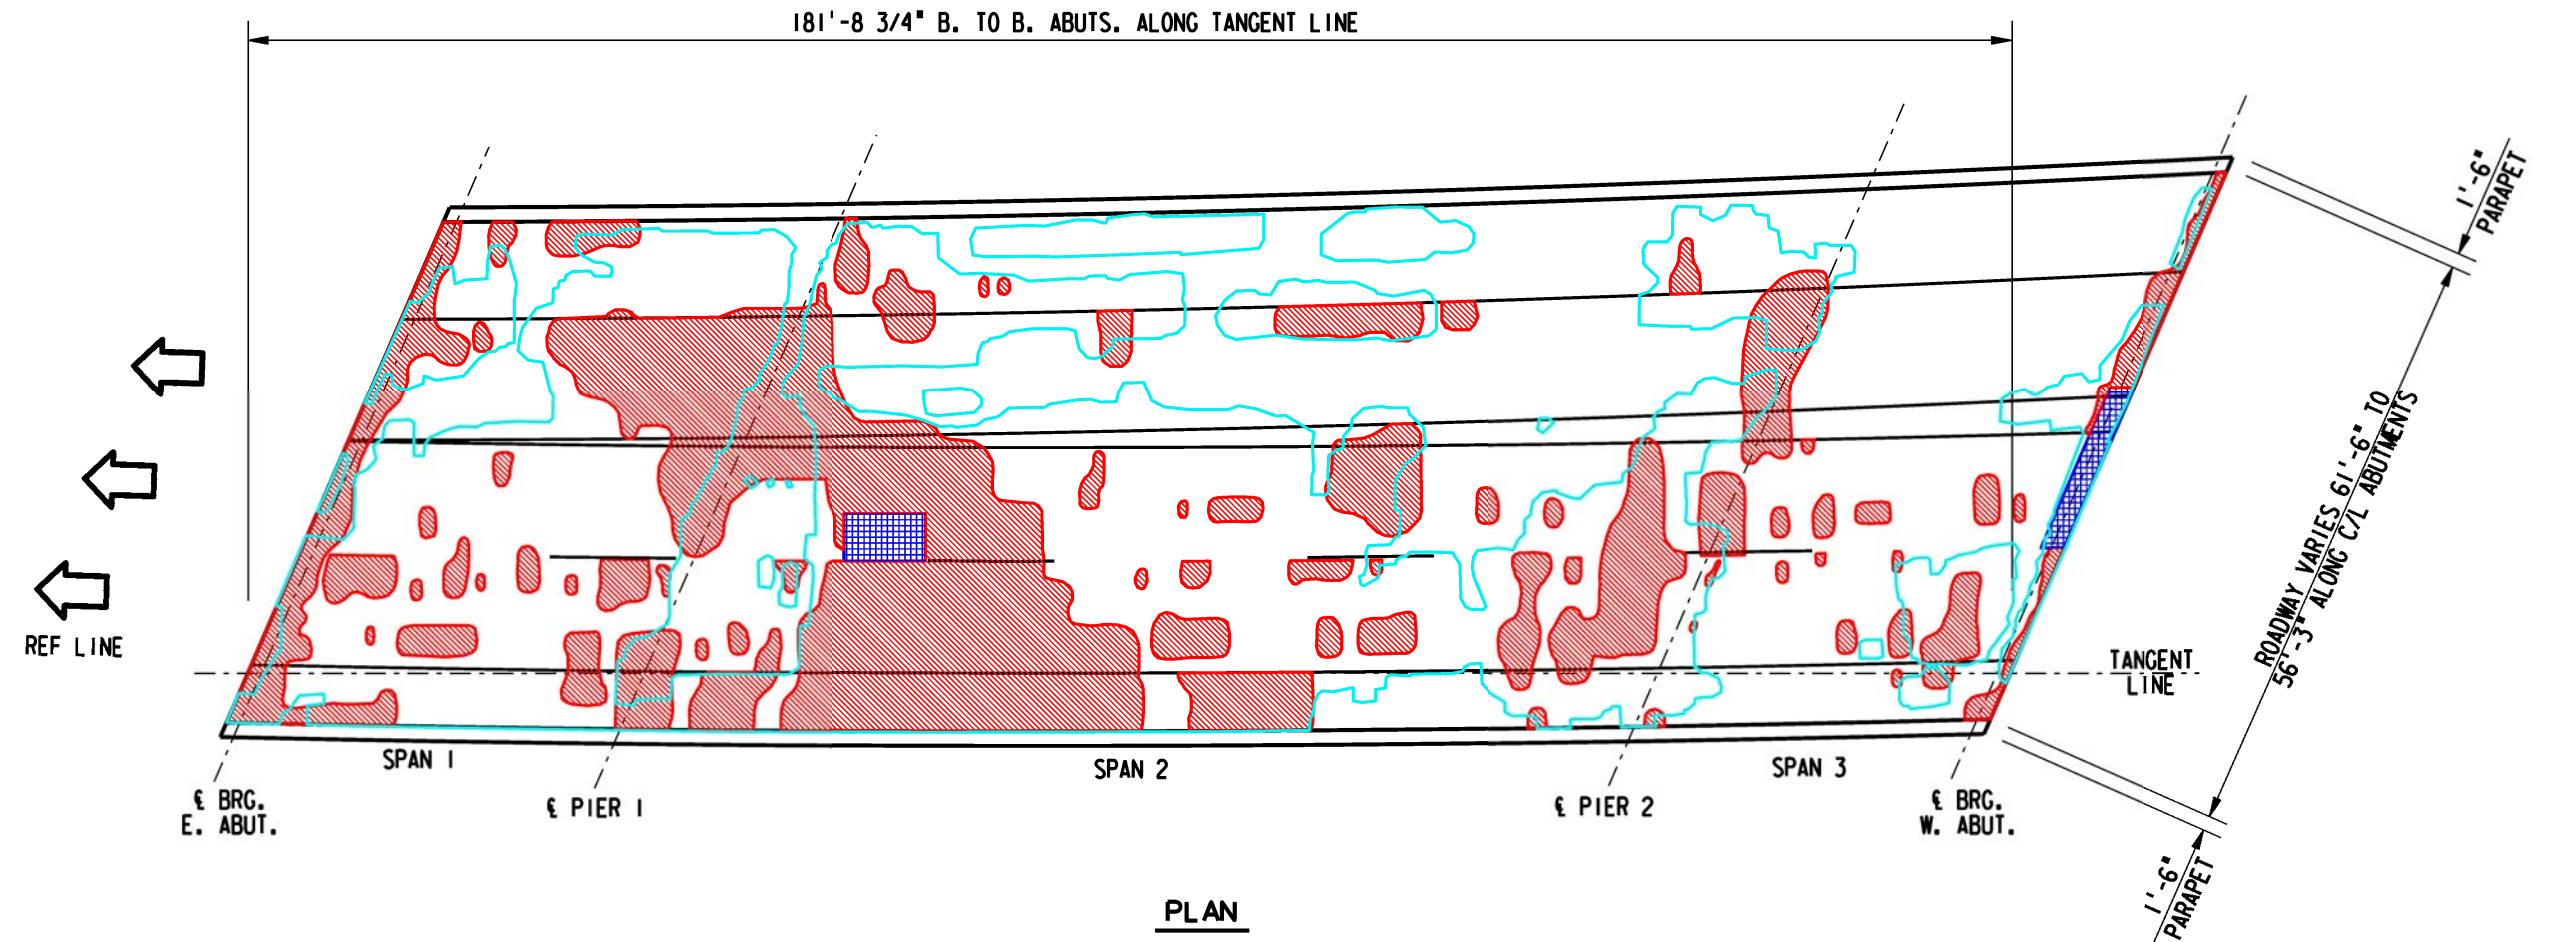
PLAN  
B-5-215

DEFECT-REHAB COMPARISON		STRUCTURE NO. B-5-215	
ITEM	UNIT	QUANT.	%
TOTAL AREA	ft <sup>2</sup>	9826	
TOTAL DEFECTS*	ft <sup>2</sup>	2783	28.3
TOTAL TYPE-1 REHAB	ft <sup>2</sup>	5688	57.9
DEFECTS/REHAB OVERLAP	ft <sup>2</sup>	2271	23.1
IR FALSE POSITIVES	ft <sup>2</sup>	512	5.2
REHAB NOT DETECTED BY IR	ft <sup>2</sup>	3417	34.8

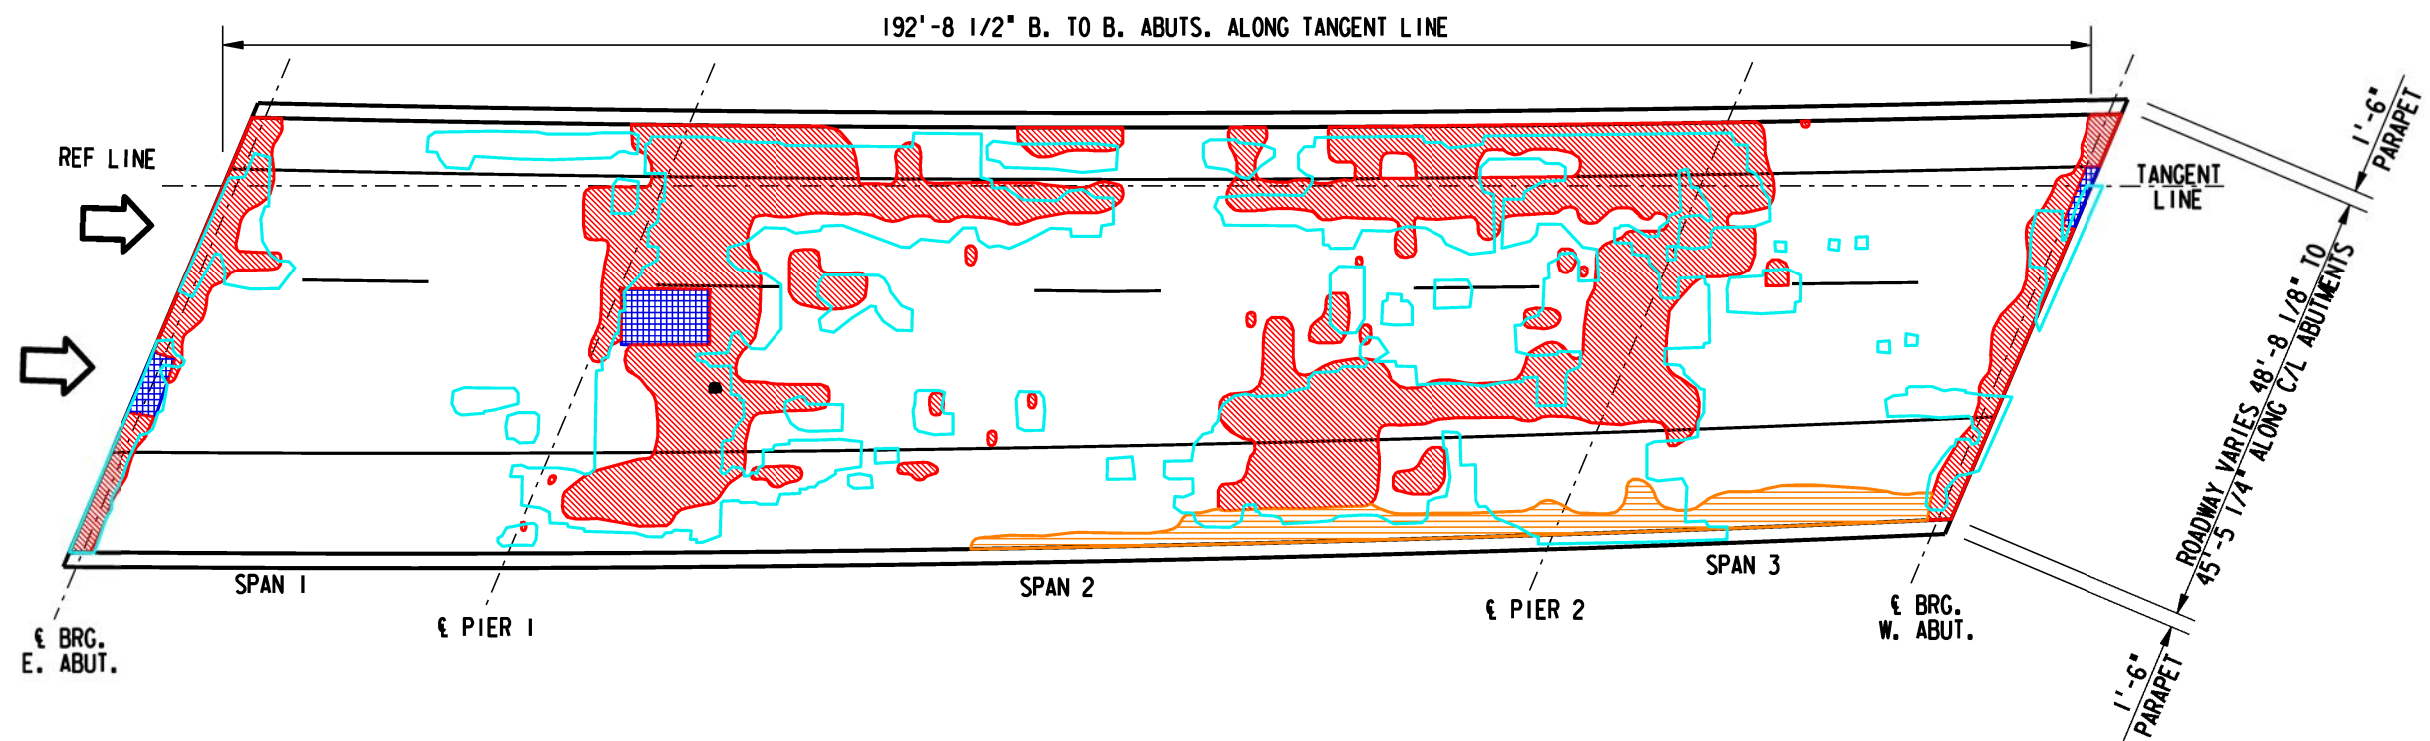
PLAN  
B-5-216

DEFECT-REHAB COMPARISON		STRUCTURE NO. B-5-216	
ITEM	UNIT	QUANT.	%
TOTAL AREA	ft <sup>2</sup>	8445	
TOTAL DEFECTS*	ft <sup>2</sup>	2208	26.2
TOTAL TYPE-1 REHAB	ft <sup>2</sup>	2846	33.7
DEFECTS/REHAB OVERLAP	ft <sup>2</sup>	1608	19.0
IR FALSE POSITIVES	ft <sup>2</sup>	601	7.1
REHAB NOT DETECTED BY IR	ft <sup>2</sup>	1238	14.7

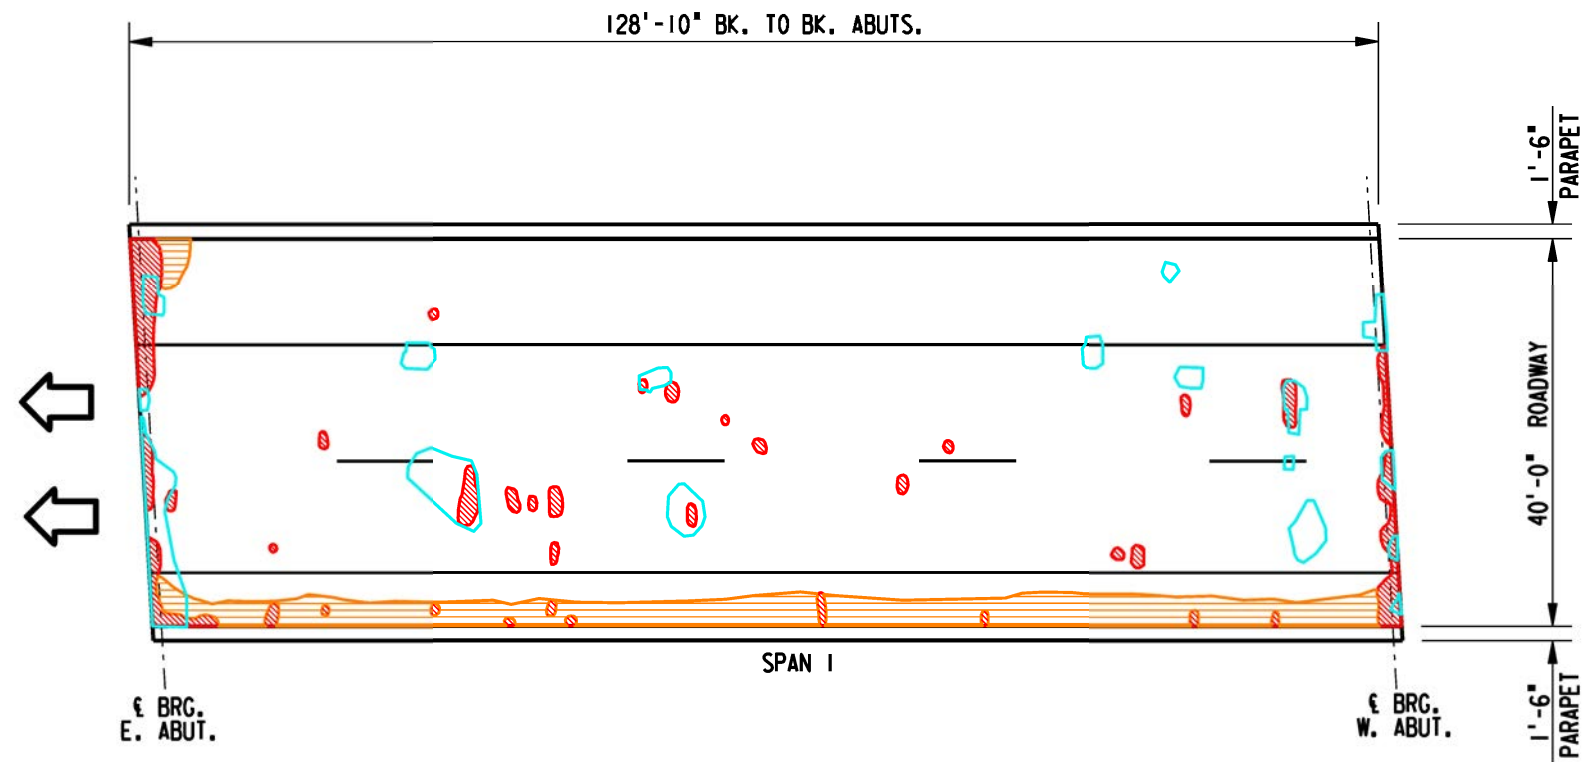
PLAN  
B-5-219

DEFECT-REHAB COMPARISON		STRUCTURE NO. B-5-219	
ITEM	UNIT	QUANT.	%
TOTAL AREA	ft <sup>2</sup>	5152	
TOTAL DEFECTS*	ft <sup>2</sup>	144	2.8
TOTAL TYPE-1 REHAB	ft <sup>2</sup>	185	3.6
DEFECTS/REHAB OVERLAP	ft <sup>2</sup>	47	0.9
IR FALSE POSITIVES	ft <sup>2</sup>	98	1.9
REHAB NOT DETECTED BY IR	ft <sup>2</sup>	138	2.7

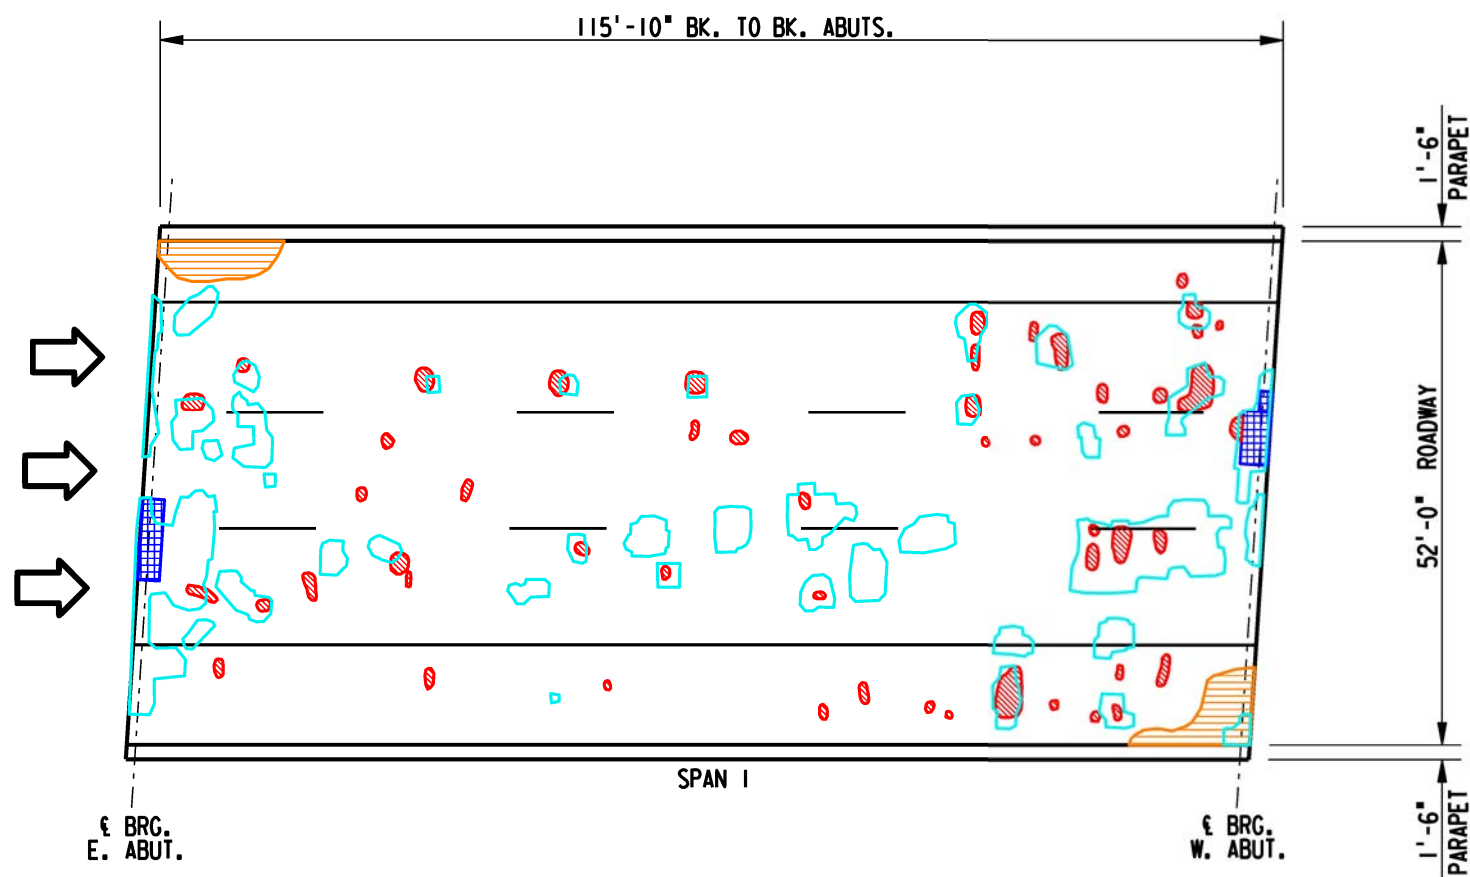
PLAN  
B-5-220

DEFECT-REHAB COMPARISON		STRUCTURE NO. B-5-220	
ITEM	UNIT	QUANT.	%
TOTAL AREA	ft <sup>2</sup>	6022	
TOTAL DEFECTS*	ft <sup>2</sup>	149	2.5
TOTAL TYPE-1 REHAB	ft <sup>2</sup>	617	10.2
DEFECTS/REHAB OVERLAP	ft <sup>2</sup>	95	1.6
IR FALSE POSITIVES	ft <sup>2</sup>	54	0.9
REHAB NOT DETECTED BY IR	ft <sup>2</sup>	522	8.7
