Investigation of MSE Wall Corrosion in Wisconsin

> Prepared by: Geocomp, Inc. Acton, MA

WisDOT ID no. 0092-24-02

June 2025

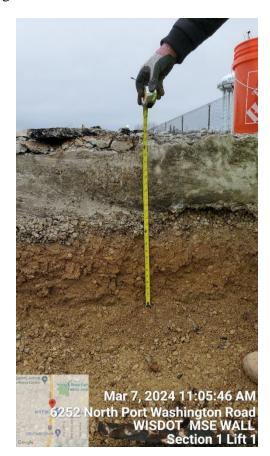
Figure 20. Concrete slab and underlying layers at the Section 1's excavation trench.

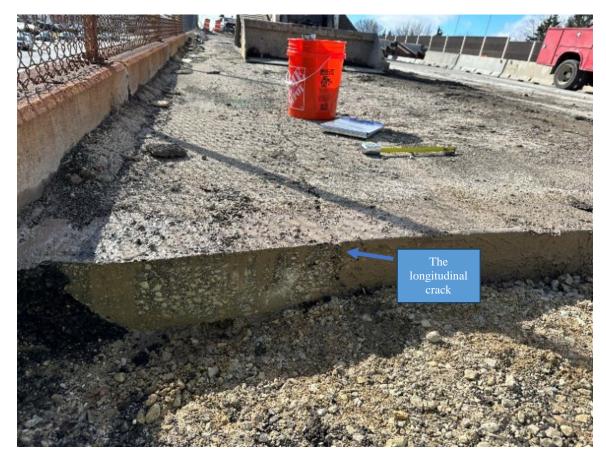
Figure 21. The longitudinal crack on the shoulder pavement along the MSE wall at Section 3.

- Regularly maintain pavement surfaces and drainage structures associated with MSE walls
 reinforced with metallic elements to prevent moisture and salt intrusion. It is also
 recommended to conduct annual inspections and make necessary repairs prior to the onset
 of winter.
- 2. Give special attention to pavement directly above the reinforced zone, ensuring cracks and concrete joints are routinely sealed to prevent moisture and salt intrusion.

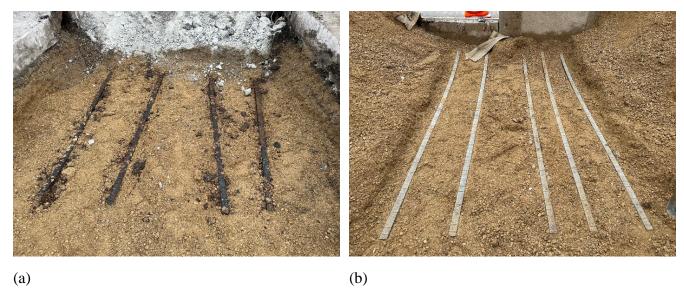
Figure 22. Photographs of reinforcing straps in (a) Section 1 lift 1 and (b) Section 3 lift 4.

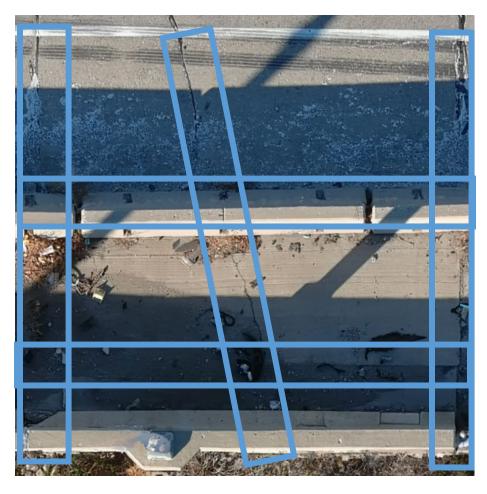
Figure 35. Cracks and concrete joints considered for calculation of crack infiltration rate in Section 1.

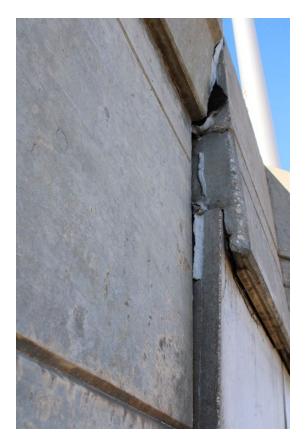
Figure 45. The 4-inch outward displacement of the top panel immediately next to the bridge abutment.
