WISCONSIN HIGHWAY RESEARCH PROGRAM

1. Report No. 0092-15-02	2. Government Accession No	3. Recipient's Catalog No	
4. Title and Subtitle Evaluation of Performance of Innovative Bridges in Wisconsin		5. Report Date July 2016	6. Performing Organization Code

EVALUATION OF PERFORMANCE OF INNOVATIVE BRIDGES IN WISCONSIN

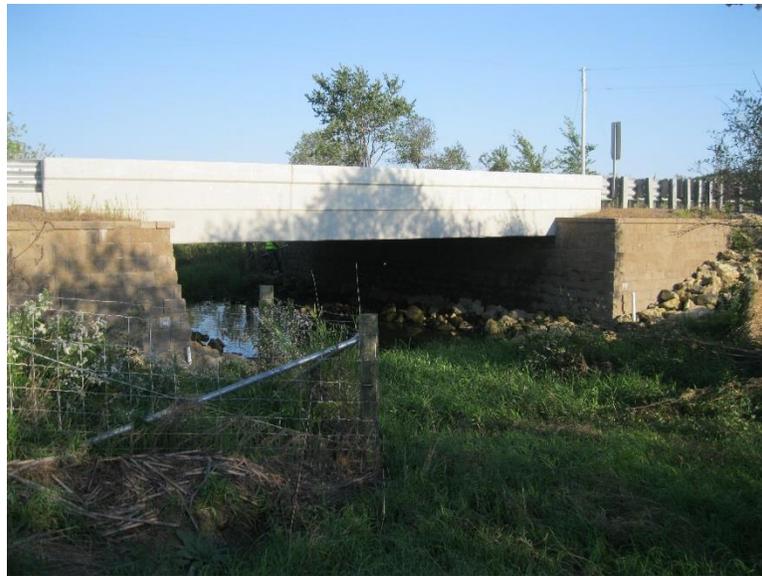
On September 15, 2015, the bridge was visited and a visual inspection was completed. The inspection consisted of a cursory review of the GRS abutments, shown in Figure 49, and a more in depth inspection of the cast-in-place slab superstructure.

Figure 49. SH 40 over Hay Creek general bridge condition

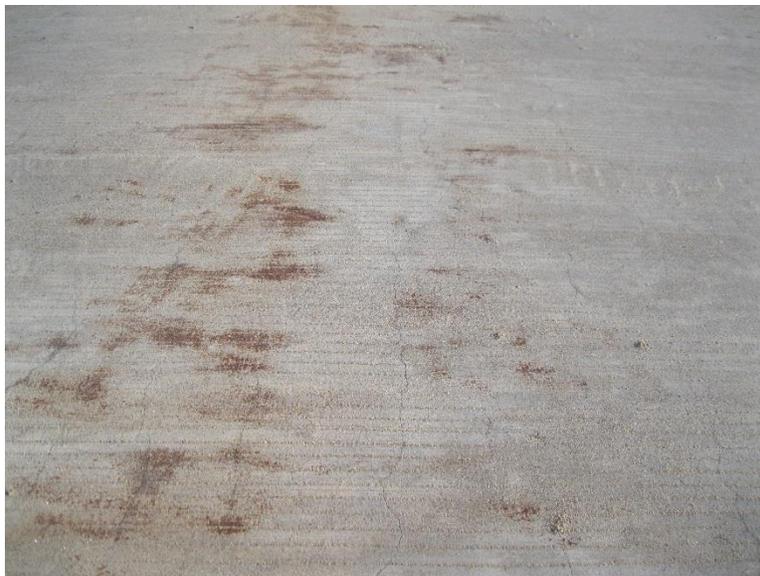
In contrast to the bottom surface of the superstructure, longitudinal cracking was observed on the top surface, although not to the extent of that seen on the underside (see Figure 53).

Figure 53. SH 40 over Hay Creek longitudinal cracking on deck surface

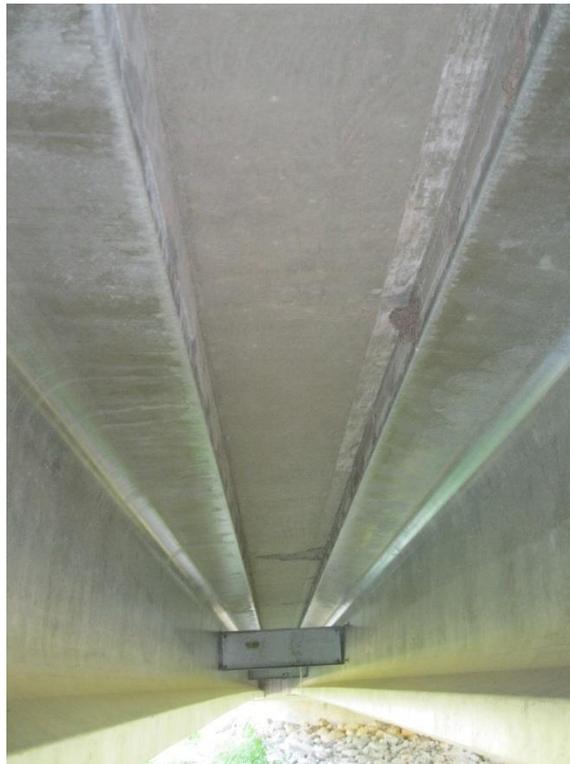
The underside of the deck showed very little degradation or cracking and appeared in very good overall condition. See Figure 93.

Figure 93. US 151 over De Neveu Creek underside condition

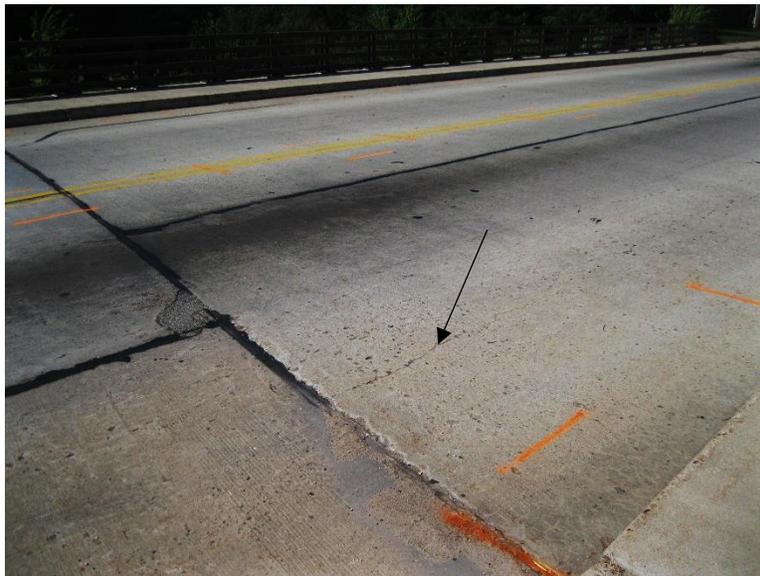
Figure 103. US 12 over Coffee Creek deck crack – 1

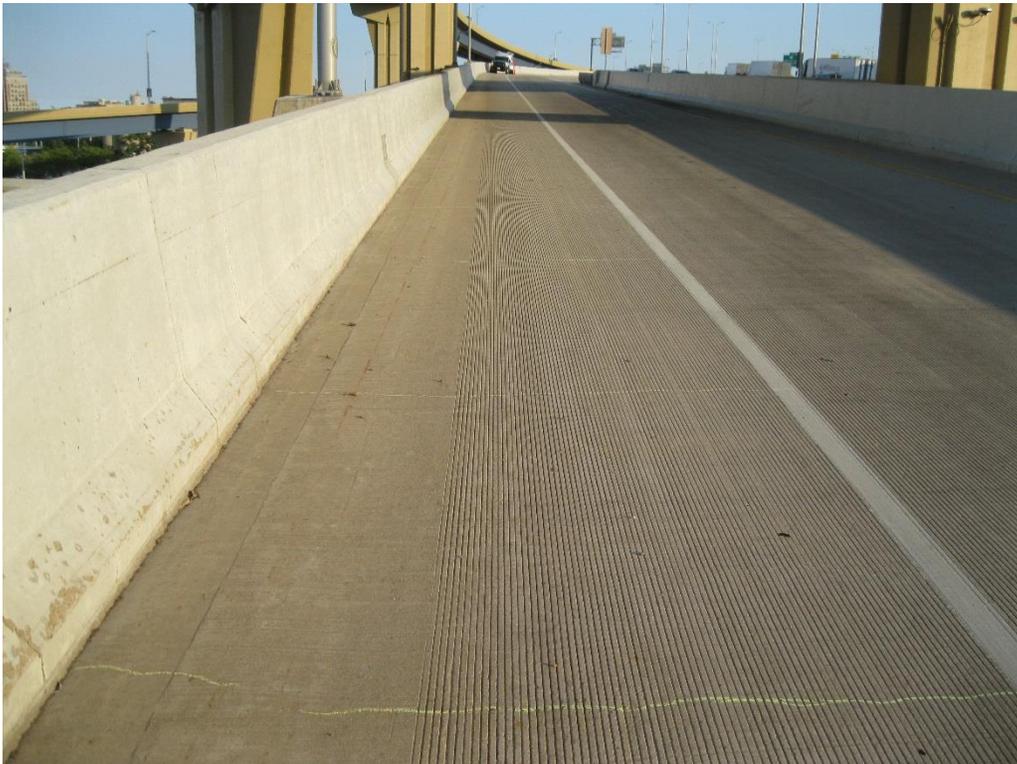
Figure 129. IH 43 northbound to Michigan Avenue south end of Span 2 transverse cracks

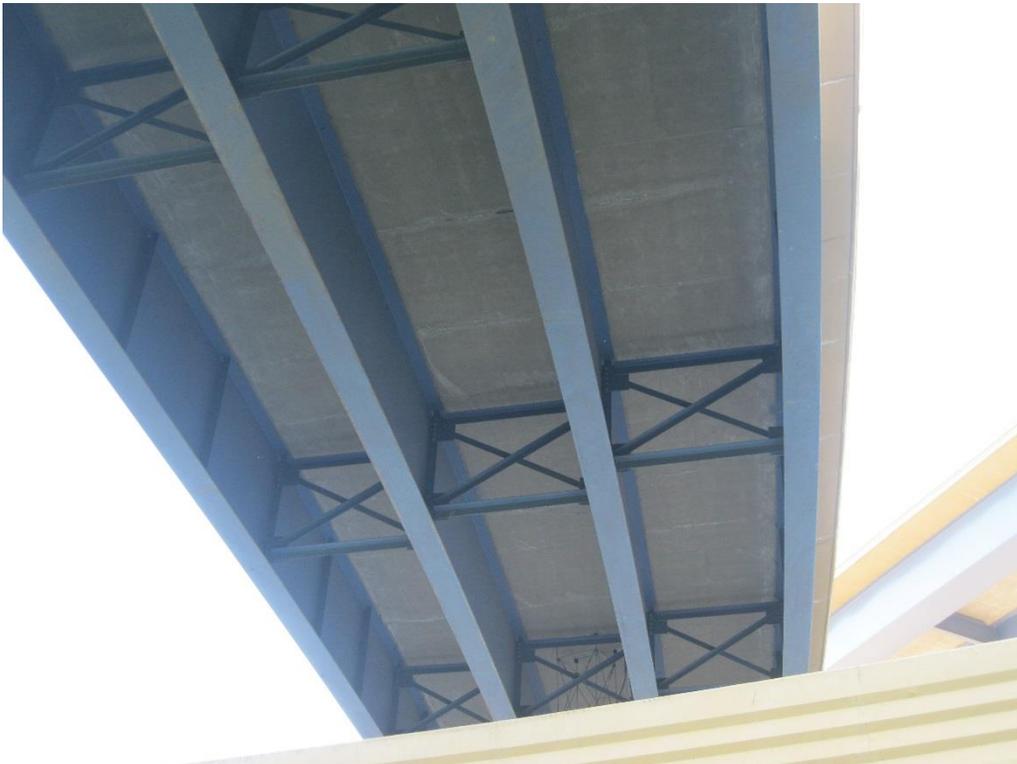
Figure 135. IH 43 northbound to Michigan Avenue chloride staining on deck underside – 2
