HIGHWAY WORK PROPOSAL – RAZING AND REMOVING

COUNTY	STATE PROJECT ID	PROJECT DESCRIPTION	HIGHWAY
Milwaukee	1229-04-21, Parcels 2, 4, 6	I-43 North South Freeway Silver Spring to STH 60	USH 43
Milwaukee	1229-04-24, Parcel 9	I-43 North South Freeway Silver Spring to County Line Rd	USH 43

Type of Work
Razing and Removing

Asbestos-Containing Material and Pre-Demolition Reconnaissance

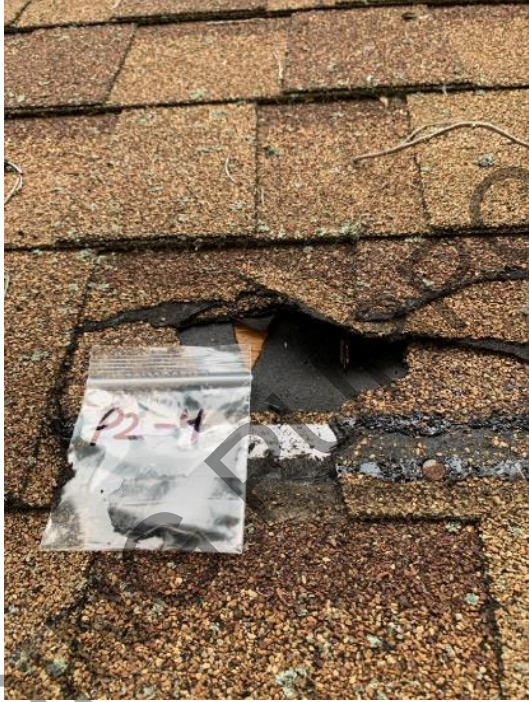
Client Name: WisDOT		Site Location: 6374 N. Port Washington Rd (Parcel 2), Glendale, Milwaukee County	Project No.: WisDOT #1229-04-21 TRC# 441231.0000
Photo No. 9	Date 7/21/2021

Description Roofing paper and shingles on house roof, both non- detect for ACM			
Photo No. 10	Date 7/21/2021

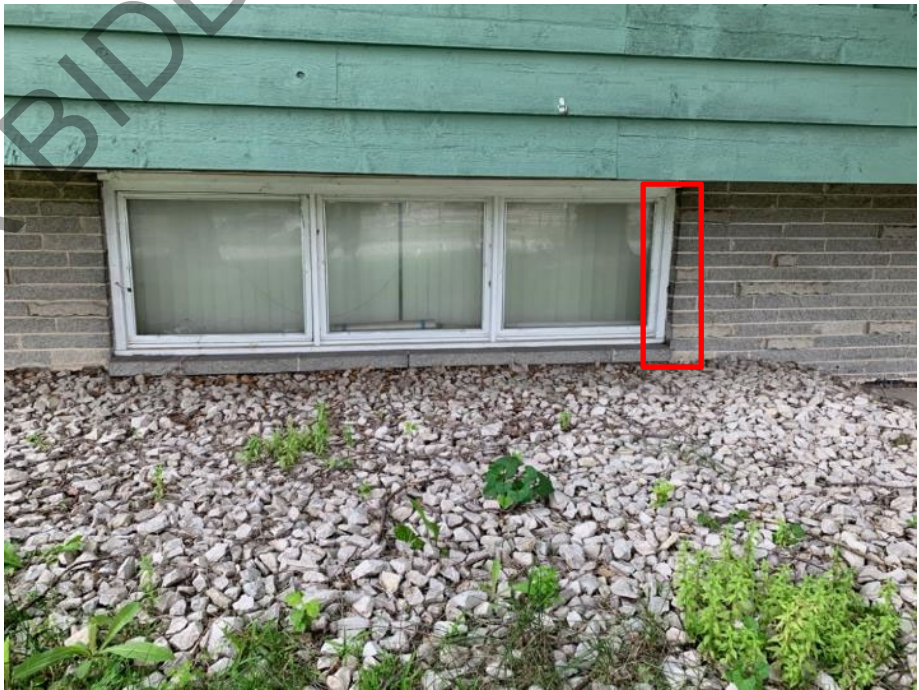
Description White caulk around exterior window frames contains 10% Cat.I non-friable ACM

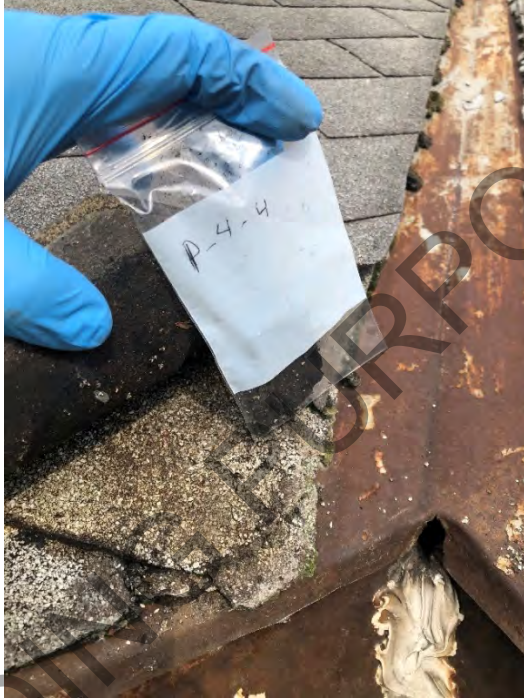
Client Name: WisDOT		Site Location: 320 W. Brentwood Lane (Parcel 4), Glendale, Milwaukee County	Project No.: WisDOT #1229-04-21 TRC# 441231.0000
Photo No. 9	Date 6/24/2021

Description Bottom layer of shingles on roof, non-detect for ACM			
Photo No. 10	Date 6/24/2021

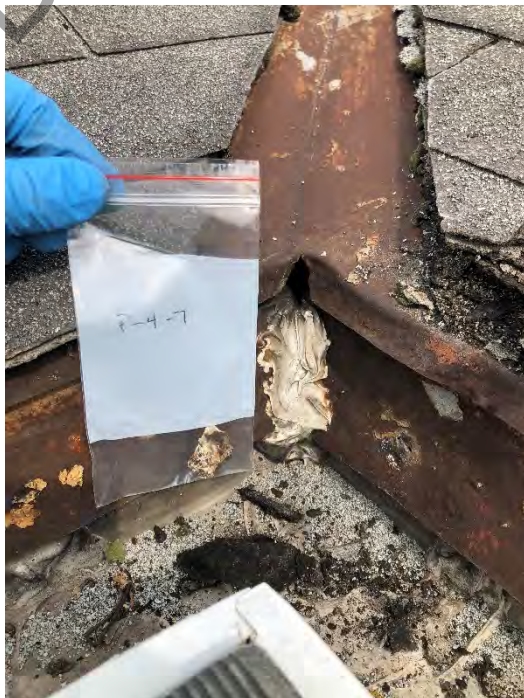
Description White caulk/sealant on roof by gutter, non-detect for ACM

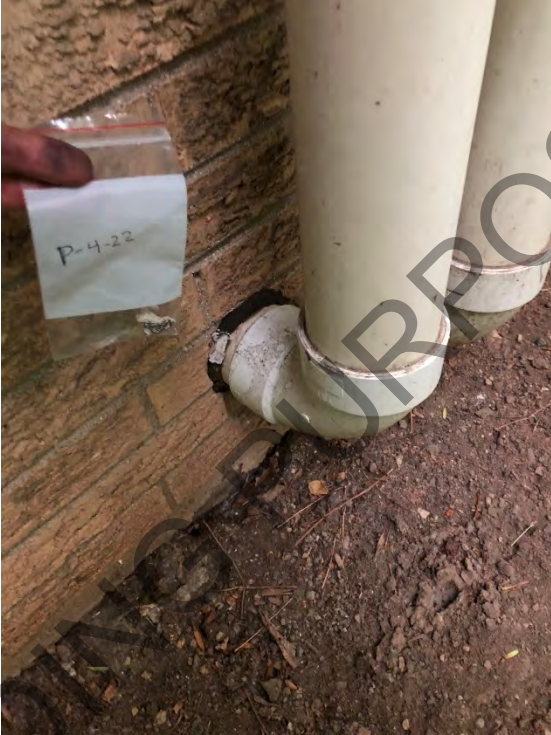
Client Name: WisDOT		Site Location: 320 W. Brentwood Lane (Parcel 4), Glendale, Milwaukee County	Project No.: WisDOT #1229-04-21 TRC# 441231.0000
Photo No. 17	Date 6/24/2021

Description White caulk/sealant around pipes on house exterior, non-detect for ACM

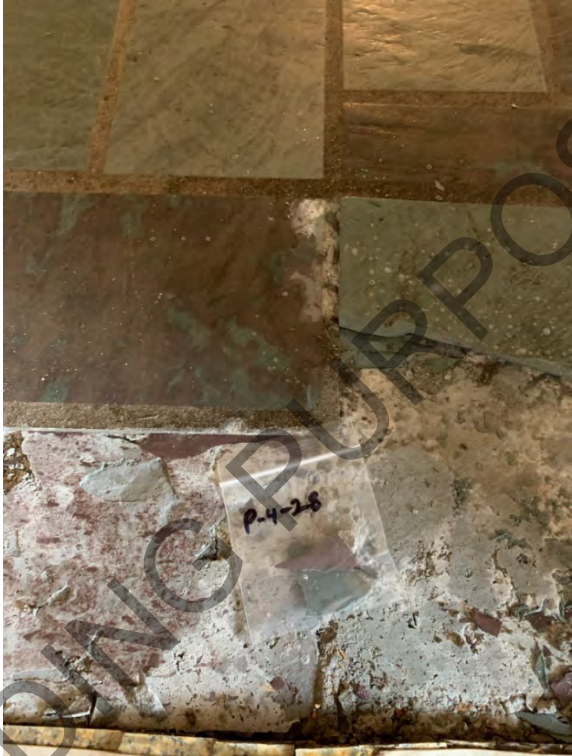
Client Name: WisDOT		Site Location: 320 W. Brentwood Lane (Parcel 4), Glendale, Milwaukee County	Project No.: WisDOT #1229-04-21 TRC# 441231.0000
Photo No. 21	Date 6/24/2021

Description Slate tile and grout on foyer floor, both non-detect for ACM

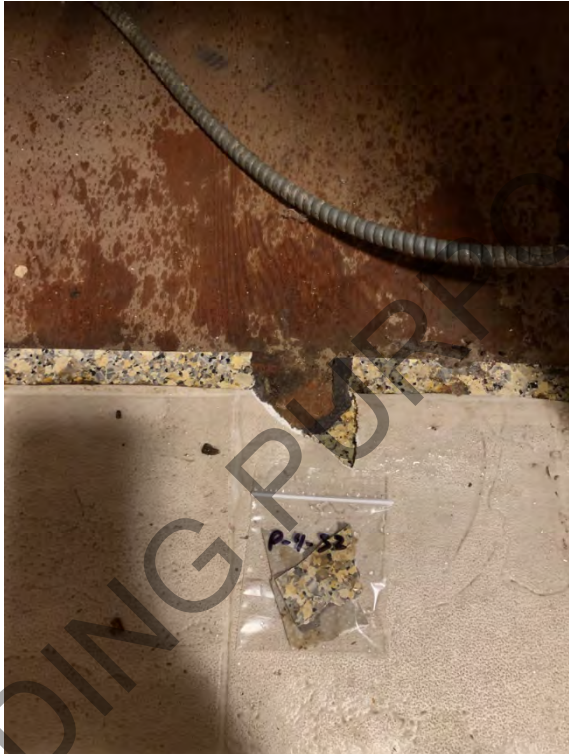
Client Name: WisDOT		Site Location: 320 W. Brentwood Lane (Parcel 4), Glendale, Milwaukee County	Project No.: WisDOT #1229-04-21 TRC# 441231.0000
Photo No. 25	Date 6/24/2021

Description Two layers of linoleum and mastic on kitchen, closet & hallway floors, all non-detect for ACM

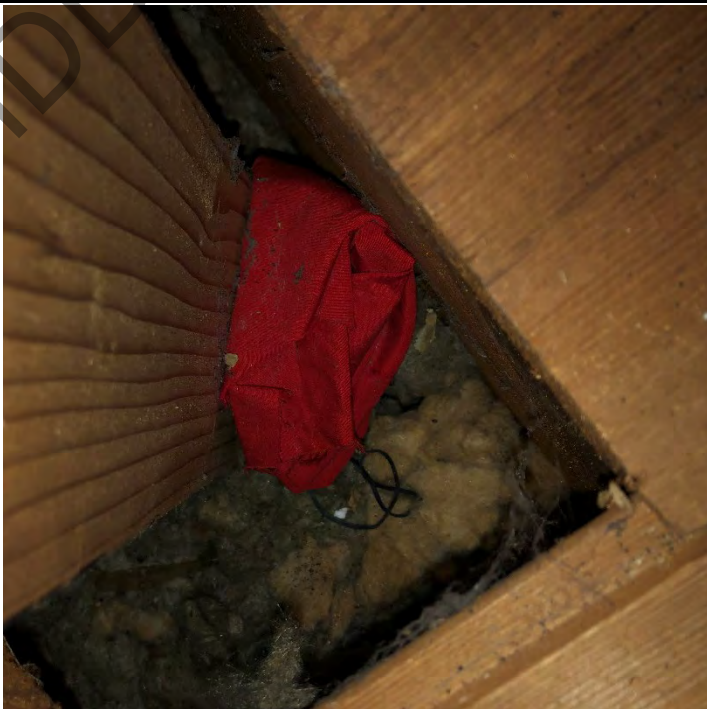
Description Insulation with paper backing in attic, non-detect for ACM

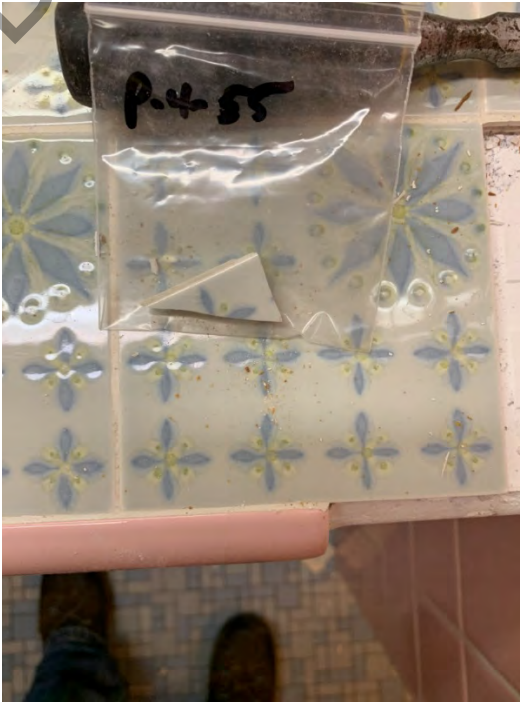
Description Grout and tile on countertop in Bathroom 2, both non-detect for ACM

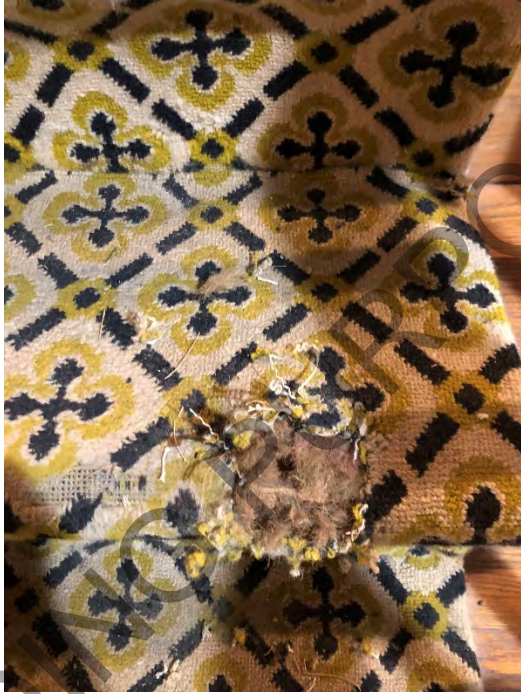
Client Name: WisDOT		Site Location: 320 W. Brentwood Lane (Parcel 4), Glendale, Milwaukee County	Project No.: WisDOT #1229-04-21 TRC# 441231.0000
Photo No. 47	Date 6/24/2021

Description Carpet and pad on basement stairs, both non-detect for ACM			
Photo No. 48	Date 6/24/2021

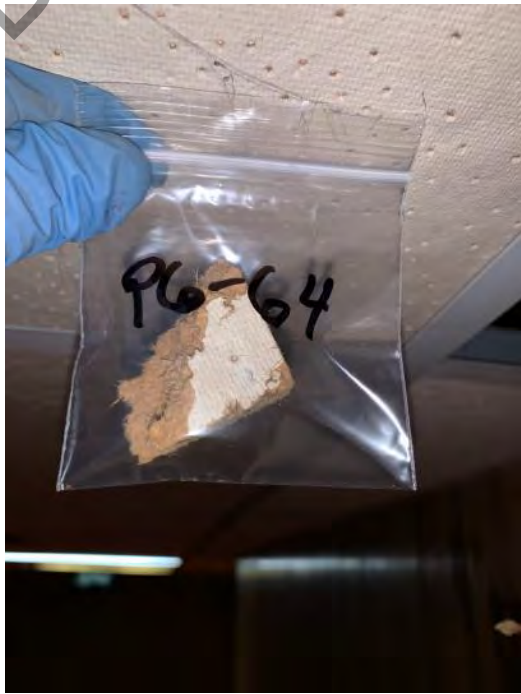
Client Name: WisDOT		Site Location: 318 W. Clovernook Lane (Parcel 6), Glendale, Milwaukee County	Project No.: WisDOT #1229-04-21 TRC# 441231.0000
Photo No. 47	Date 7/14/2021

Description 1'x1' ceiling tile in basement rec room, non-detect for ACM			
Photo No. 48	Date 7/14/2021	Description 4'x2' ceiling tile in basement rec room, non-detect for ACM

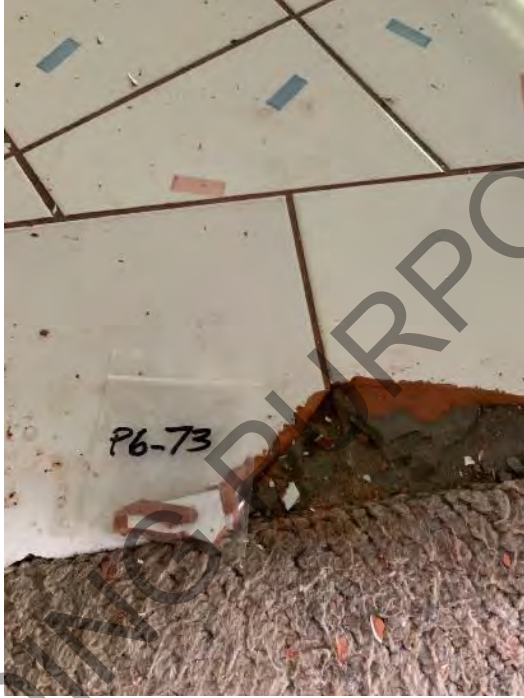
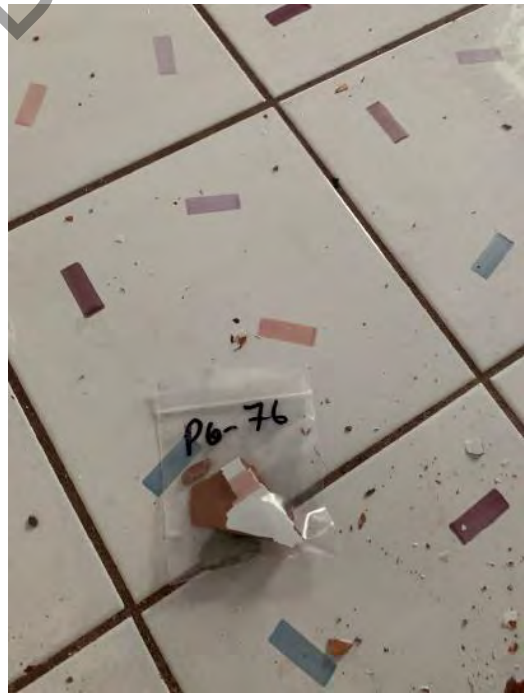
Client Name: WisDOT		Site Location: 318 W. Clovernook Lane (Parcel 6), Glendale, Milwaukee County	Project No.: WisDOT #1229-04-21 TRC# 441231.0000
Photo No. 61	Date 7/14/2021

Description Leveling cement, grout and 7"x7" white ceramic tile border on Bathroom 2 floor, all non-detect for ACM			
Photo No. 62	Date 7/14/2021	Description Leveling cement, grout and 8"x8" ceramic tile on Bathroom 2 floor, all non- detect for ACM

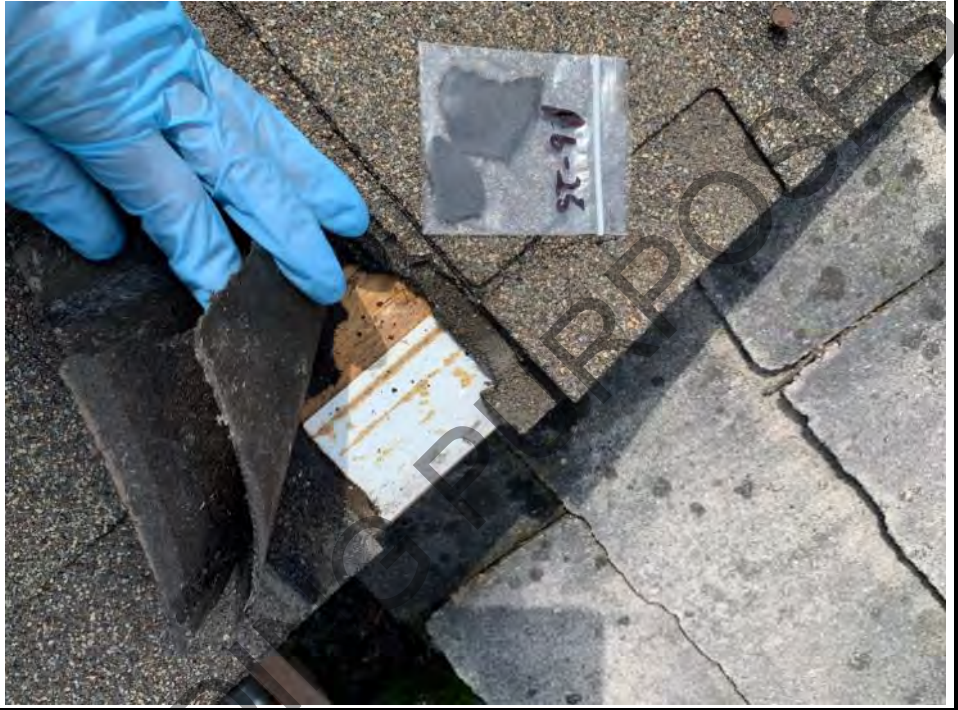
Client Name: WisDOT		Site Location: 330 W. Apple Tree Road (Parcel 9), Glendale, Milwaukee County	Project No.: WisDOT #1229-04-24 TRC# 441233.0000
Photo No. 19	Date 6/30/2021

Description Tar paper and shingles on roof of shed attached to garage, non-detect for ACM			
Photo No. 20	Date 6/30/2021

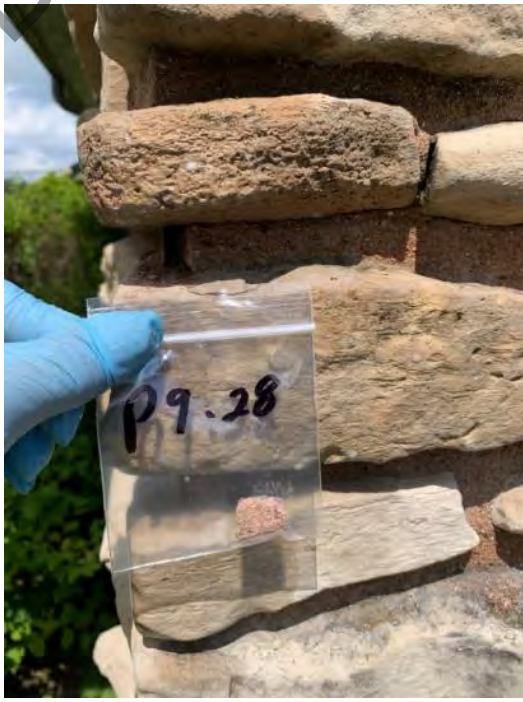
Description Mortar between stones on exterior of house, non-detect for ACM

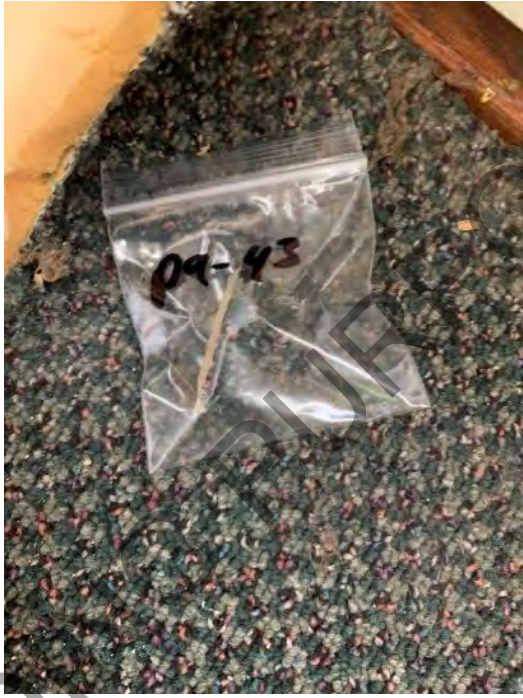
Client Name: WisDOT		Site Location: 330 W. Apple Tree Road (Parcel 9), Glendale, Milwaukee County	Project No.: WisDOT #1229-04-24 TRC# 441233.0000
Photo No. 31	Date 6/30/2021

Description Carpet and pad on bedroom 1 floor, non-detect for ACM			
Photo No. 32	Date 6/30/2021

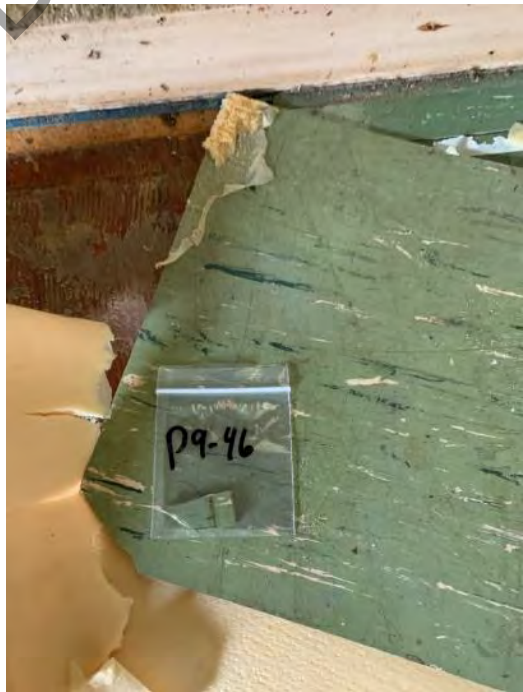
Description Green 12"x12" linoleum tile with mastic on bedroom 1 floor under carpet, non-detect for ACM

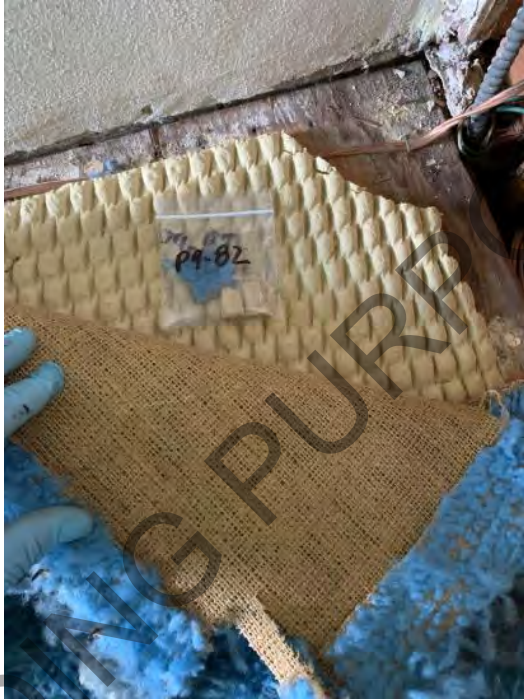
Client Name: WisDOT		Site Location: 330 W. Apple Tree Road (Parcel 9), Glendale, Milwaukee County	Project No.: WisDOT #1229-04-24 TRC# 441233.0000
Photo No. 57	Date 6/30/2021

Description Blue carpet with pad on bedroom 4 floor, non-detect for ACM			
Photo No. 58	Date 6/30/2021

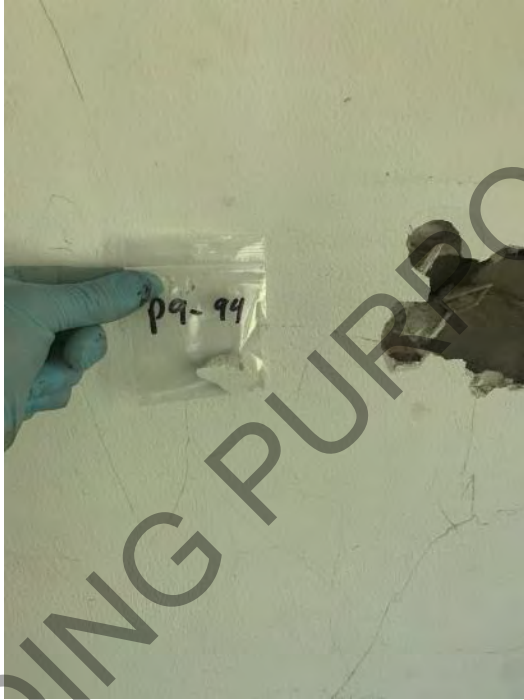
Client Name: WisDOT		Site Location: 330 W. Apple Tree Road (Parcel 9), Glendale, Milwaukee County	Project No.: WisDOT #1229-04-24 TRC# 441233.0000
Photo No. 63	Date 6/30/2021

Description Smooth texture and drywall on walls and ceilings throughout house, non-detect for ACM			
Photo No. 64	Date 6/30/2021

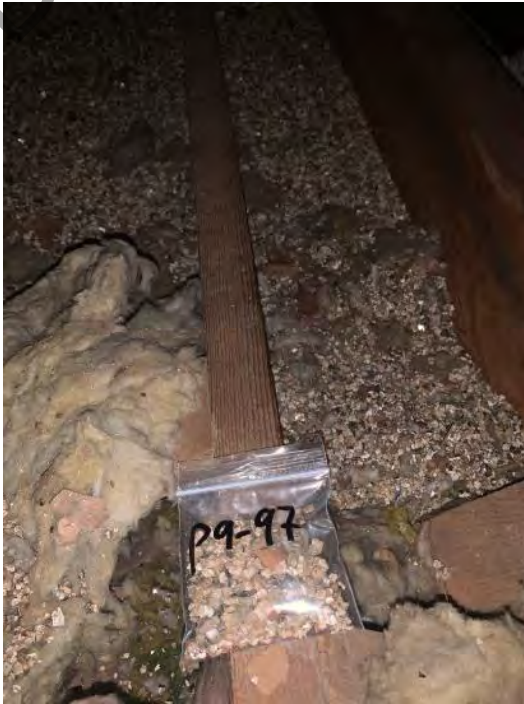
Description Insulation in attic, non-detect for ACM

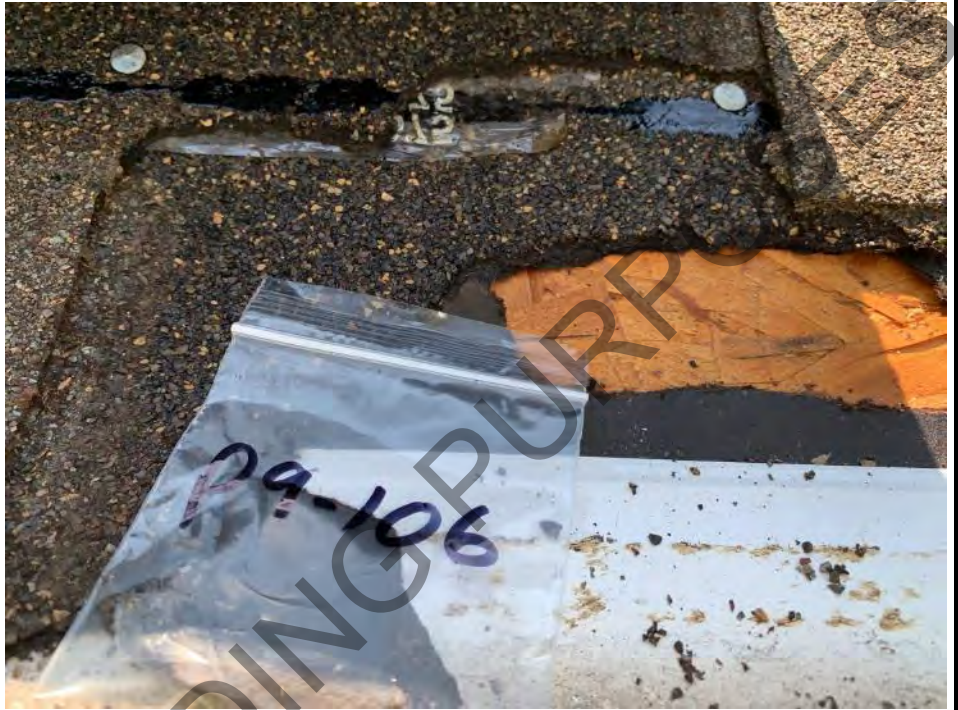
Client Name: WisDOT		Site Location: 330 W. Apple Tree Road (Parcel 9), Glendale, Milwaukee County	Project No.: WisDOT #1229-04-24 TRC# 441233.0000
Photo No. 75	Date 6/30/2021

Description Shingles and felt paper on outbuilding/shed roof, non- detect for ACM
