Appendix O. Wetland Rapid Assessment Methodology Reports

Wetland Rapid Assessment Methodology
US 151/High Crossing Interchange
WisDOT Project ID: 1015-05-00
Dane County, Wisconsin

GEI Consultants, Inc.
3159 Voyager Drive
Green Bay, WI 54311
920.455.8200

May 30, 2024
Project 2404021

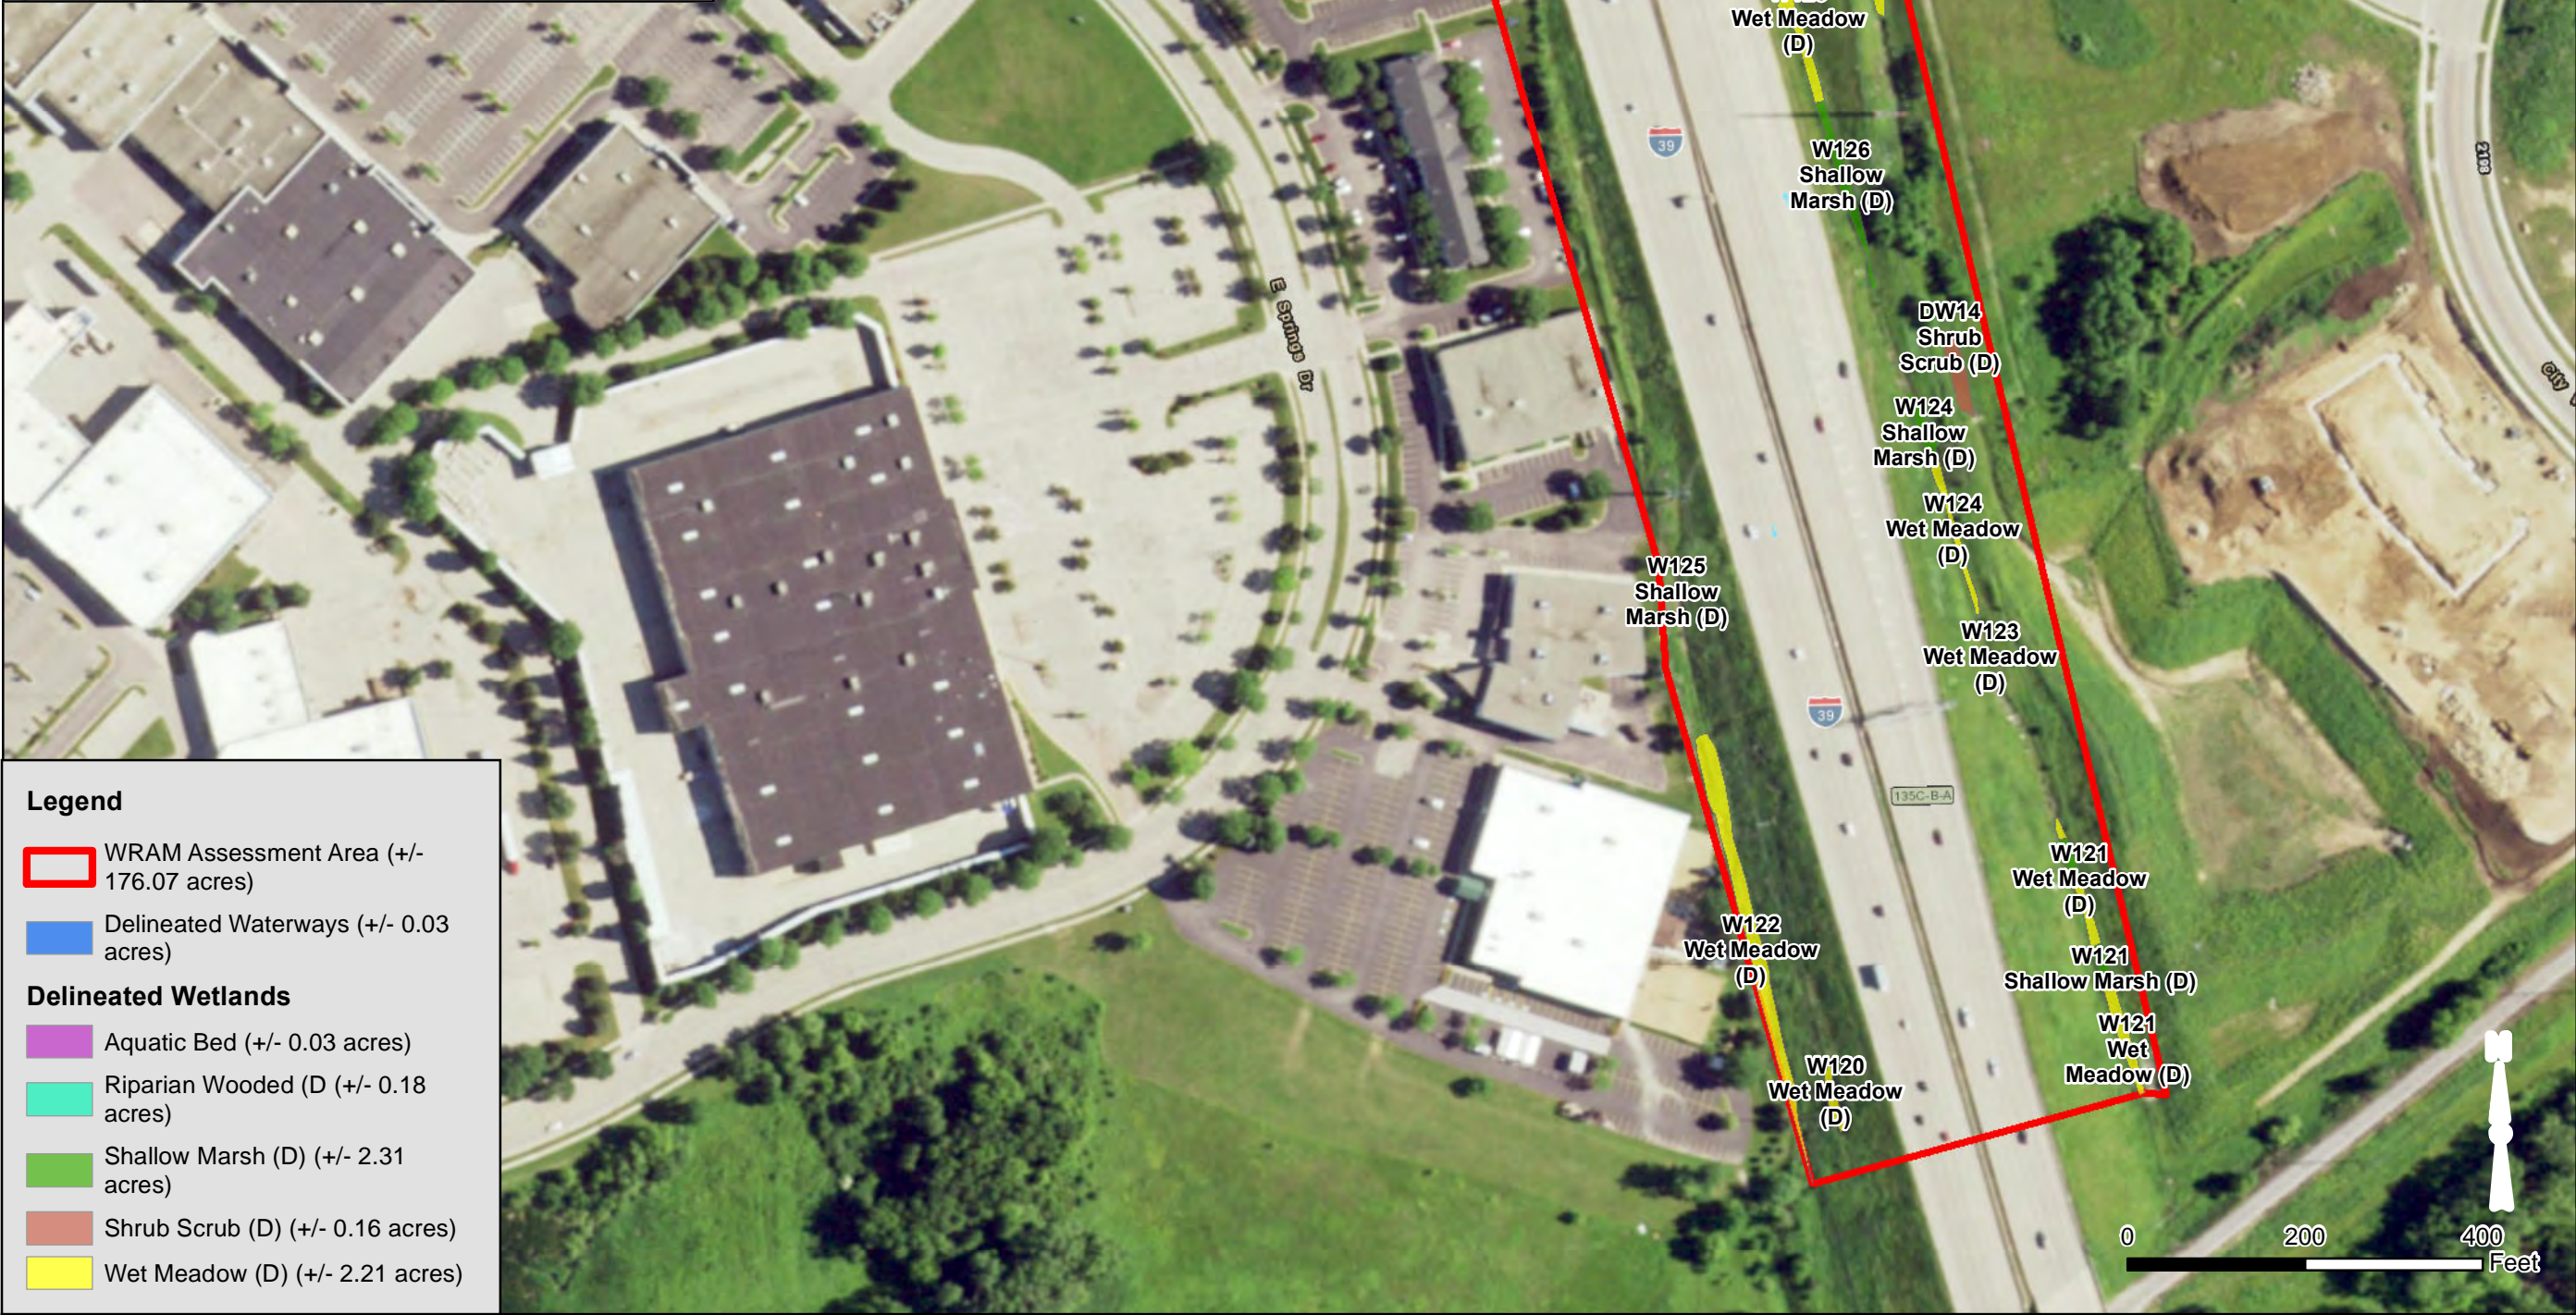
- WRAM Assessment Area (+/- 176.07 acres)
- Delineated Waterways (+/- 0.03 acres)
- Delineated Wetlands**
 - Aquatic Bed (+/- 0.03 acres)
 - Riparian Wooded (D) (+/- 0.18 acres)
 - Shallow Marsh (D) (+/- 2.31 acres)
 - Shrub Scrub (D) (+/- 0.16 acres)
 - Wet Meadow (D) (+/- 2.21 acres)

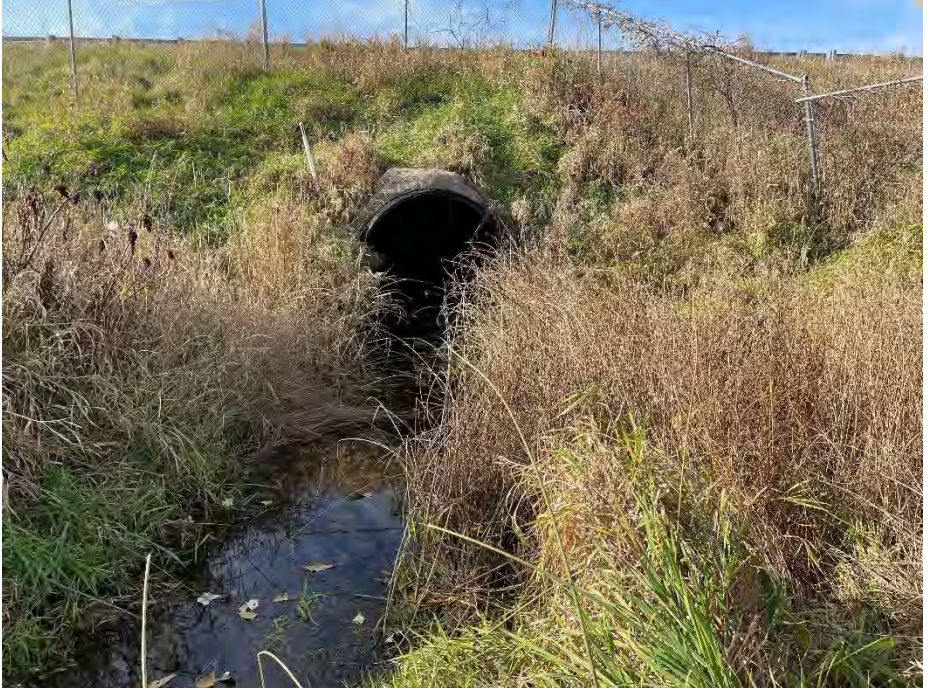
PHOTOGRAPH No: 3	DATE: November 9, 2021	LATITUDE: 43.14409367	LONGITUDE: -89.3000415
DIRECTION: West	SITE LOCATION: USH 151/High Crossing Interchange		
DESCRIPTION: Wetland 164, Aquatic Bed (foreground)

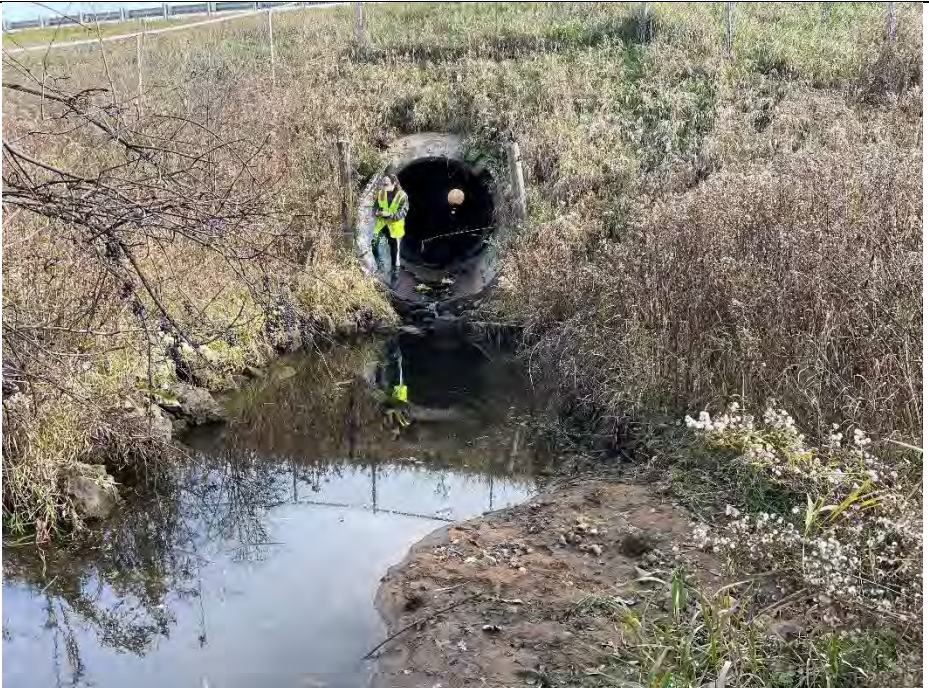
PHOTOGRAPH No: 4	DATE: November 9, 2021	LATITUDE: 43.14356863	LONGITUDE: -89.30095992
DIRECTION: East	SITE LOCATION: USH 151/High Crossing Interchange		
DESCRIPTION: Wetland W163, Aquatic Bed (foreground)

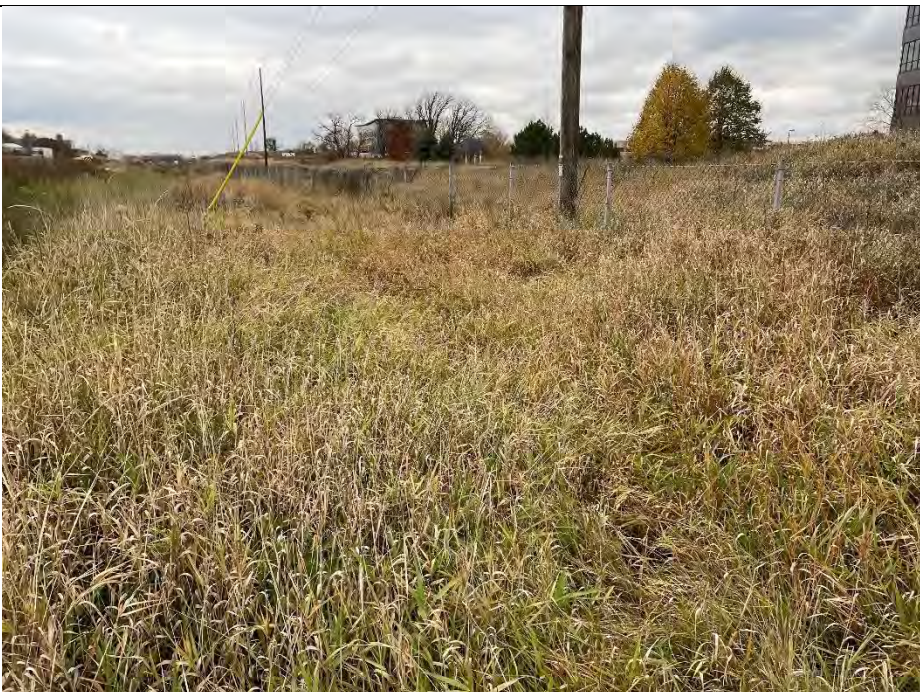
PHOTOGRAPH No: 6	DATE: November 11, 2021	LATITUDE: 43.14273833	LONGITUDE: -89.299309
DIRECTION: North	SITE LOCATION: USH 151/High Crossing Interchange		
DESCRIPTION: Wetland W161, Wet Meadow - D (foreground)

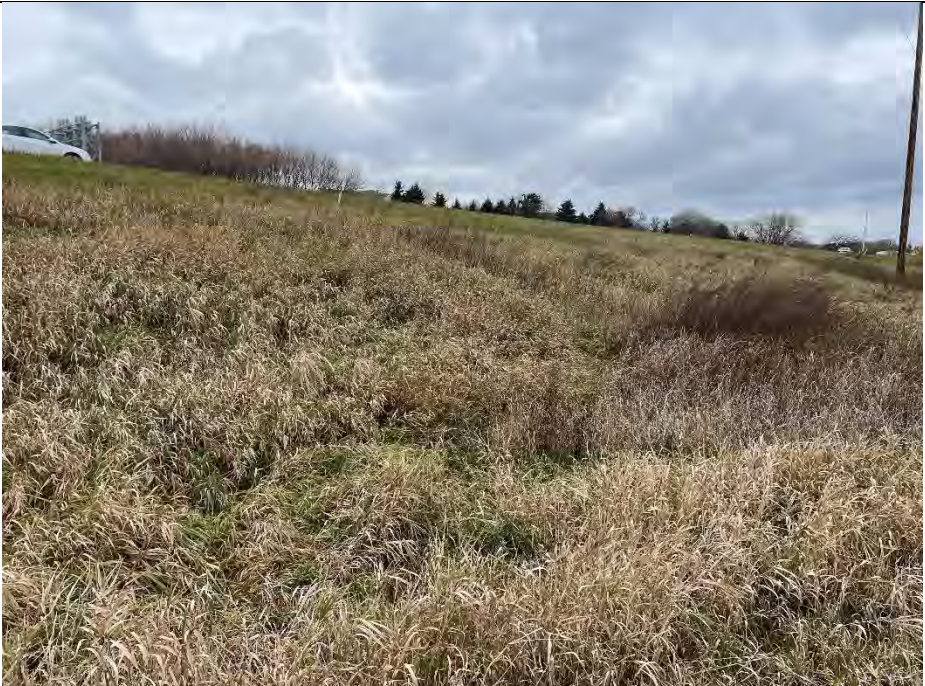
PHOTOGRAPH No: 12	DATE: November 11, 2021	LATITUDE: 43.14027983	LONGITUDE: -89.2973505
DIRECTION:	SITE LOCATION: USH 151/High Crossing Interchange		
DESCRIPTION: Wetland W157, Wet Meadow - D (foreground)

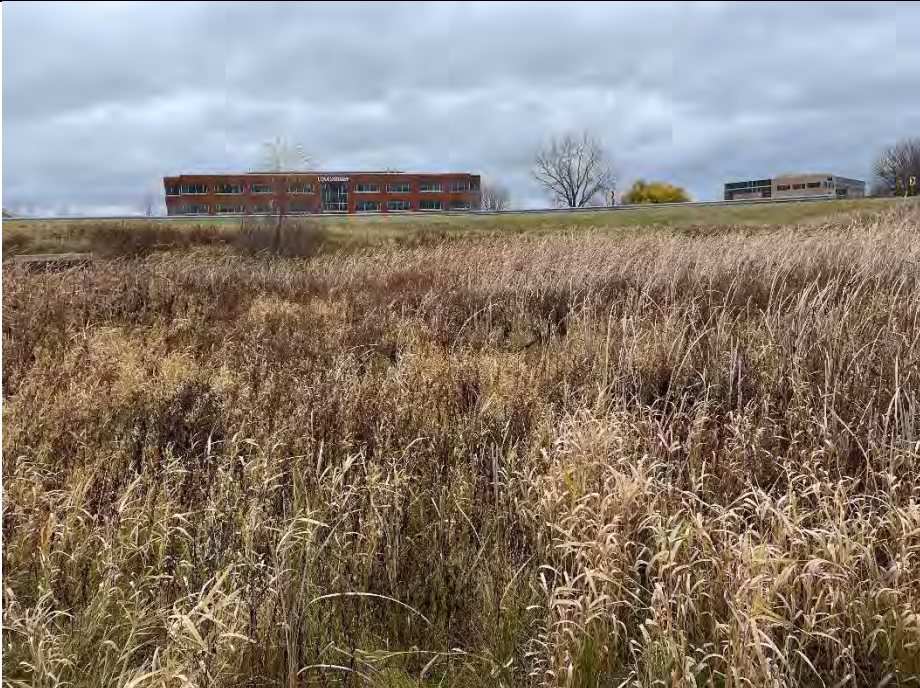
PHOTOGRAPH No: 15	DATE: November 11, 2021	LATITUDE: 43.139947	LONGITUDE: -89.2954425
DIRECTION: North	SITE LOCATION: USH 151/High Crossing Interchange		
DESCRIPTION: Wetland W153, Wet Meadow - D (foreground)

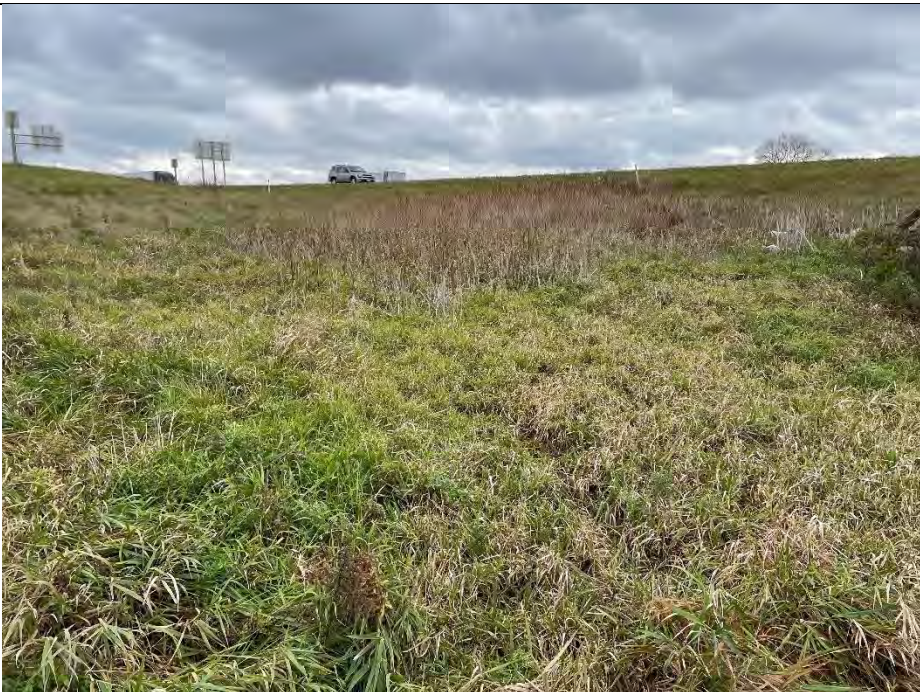
PHOTOGRAPH No: 16	DATE: November 11, 2021	LATITUDE: 43.13992067	LONGITUDE: -89.29707733
DIRECTION: South	SITE LOCATION: USH 151/High Crossing Interchange		
DESCRIPTION: Wetland W154, Wet Meadow - D (foreground)

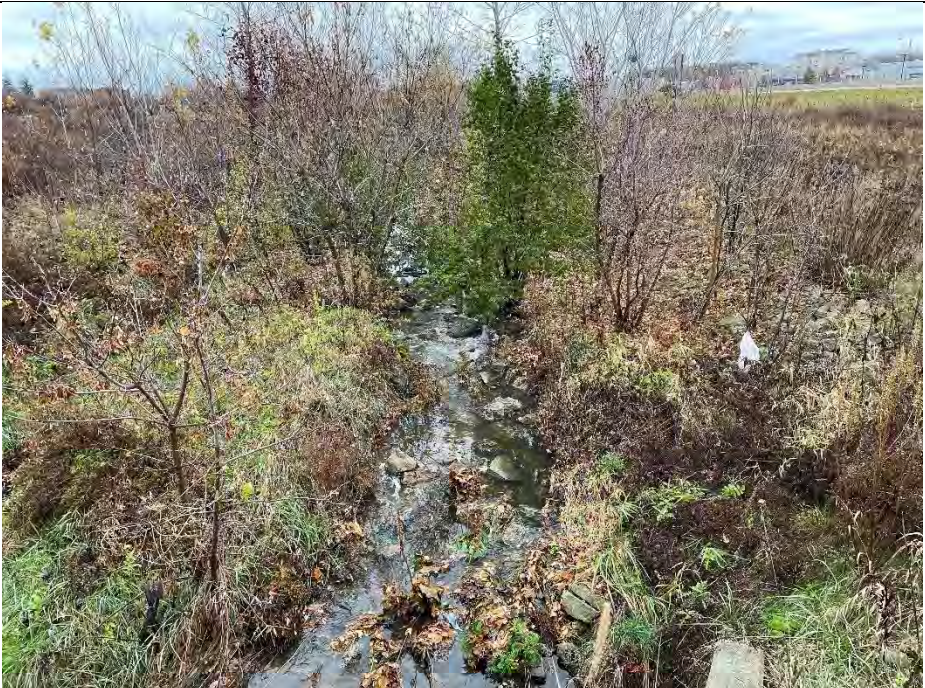
PHOTOGRAPH No: 18	DATE: November 11, 2021	LATITUDE: 43.13966683	LONGITUDE: -89.293996
DIRECTION: North	SITE LOCATION: USH 151/High Crossing Interchange		
DESCRIPTION: Wetland W156, Aquatic Bed (foreground)

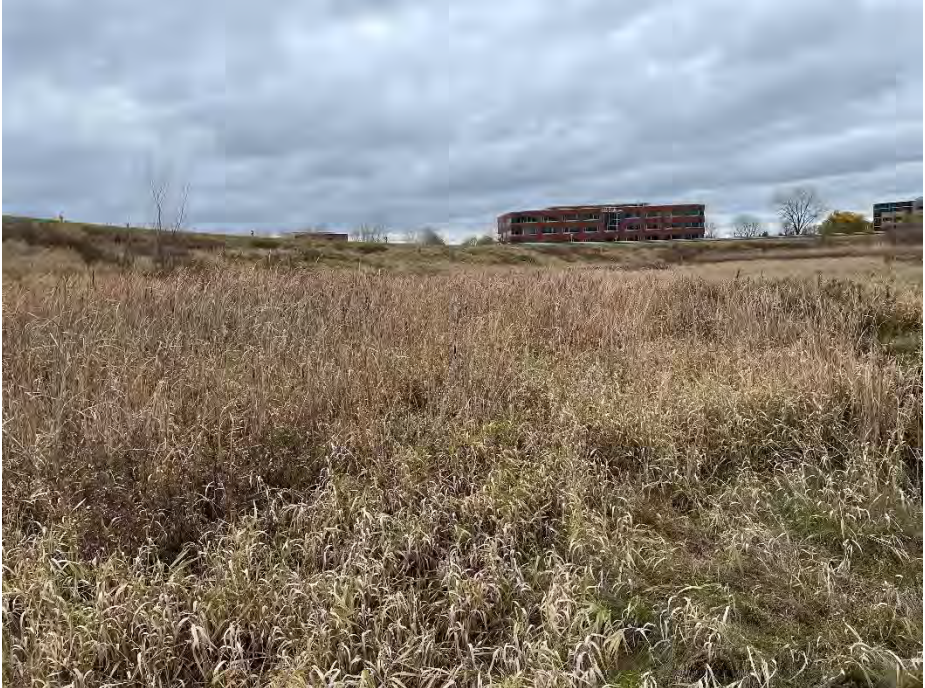
PHOTOGRAPH No: 21	DATE: November 11, 2021	LATITUDE: 43.13930067	LONGITUDE: -89.296431
DIRECTION: North	SITE LOCATION: USH 151/High Crossing Interchange		
DESCRIPTION: Wetland 153, Shallow Marsh - D (foreground)

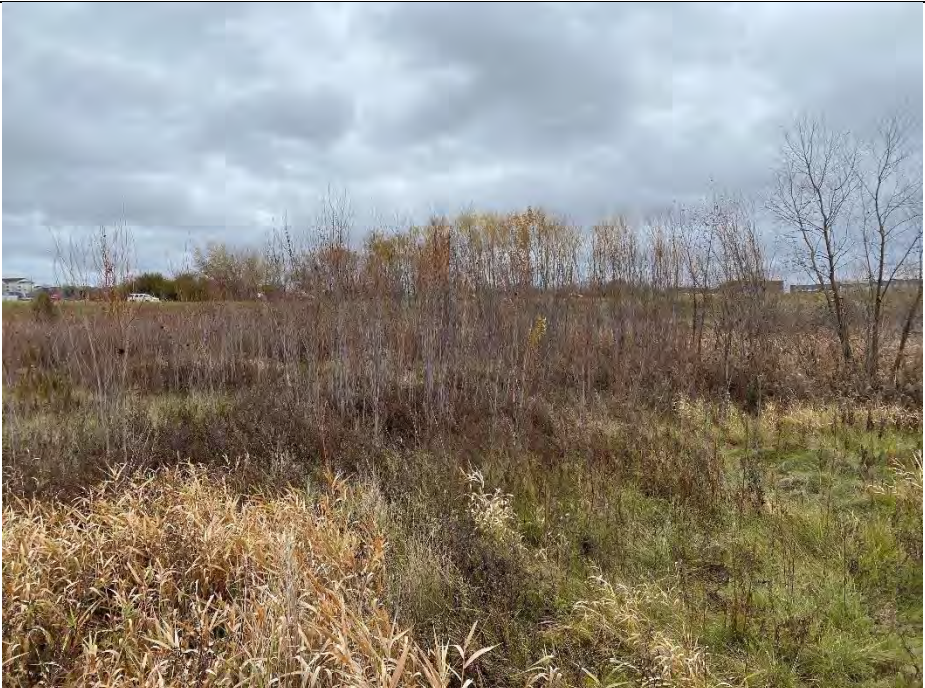
PHOTOGRAPH No: 22	DATE: November 11, 2021	LATITUDE: 43.13909292	LONGITUDE: -89.29561126
DIRECTION: South	SITE LOCATION: USH 151/High Crossing Interchange		
DESCRIPTION: Wetland W153, Shrub Scrub - D (foreground)

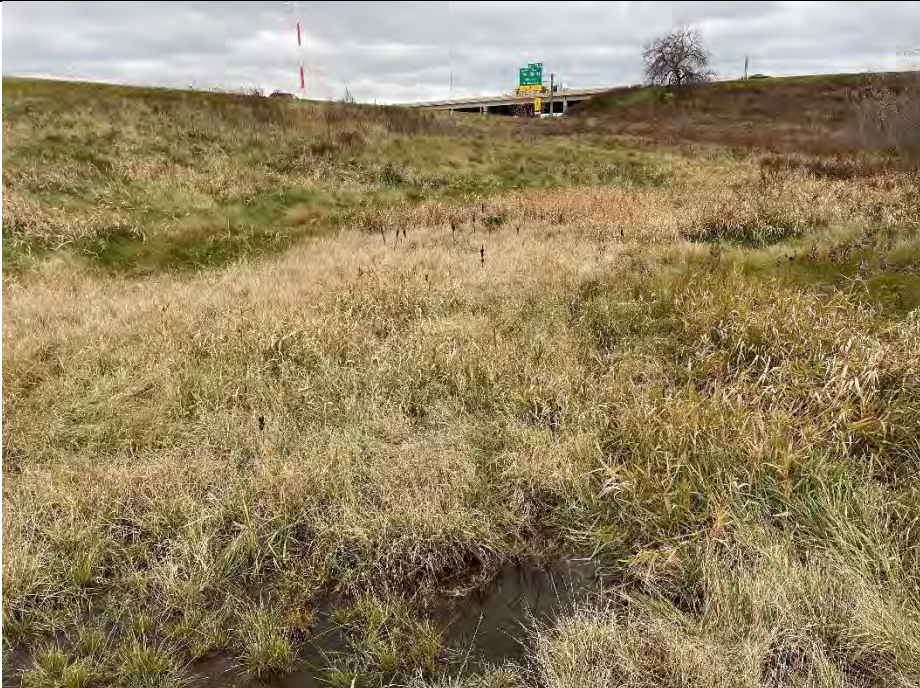
PHOTOGRAPH No: 25	DATE: November 11, 2021	LATITUDE: 43.13899267	LONGITUDE: -89.29474133
DIRECTION: South	SITE LOCATION: USH 151/High Crossing Interchange		
DESCRIPTION: Wetland W153, Wet Meadow - D (foreground)

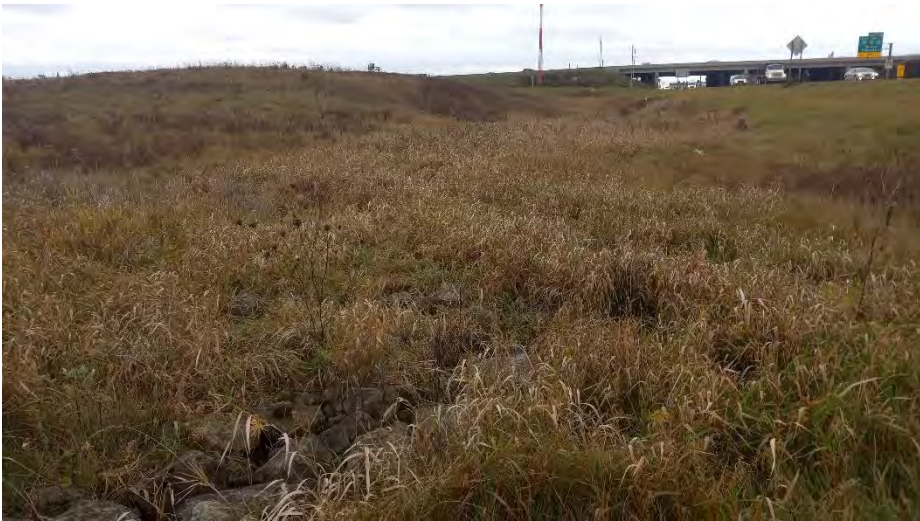
PHOTOGRAPH No: 26	DATE: November 11, 2021	LATITUDE: 43.1385935	LONGITUDE: -89.2936333
DIRECTION: South	SITE LOCATION: USH 151/High Crossing Interchange		
DESCRIPTION: Wetland W149, Wet Meadow - D (foreground)

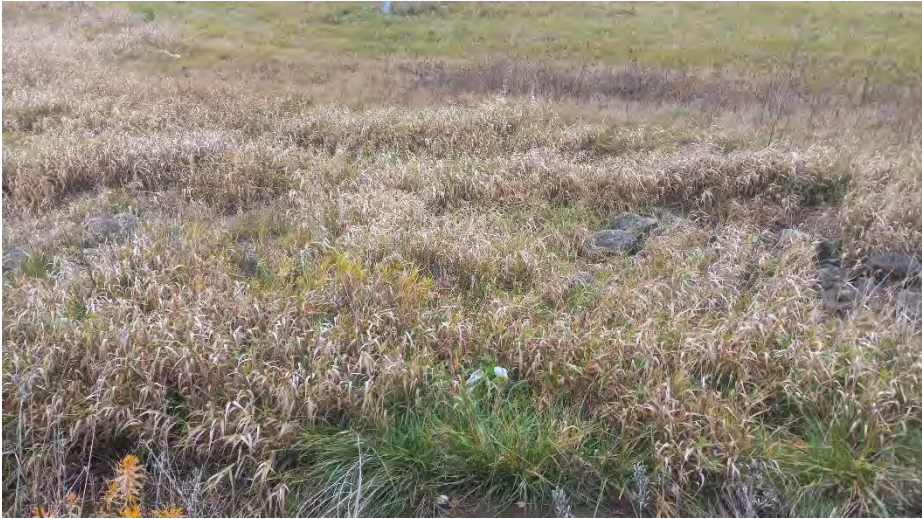
PHOTOGRAPH No: 27	DATE: November 11, 2021	LATITUDE: 43.1385014	LONGITUDE: -89.2936397
DIRECTION: West	SITE LOCATION: USH 151/High Crossing Interchange		
DESCRIPTION: Wetland W149, Wet Meadow - D (foreground)

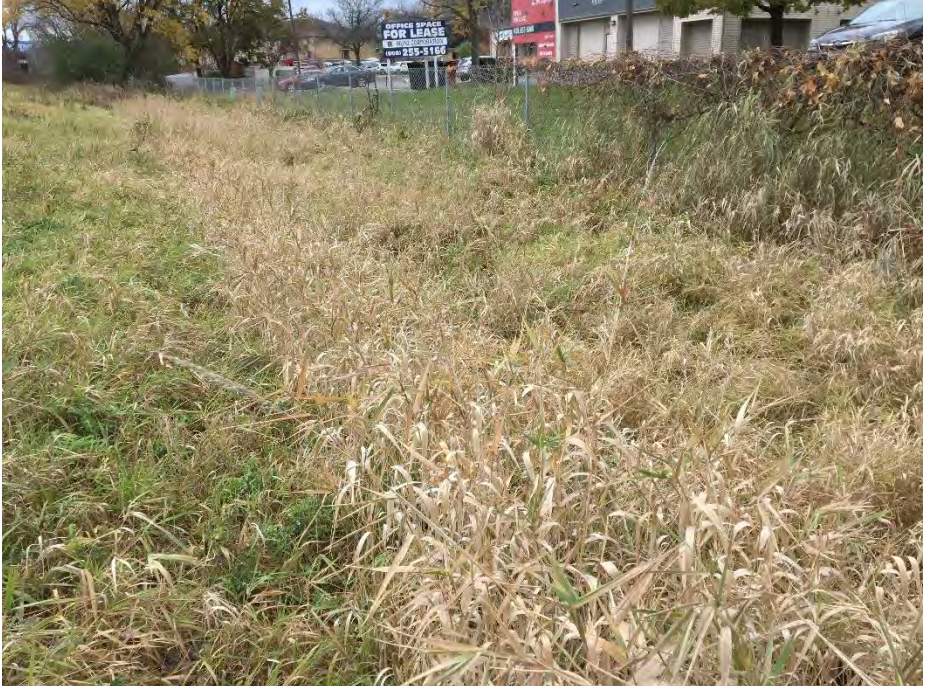
PHOTOGRAPH No: 29	DATE: November 11, 2021	LATITUDE: 43.13841711	LONGITUDE: -89.29860176
DIRECTION: Southwest	SITE LOCATION: USH 151/High Crossing Interchange		
DESCRIPTION: Wetland W147, Wet Meadow - D (foreground)

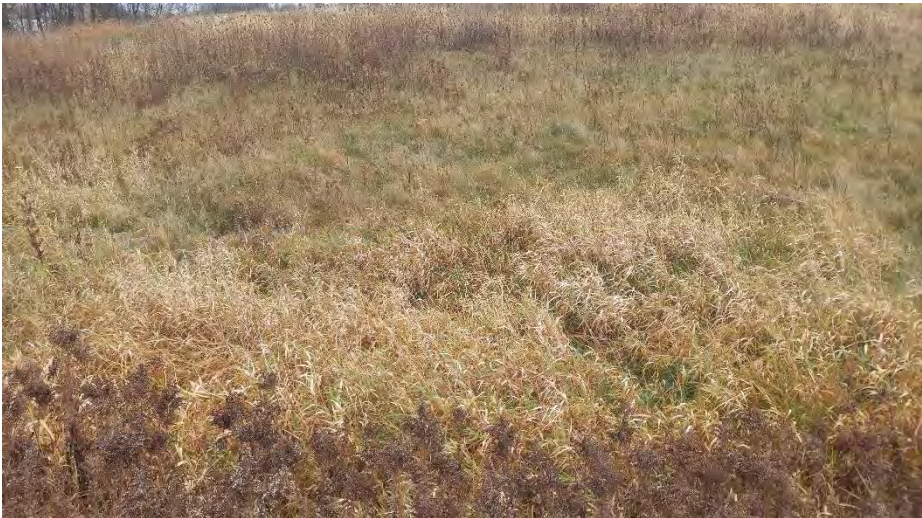
PHOTOGRAPH No: 31	DATE: November 11, 2021	LATITUDE: 43.1381749	LONGITUDE: -89.2943172
DIRECTION: East	SITE LOCATION: USH 151/High Crossing Interchange		
DESCRIPTION: Wetland W148 , Wet Meadow - D (foreground)

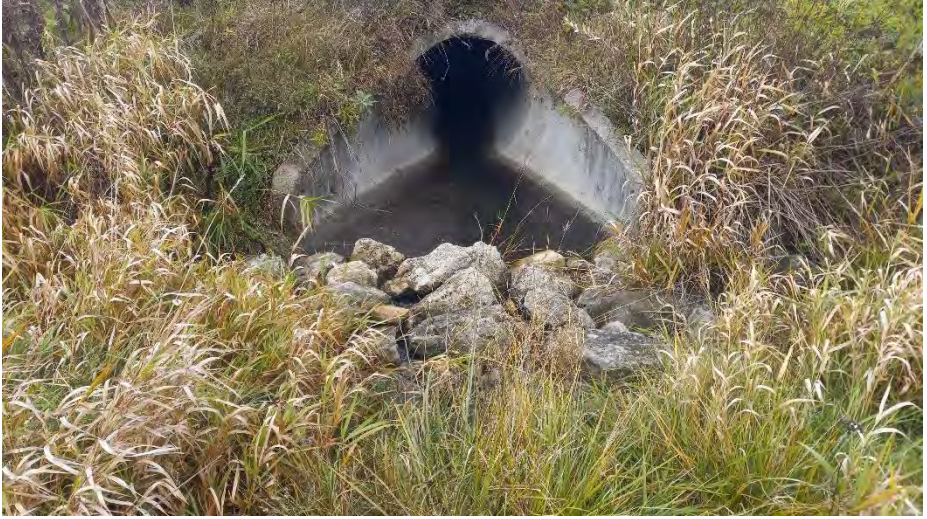
PHOTOGRAPH No: 38	DATE: November 11, 2021	LATITUDE: 43.1375334	LONGITUDE: -89.2946686
DIRECTION: West	SITE LOCATION: USH 151/High Crossing Interchange		
DESCRIPTION: Wetland W144, Aquatic Bed - D (foreground)

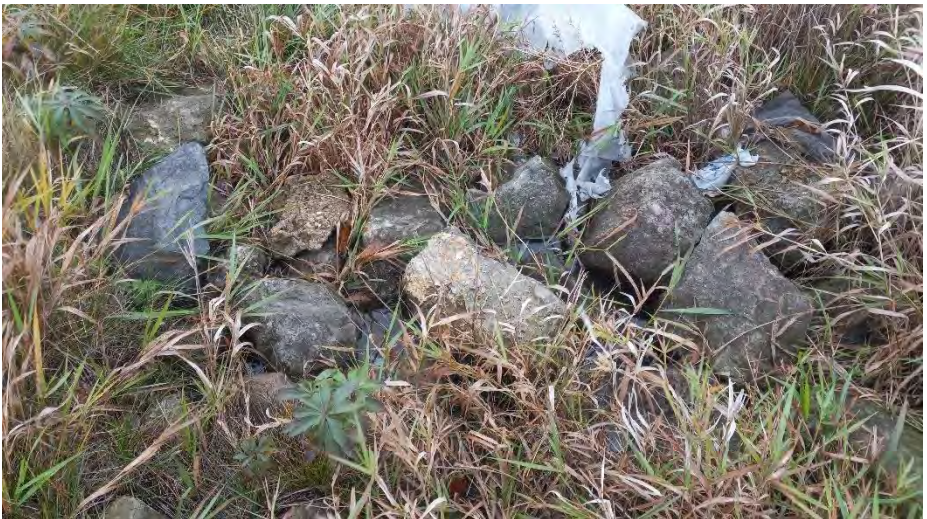
PHOTOGRAPH No: 42	DATE: November 11, 2021	LATITUDE: 43.1374203	LONGITUDE: -89.2931409
DIRECTION: Northeast	SITE LOCATION: USH 151/High Crossing Interchange		
DESCRIPTION: Wetland W143, Aquatic Bed - D (foreground)

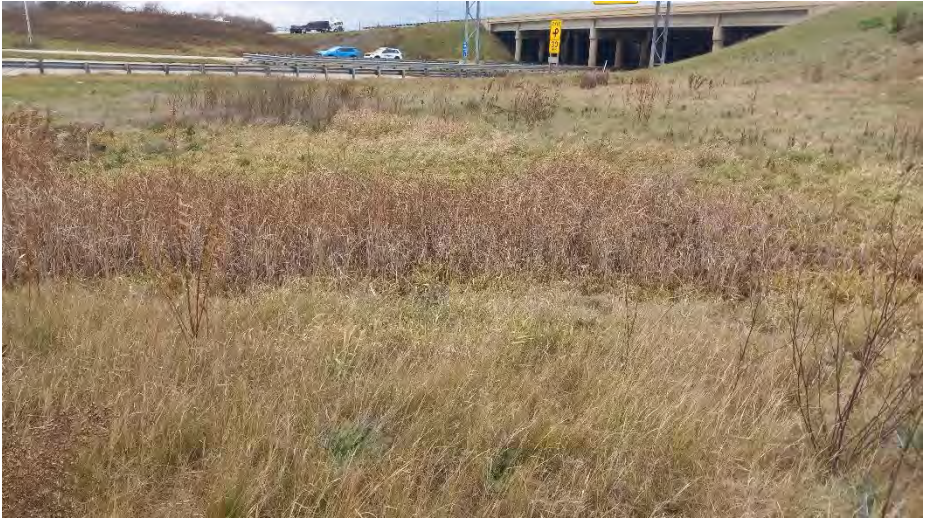
PHOTOGRAPH No: 51	DATE: November 11, 2021	LATITUDE: 43.1361016	LONGITUDE: -89.2964228
DIRECTION: North	SITE LOCATION: USH 151/High Crossing Interchange		
DESCRIPTION: Wetland W139, Shallow Marsh - D (foreground)

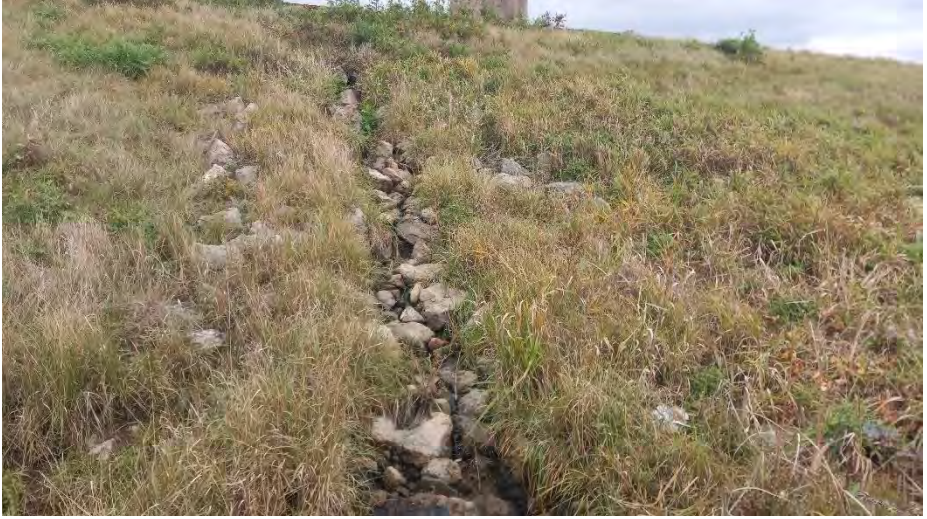
PHOTOGRAPH No: 56	DATE: November 11, 2021	LATITUDE: 43.1357292	LONGITUDE: -89.2957849
DIRECTION: Northeast	SITE LOCATION: USH 151/High Crossing Interchange		
DESCRIPTION: Wetland W139, Shallow Marsh - D (foreground)

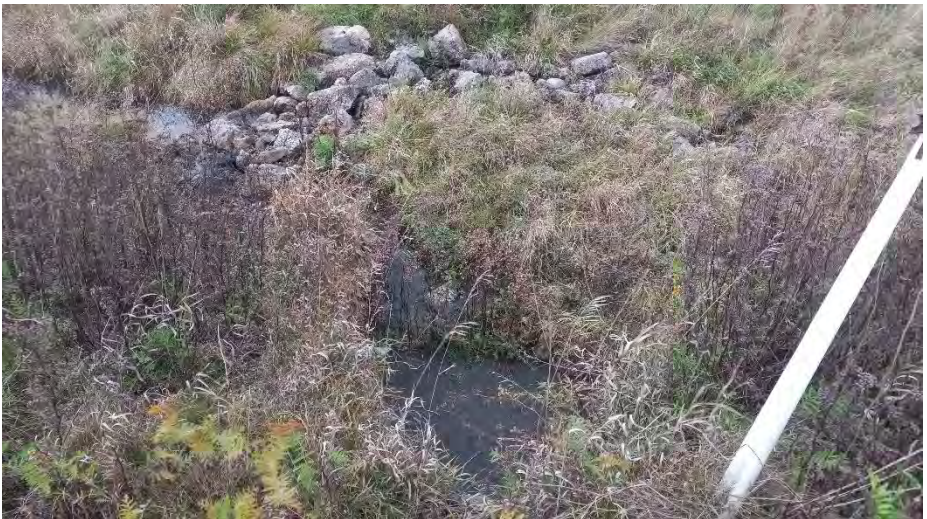
PHOTOGRAPH No: 72	DATE: November 11, 2021	LATITUDE: 43.1348817	LONGITUDE: -89.2964733
DIRECTION: Northwest	SITE LOCATION: USH 151/High Crossing Interchange		
DESCRIPTION: Wetland W132, Aquatic Bed - D (foreground)

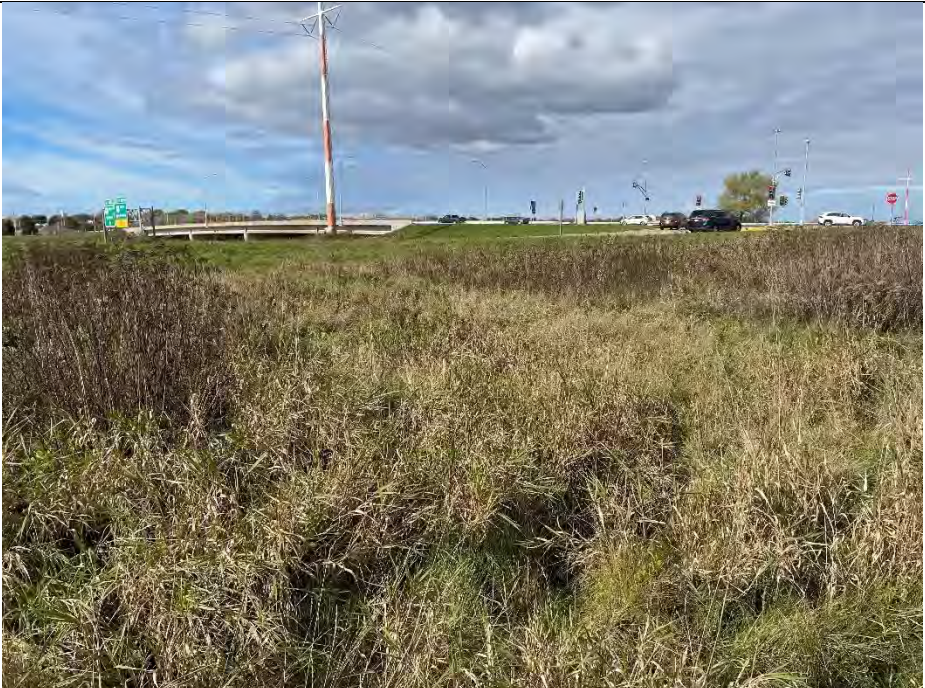
PHOTOGRAPH No: 76	DATE: November 3, 2021	LATITUDE: 43.13385283	LONGITUDE: -89.29217904
DIRECTION: Northwest	SITE LOCATION: USH 151/High Crossing Interchange		
DESCRIPTION: Wetland W127, Wet Meadow - D (foreground)

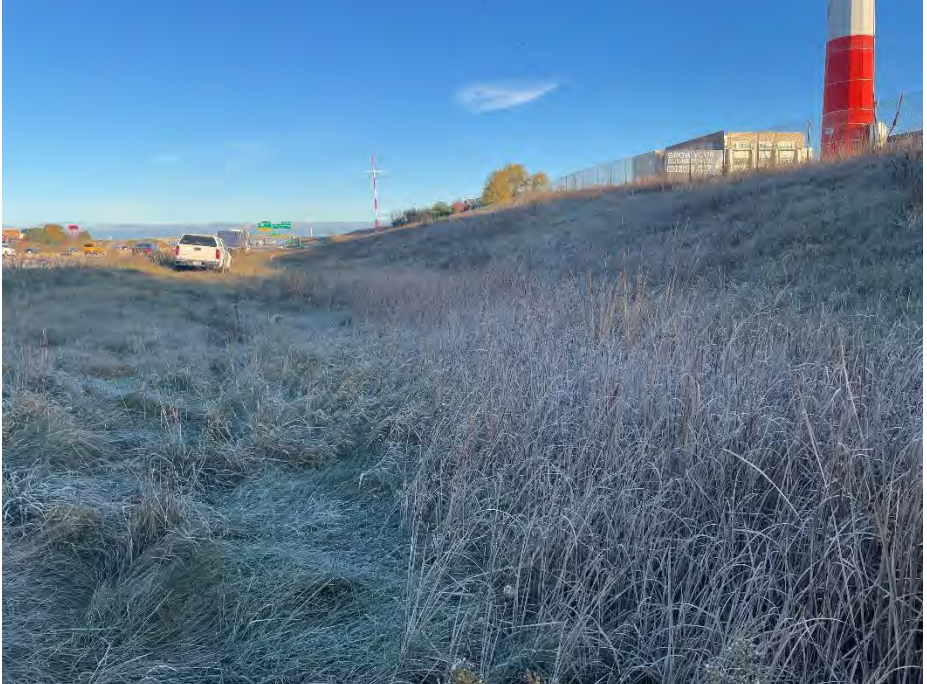
PHOTOGRAPH No: 78	DATE: November 3, 2021	LATITUDE: 43.12860311	LONGITUDE: -89.29131889
DIRECTION: North	SITE LOCATION: USH 151/High Crossing Interchange		
DESCRIPTION: Wetland W126, Shallow Marsh - D (foreground)

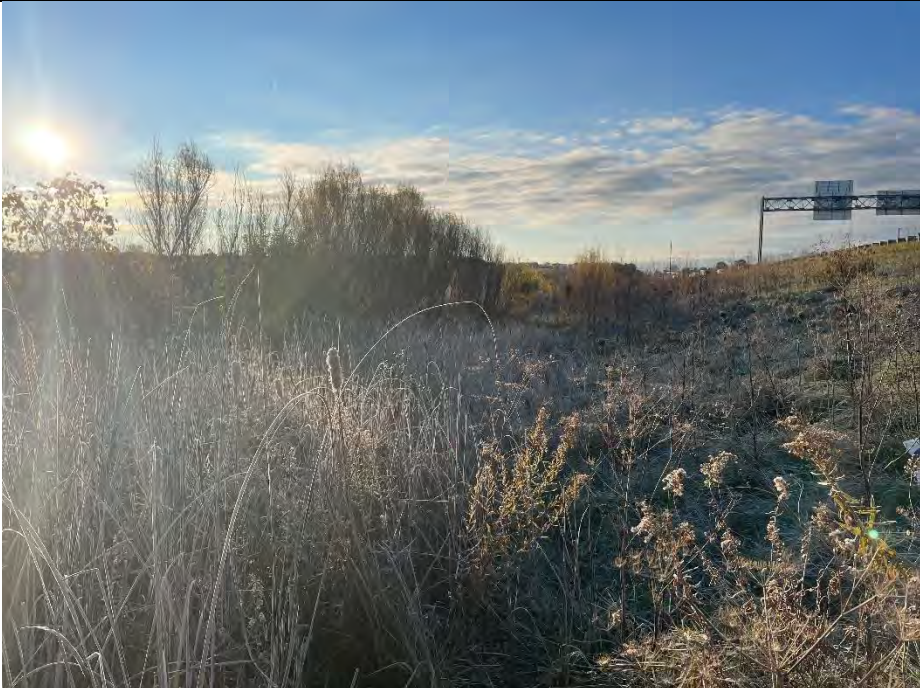
PHOTOGRAPH No: 81	DATE: November 3, 2021	LATITUDE: 43.12783458	LONGITUDE: -89.29084732
DIRECTION: South	SITE LOCATION: USH 151/High Crossing Interchange		
DESCRIPTION: Wetland W124, Shallow Marsh - D (foreground)

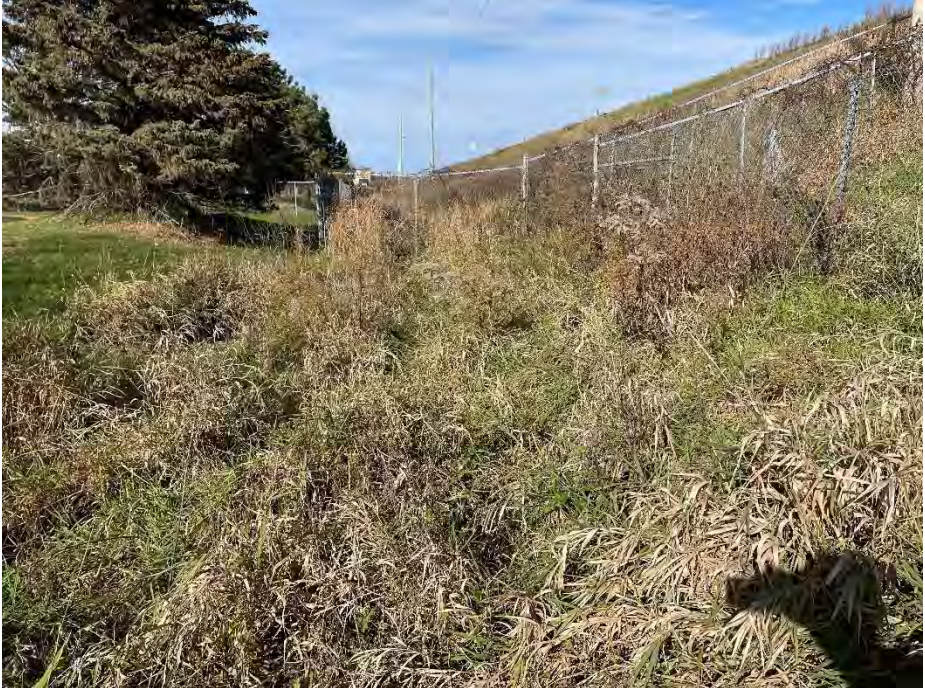
PHOTOGRAPH No: 87	DATE: November 9, 2021	LATITUDE: 43.12557733	LONGITUDE: -89.29155883
DIRECTION: North	SITE LOCATION: USH 151/High Crossing Interchange		
<p>DESCRIPTION:</p> <p>Wetland W122, Wet Meadow - D (foreground)</p>

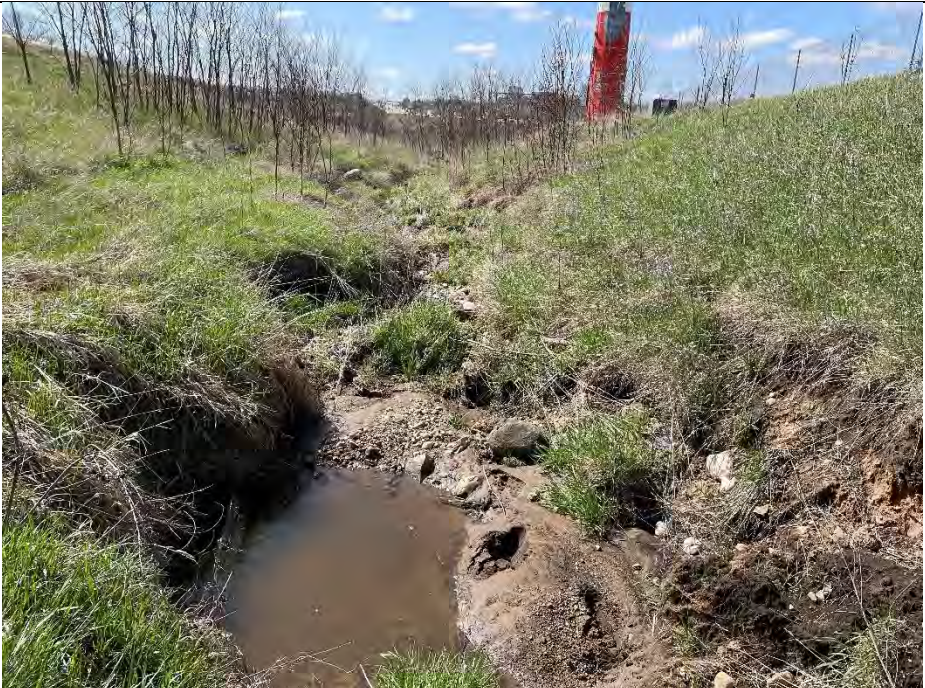
PHOTOGRAPH No: 1	DATE: May 4, 2022	LATITUDE: 43.12911848	LONGITUDE: -89.29110357
DIRECTION: South	SITE LOCATION: USH 151/High Crossing Interchange		
DESCRIPTION: Wetland DW15, Wet Meadow (foreground)

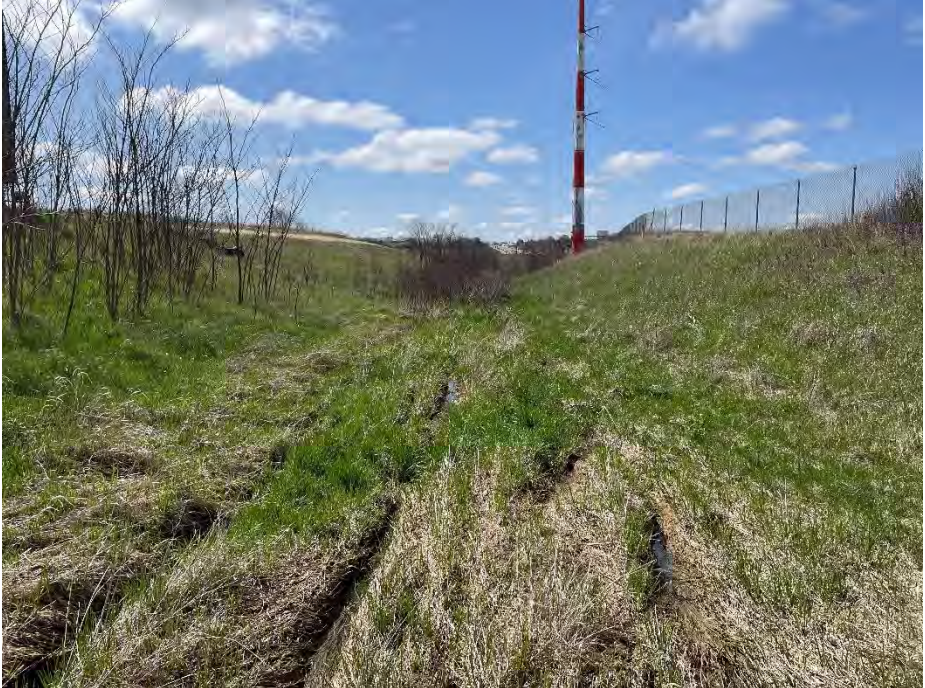
PHOTOGRAPH No: 1	DATE: May 4, 2022	LATITUDE: 43.12961894	LONGITUDE: -89.29127276
DIRECTION: South	SITE LOCATION: USH 151/High Crossing Interchange		
DESCRIPTION: Wetland DW15, Wet Meadow - D (foreground)

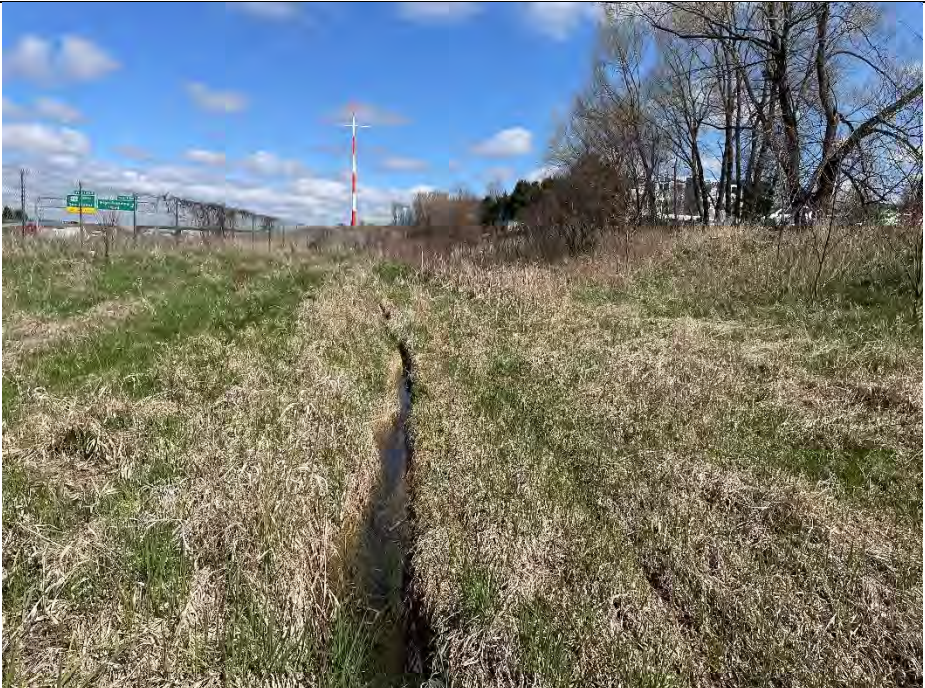
PHOTOGRAPH No: 1	DATE: May 4, 2022	LATITUDE: 43.12996041	LONGITUDE: -89.29137983
DIRECTION: North	SITE LOCATION: USH 151/High Crossing Interchange		
DESCRIPTION: Wetland DW15, Wet Meadow - D (foreground)

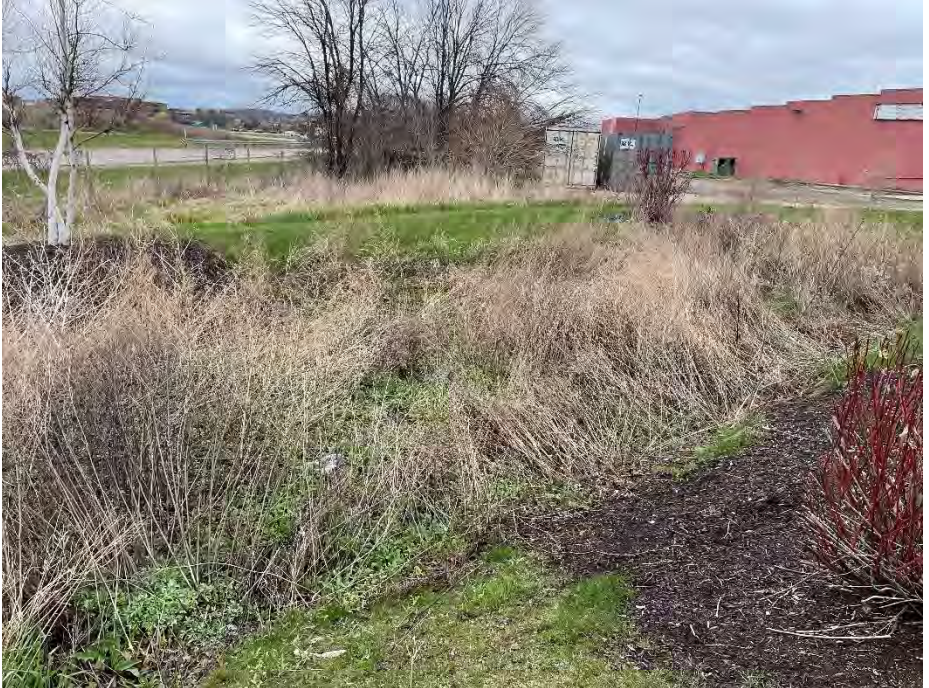
PHOTOGRAPH No: 12	DATE: May 3, 2022	LATITUDE: 43.1356336	LONGITUDE: -89.29364963
DIRECTION:	SITE LOCATION: USH 151/High Crossing Interchange		
DESCRIPTION: Wetland W127, Wet Meadow (foreground)

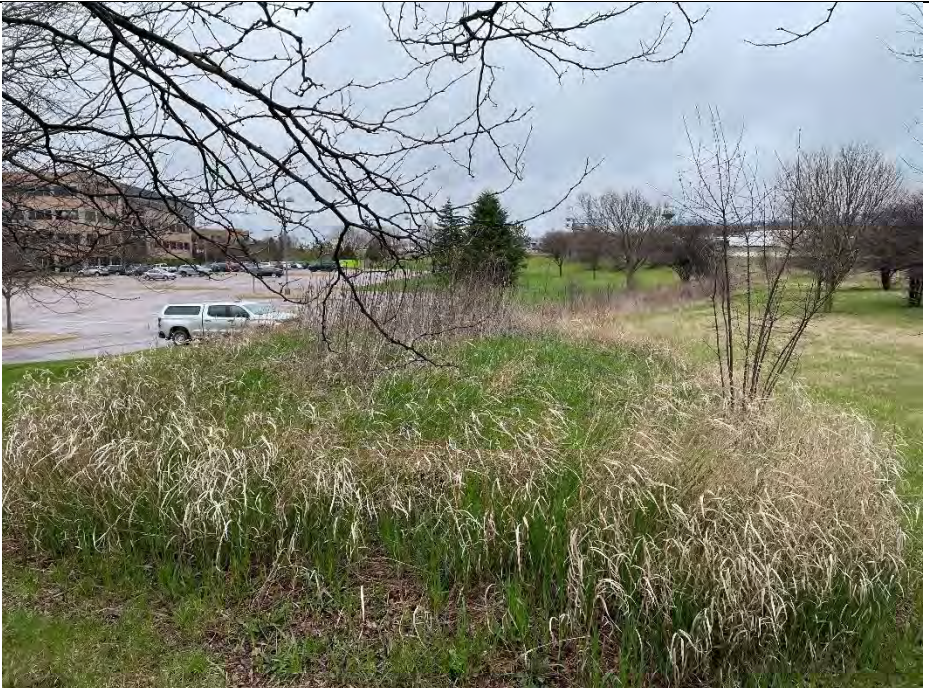
PHOTOGRAPH No: 15	DATE: May 3, 2022	LATITUDE: 43.14055092	LONGITUDE: -89.2937391
DIRECTION: East	SITE LOCATION: USH 151/High Crossing Interchange		
DESCRIPTION: Wetland DW21, Shallow Marsh (foreground)

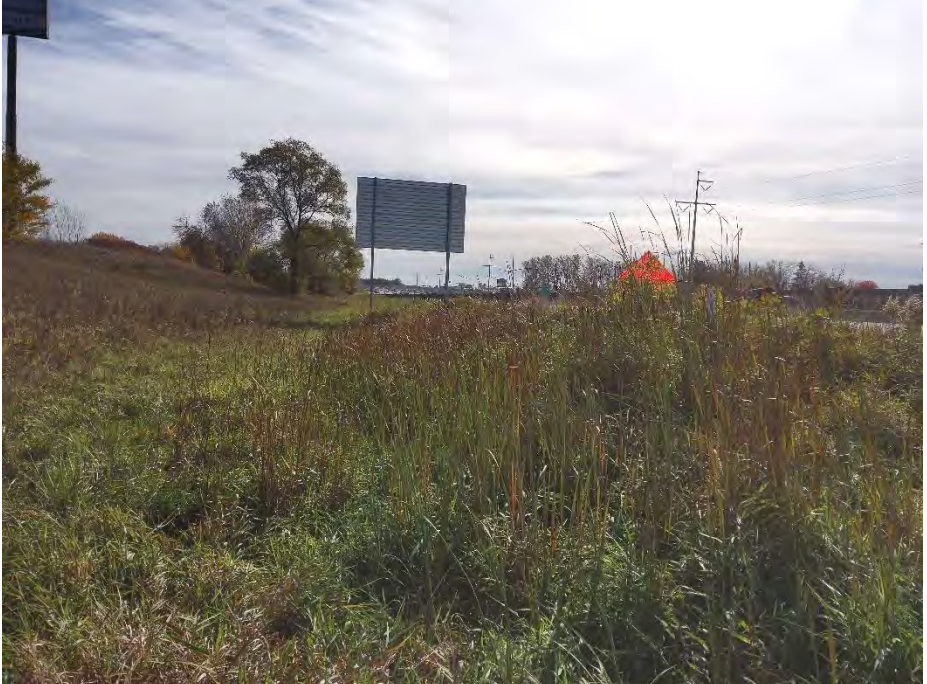
PHOTOGRAPH No: 2	DATE: November 1, 2021	LATITUDE: 43.1841543	LONGITUDE: -89.3308452
DIRECTION: Southeast	SITE LOCATION: USH 51 Interchange		
DESCRIPTION: Wetland W219, Deep Marsh - D (foreground)

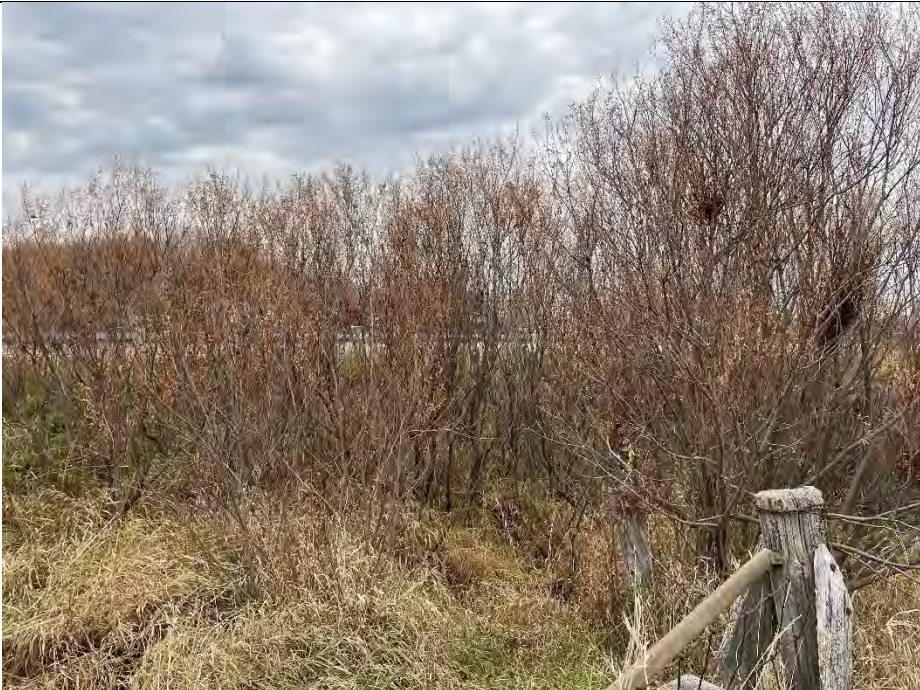
PHOTOGRAPH No: 8	DATE: November 10, 2021	LATITUDE: 43.18184983	LONGITUDE: -89.32376717
DIRECTION: North	SITE LOCATION: USH 51 Interchange		
DESCRIPTION: Wetland W216, Shrub Scrub - D (foreground)
