Appendix O. Wetland Rapid Assessment Methodology Reports

Wetland Rapid Assessment Methodology
US 151/High Crossing Interchange
WisDOT Project ID: 1015-05-00
Dane County, Wisconsin

GEI Consultants, Inc.
3159 Voyager Drive
Green Bay, WI 54311
920.455.8200

May 30, 2024
Project 2404021

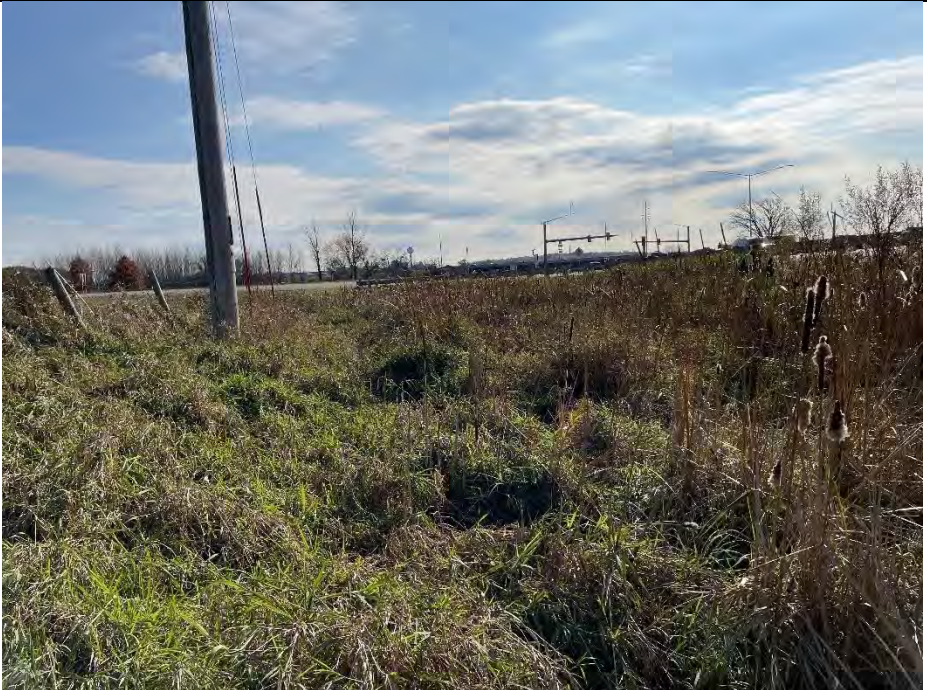
PHOTOGRAPH No: 11	DATE: November 4, 2021	LATITUDE: 43.18180907	LONGITUDE: -89.32377813
DIRECTION: South	SITE LOCATION: USH 51 Interchange		
DESCRIPTION: Wetland W206, Wet Meadow - D (foreground)

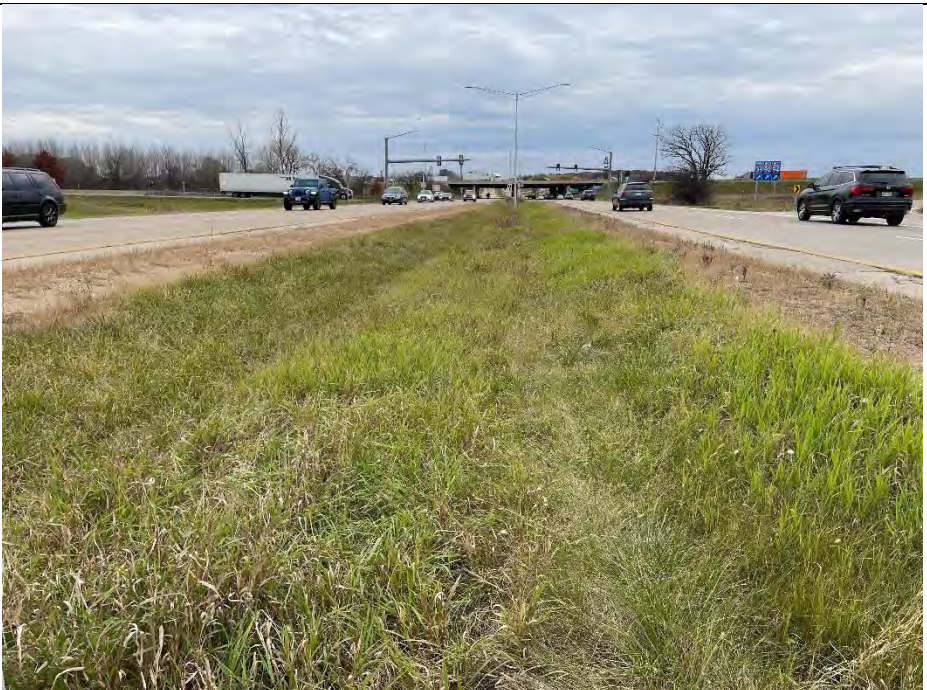
PHOTOGRAPH No: 12	DATE: November 10, 2021	LATITUDE: 43.18173317	LONGITUDE: -89.32426033
DIRECTION: West	SITE LOCATION: USH 51 Interchange		
DESCRIPTION: Wetland W214, Wet Meadow - D (foreground)

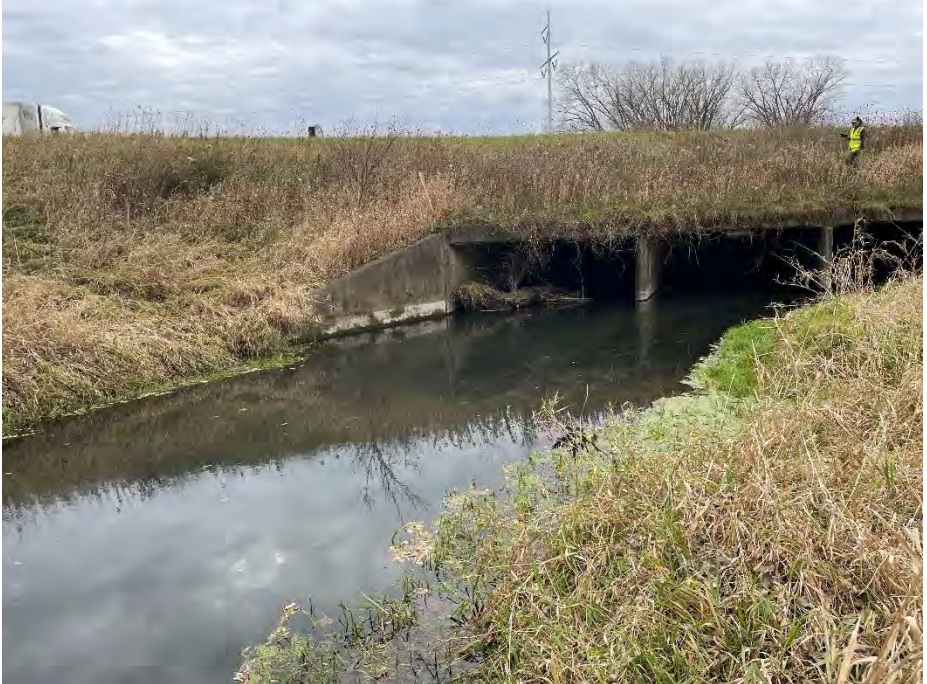
PHOTOGRAPH No: 17	DATE: November 10, 2021	LATITUDE: 43.18148283	LONGITUDE: -89.32673567
DIRECTION: West	SITE LOCATION: USH 51 Interchange		
DESCRIPTION: Wetland W219, Aquatic Bed (foreground)

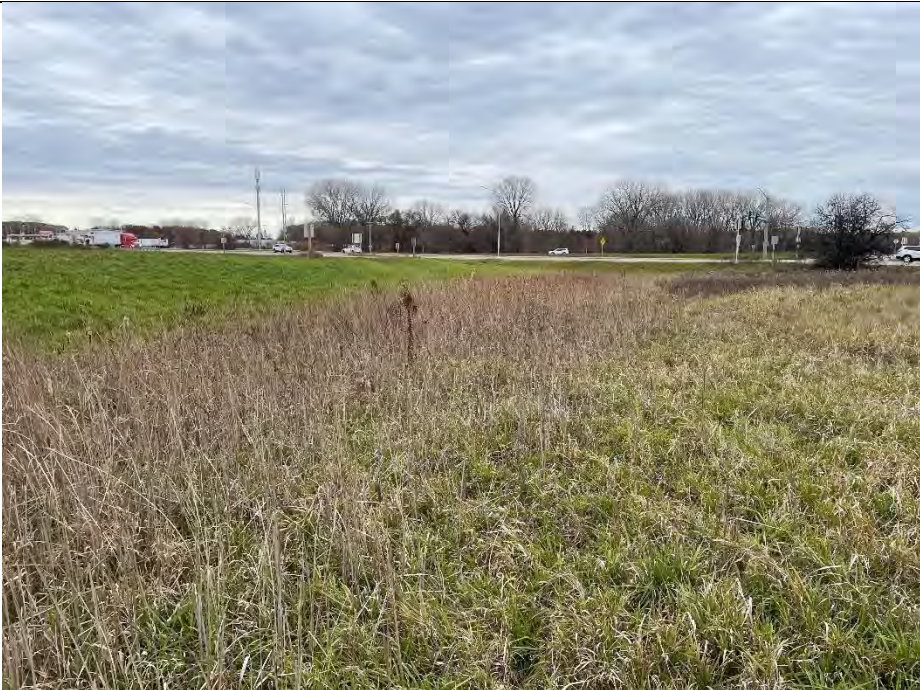
PHOTOGRAPH No: 26	DATE: November 10, 2021	LATITUDE: 43.18050833	LONGITUDE: -89.32547317
DIRECTION: Northeast	SITE LOCATION: USH 51 Interchange		
DESCRIPTION: Wetland W209, Deep Marsh - D (foreground)

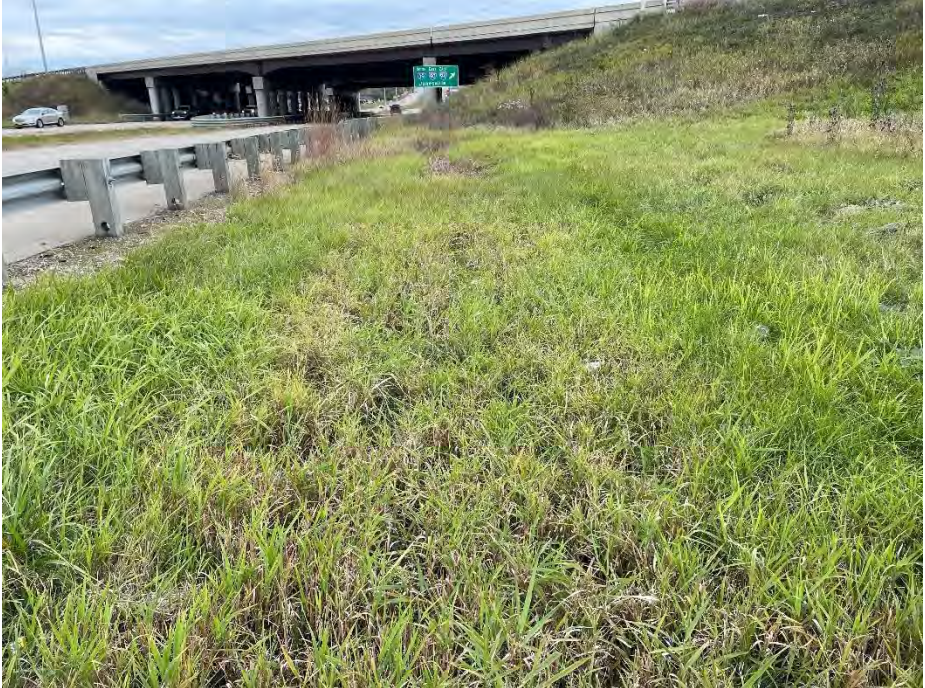
PHOTOGRAPH No: 35	DATE: November 10, 2021	LATITUDE: 43.18000167	LONGITUDE: -89.32461067
DIRECTION: West	SITE LOCATION: USH 51 Interchange		
DESCRIPTION: Wetland W204, Wet Meadow - D (foreground)

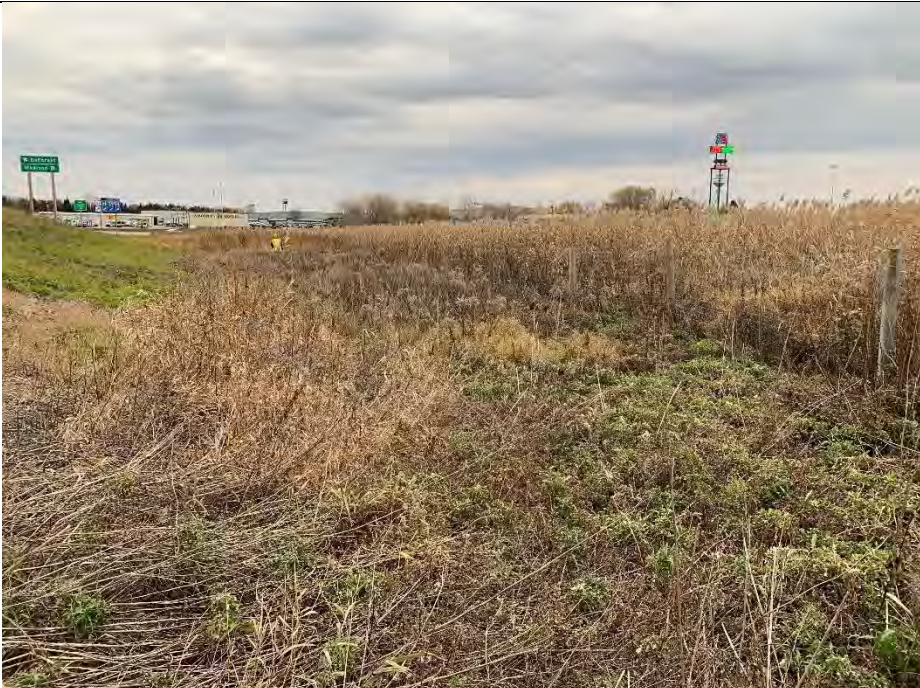
PHOTOGRAPH No: 48	DATE: November 10, 2021	LATITUDE: 43.17751826	LONGITUDE: -89.32688271
DIRECTION: South	SITE LOCATION: USH 51 Interchange		
DESCRIPTION: Wetland W187, Wet Meadow - D (foreground)

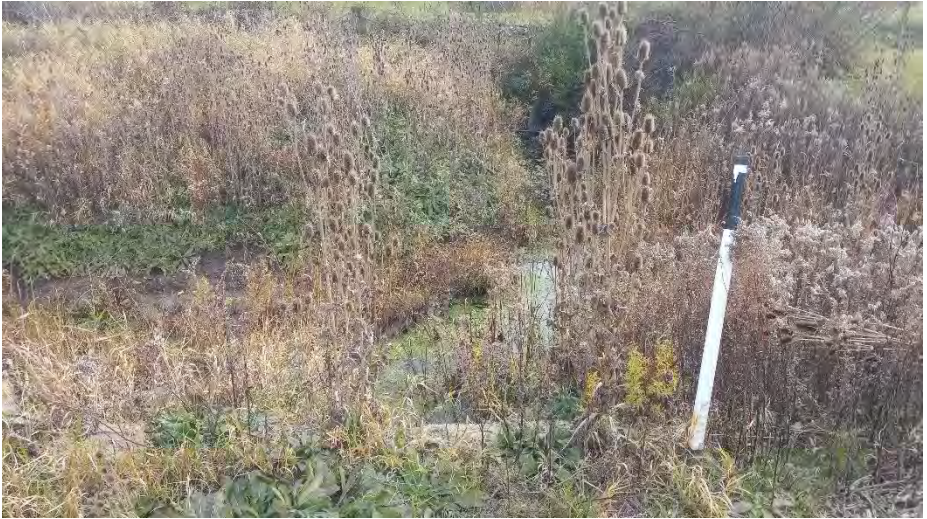
PHOTOGRAPH No: 53	DATE: November 10, 2021	LATITUDE: 43.1770343	LONGITUDE: -89.3237033
DIRECTION: South	SITE LOCATION: USH 51 Interchange		
DESCRIPTION: Wetland W192, Aquatic Bed - D (foreground)

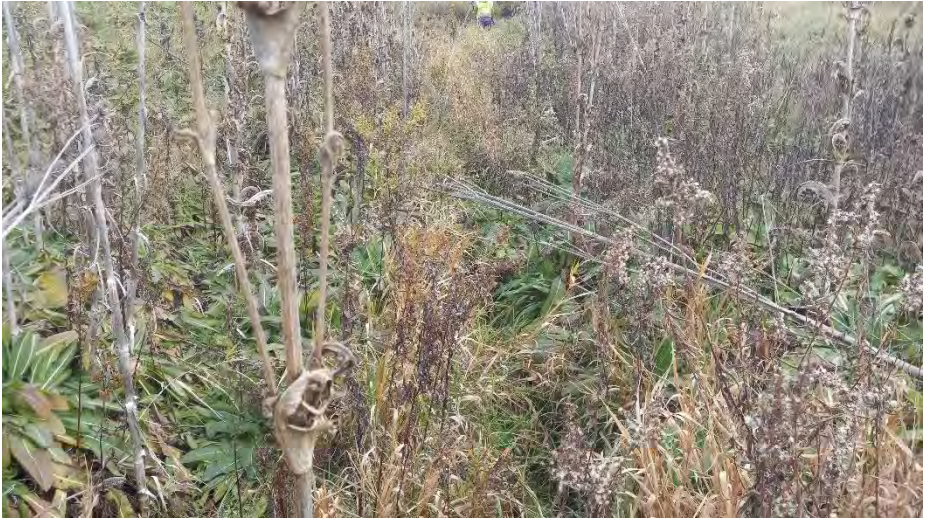
PHOTOGRAPH No: 55	DATE: November 10, 2021	LATITUDE: 43.1768	LONGITUDE: -89.3222208
DIRECTION: Southeast	SITE LOCATION: USH 51 Interchange		
DESCRIPTION: Wetland W190, Aquatic Bed - D (foreground)

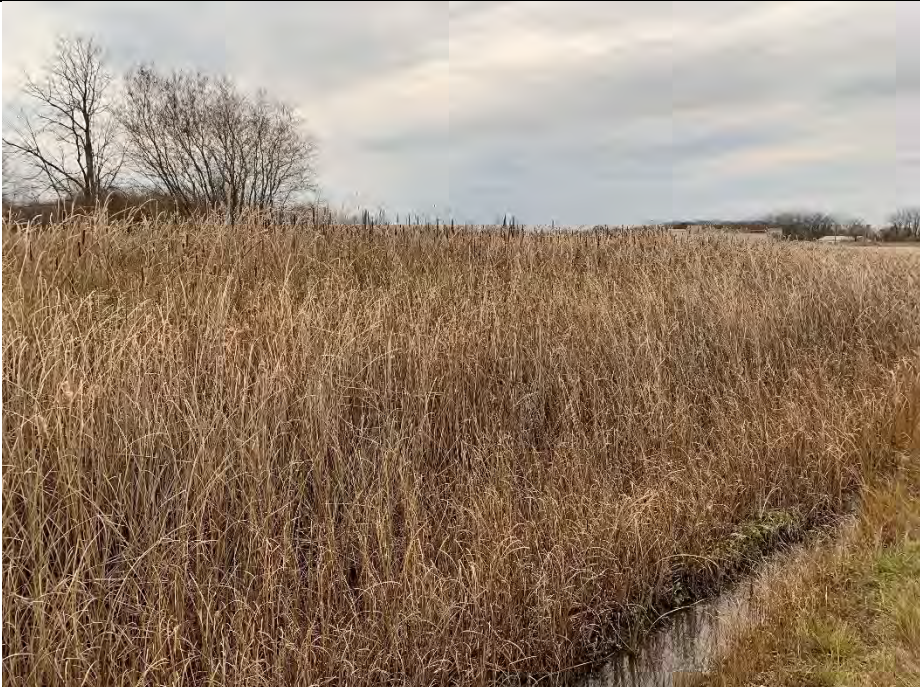
PHOTOGRAPH No: 58	DATE: November 10, 2021	LATITUDE: 43.17645473	LONGITUDE: -89.32481234
DIRECTION: North	SITE LOCATION: USH 51 Interchange		
DESCRIPTION: Wetland W187, Deep Marsh - D (foreground)

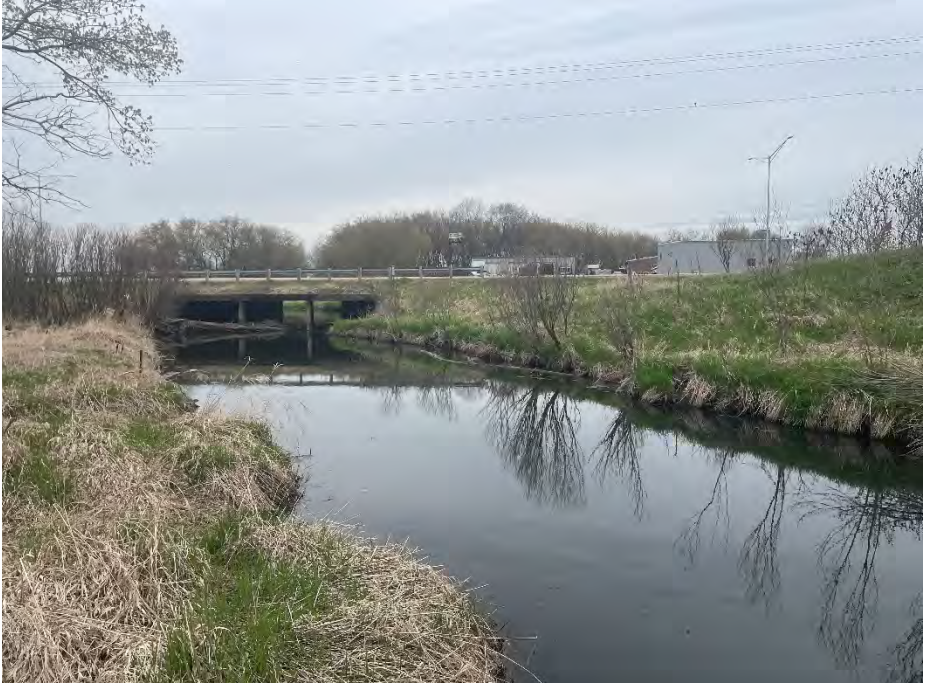
PHOTOGRAPH No: 69	DATE: May 6, 2022	LATITUDE: 43.18212566	LONGITUDE: -89.32336426
DIRECTION: West	SITE LOCATION: USH 51 Interchange		
DESCRIPTION: Wetland 206, Aquatic Bed (foreground)

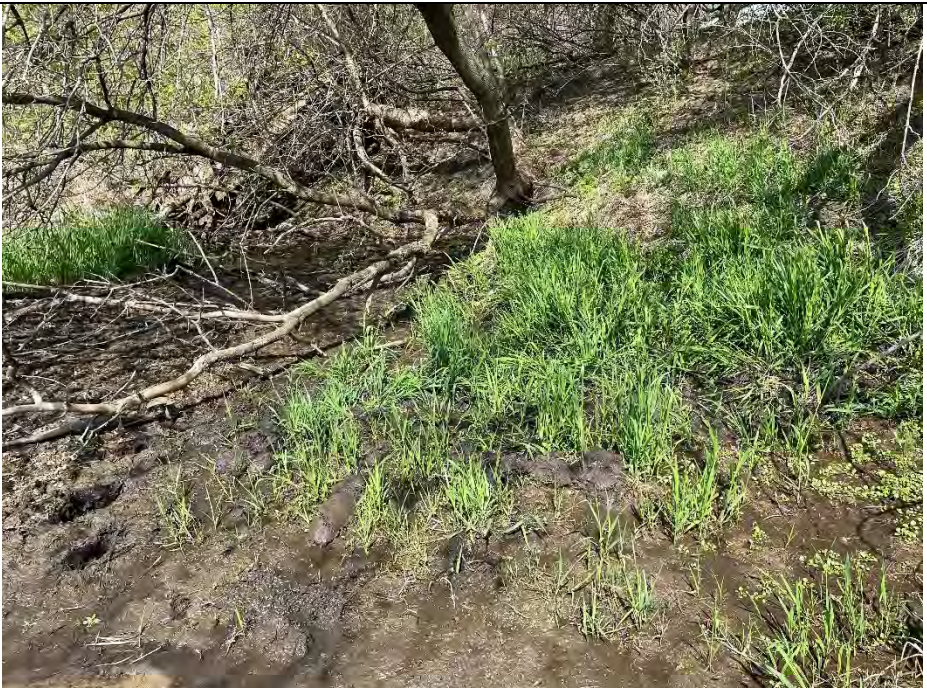
PHOTOGRAPH No: 73	DATE: May 9, 2022	LATITUDE: 43.1818213	LONGITUDE: -89.32509934
DIRECTION: North	SITE LOCATION: USH 51 Interchange		
DESCRIPTION: Wetland 219, Riparian Forested - D (foreground)

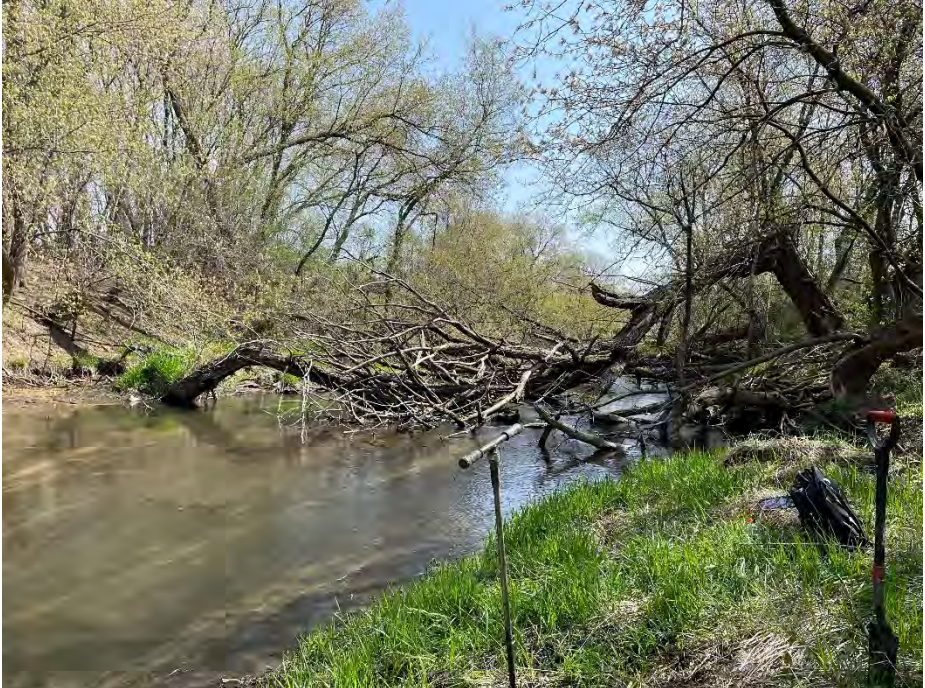
PHOTOGRAPH No: 74	DATE: May 9, 2022	LATITUDE: 43.18151951	LONGITUDE: -89.32615811
DIRECTION: East	SITE LOCATION: USH 51 Interchange		
DESCRIPTION: Wetland 219, Riparian Forested - D (foreground)
