Appendix O. Wetland Rapid Assessment Methodology Reports

Wetland Rapid Assessment Methodology
US 151/High Crossing Interchange
WisDOT Project ID: 1015-05-00
Dane County, Wisconsin

GEI Consultants, Inc.
3159 Voyager Drive
Green Bay, WI 54311
920.455.8200

May 30, 2024
Project 2404021

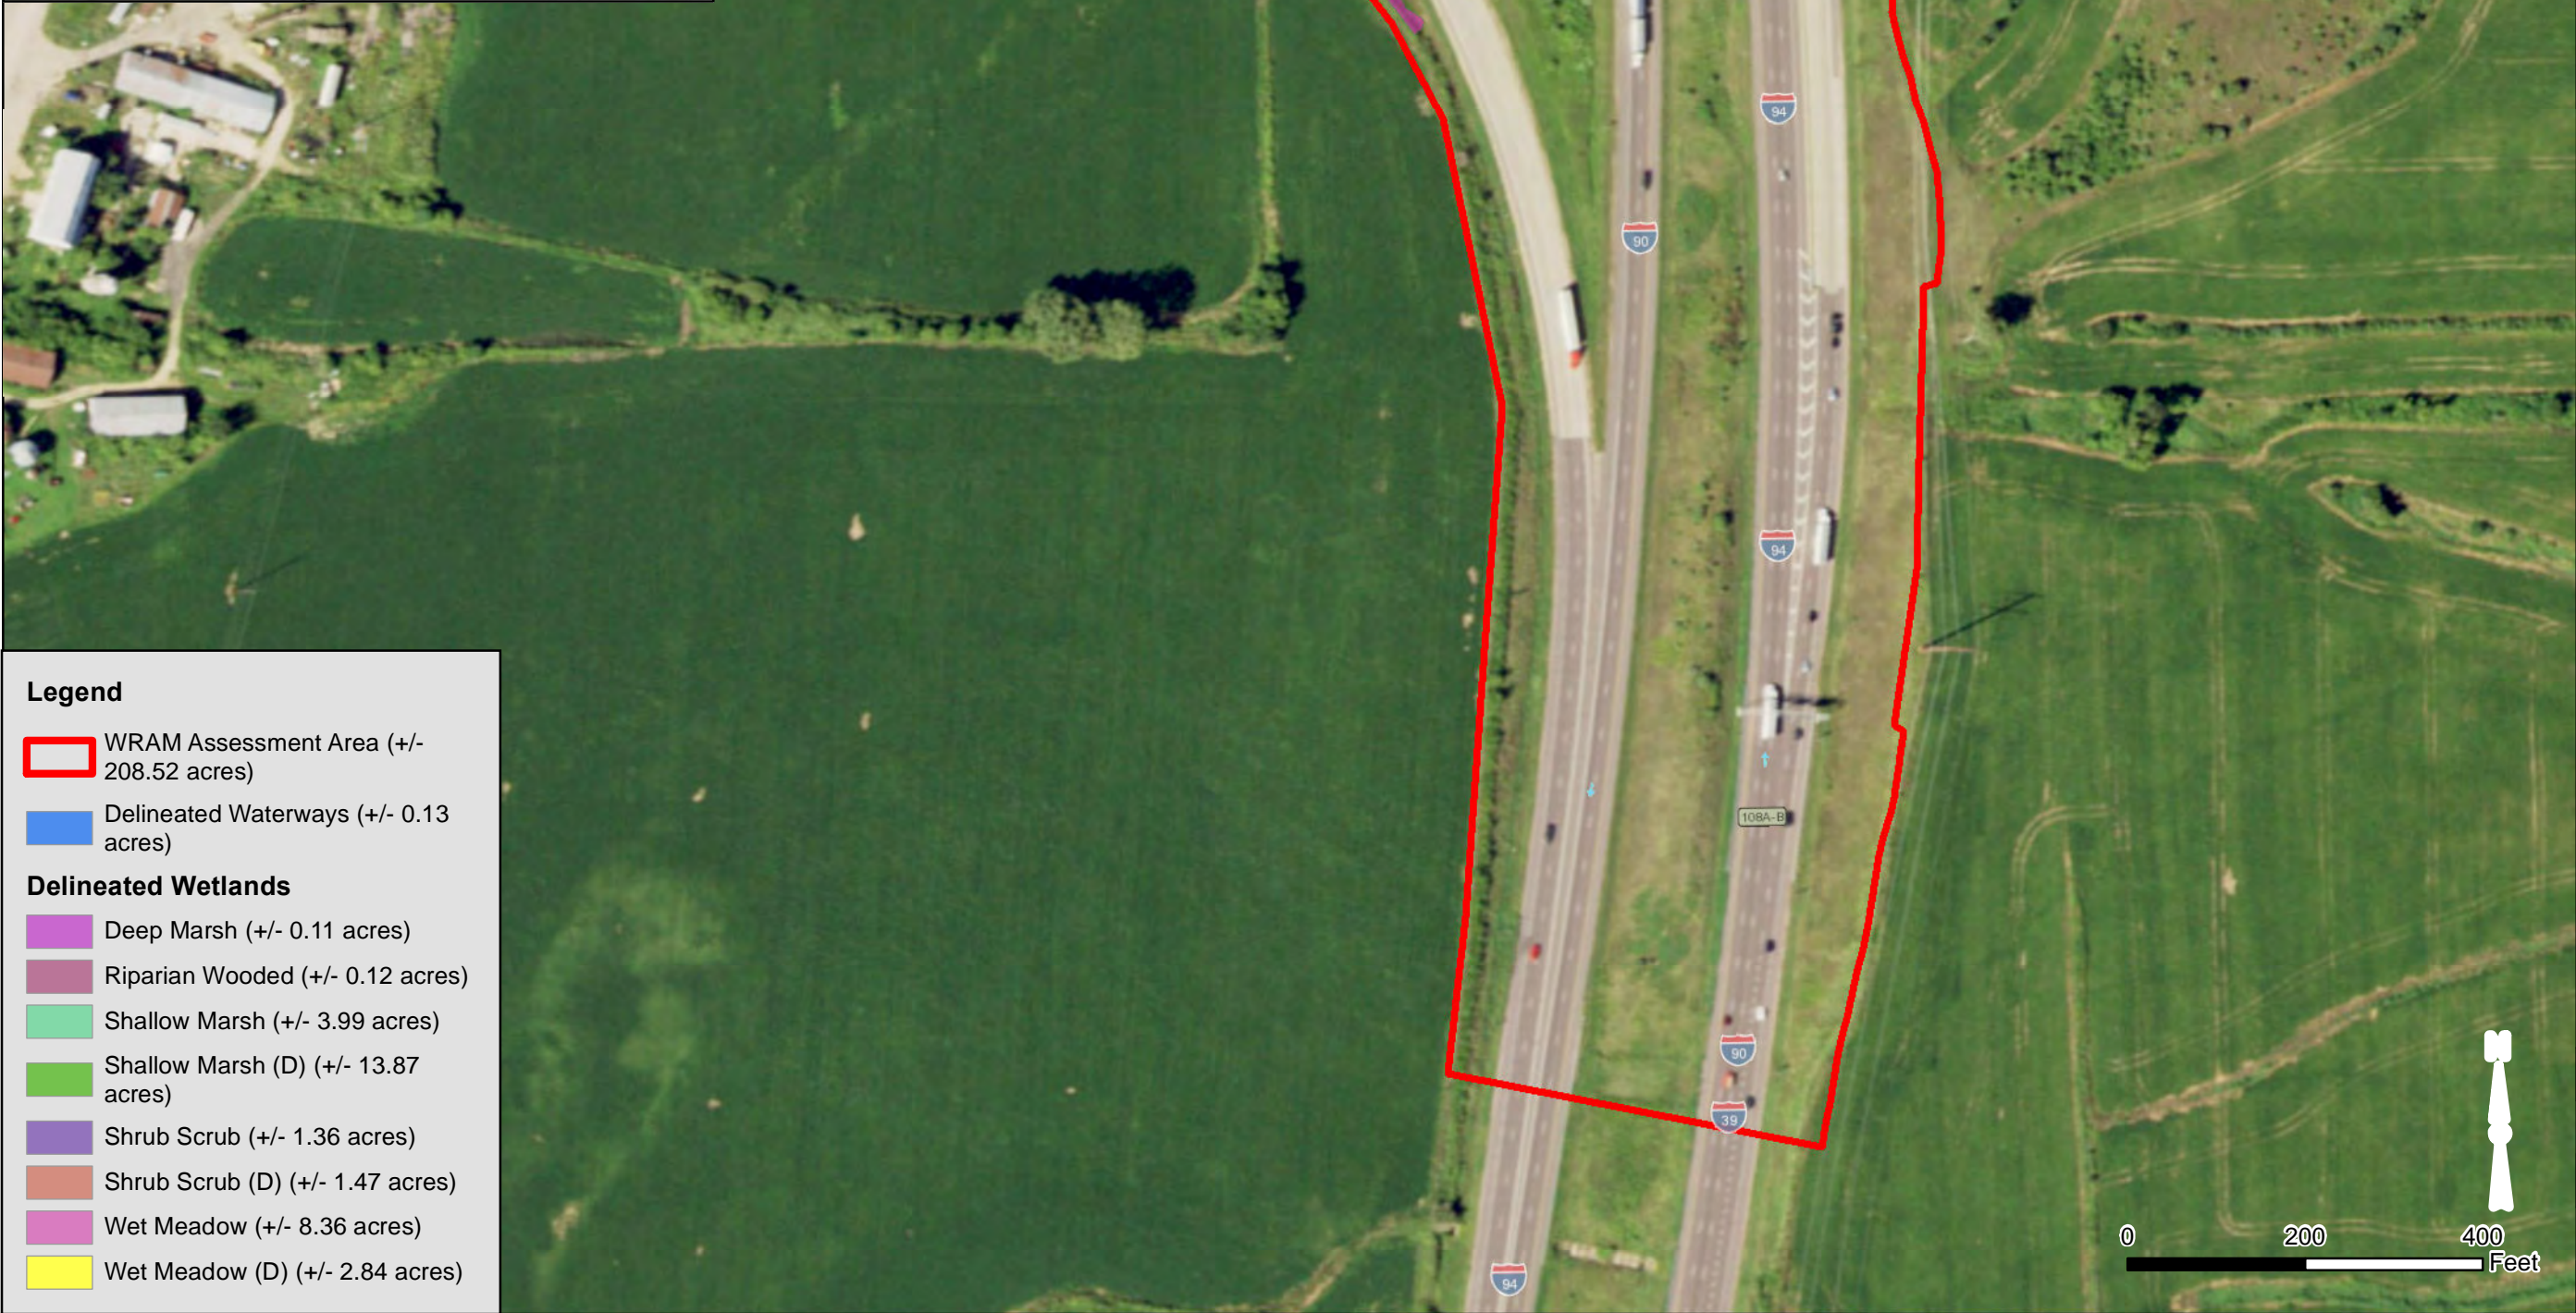
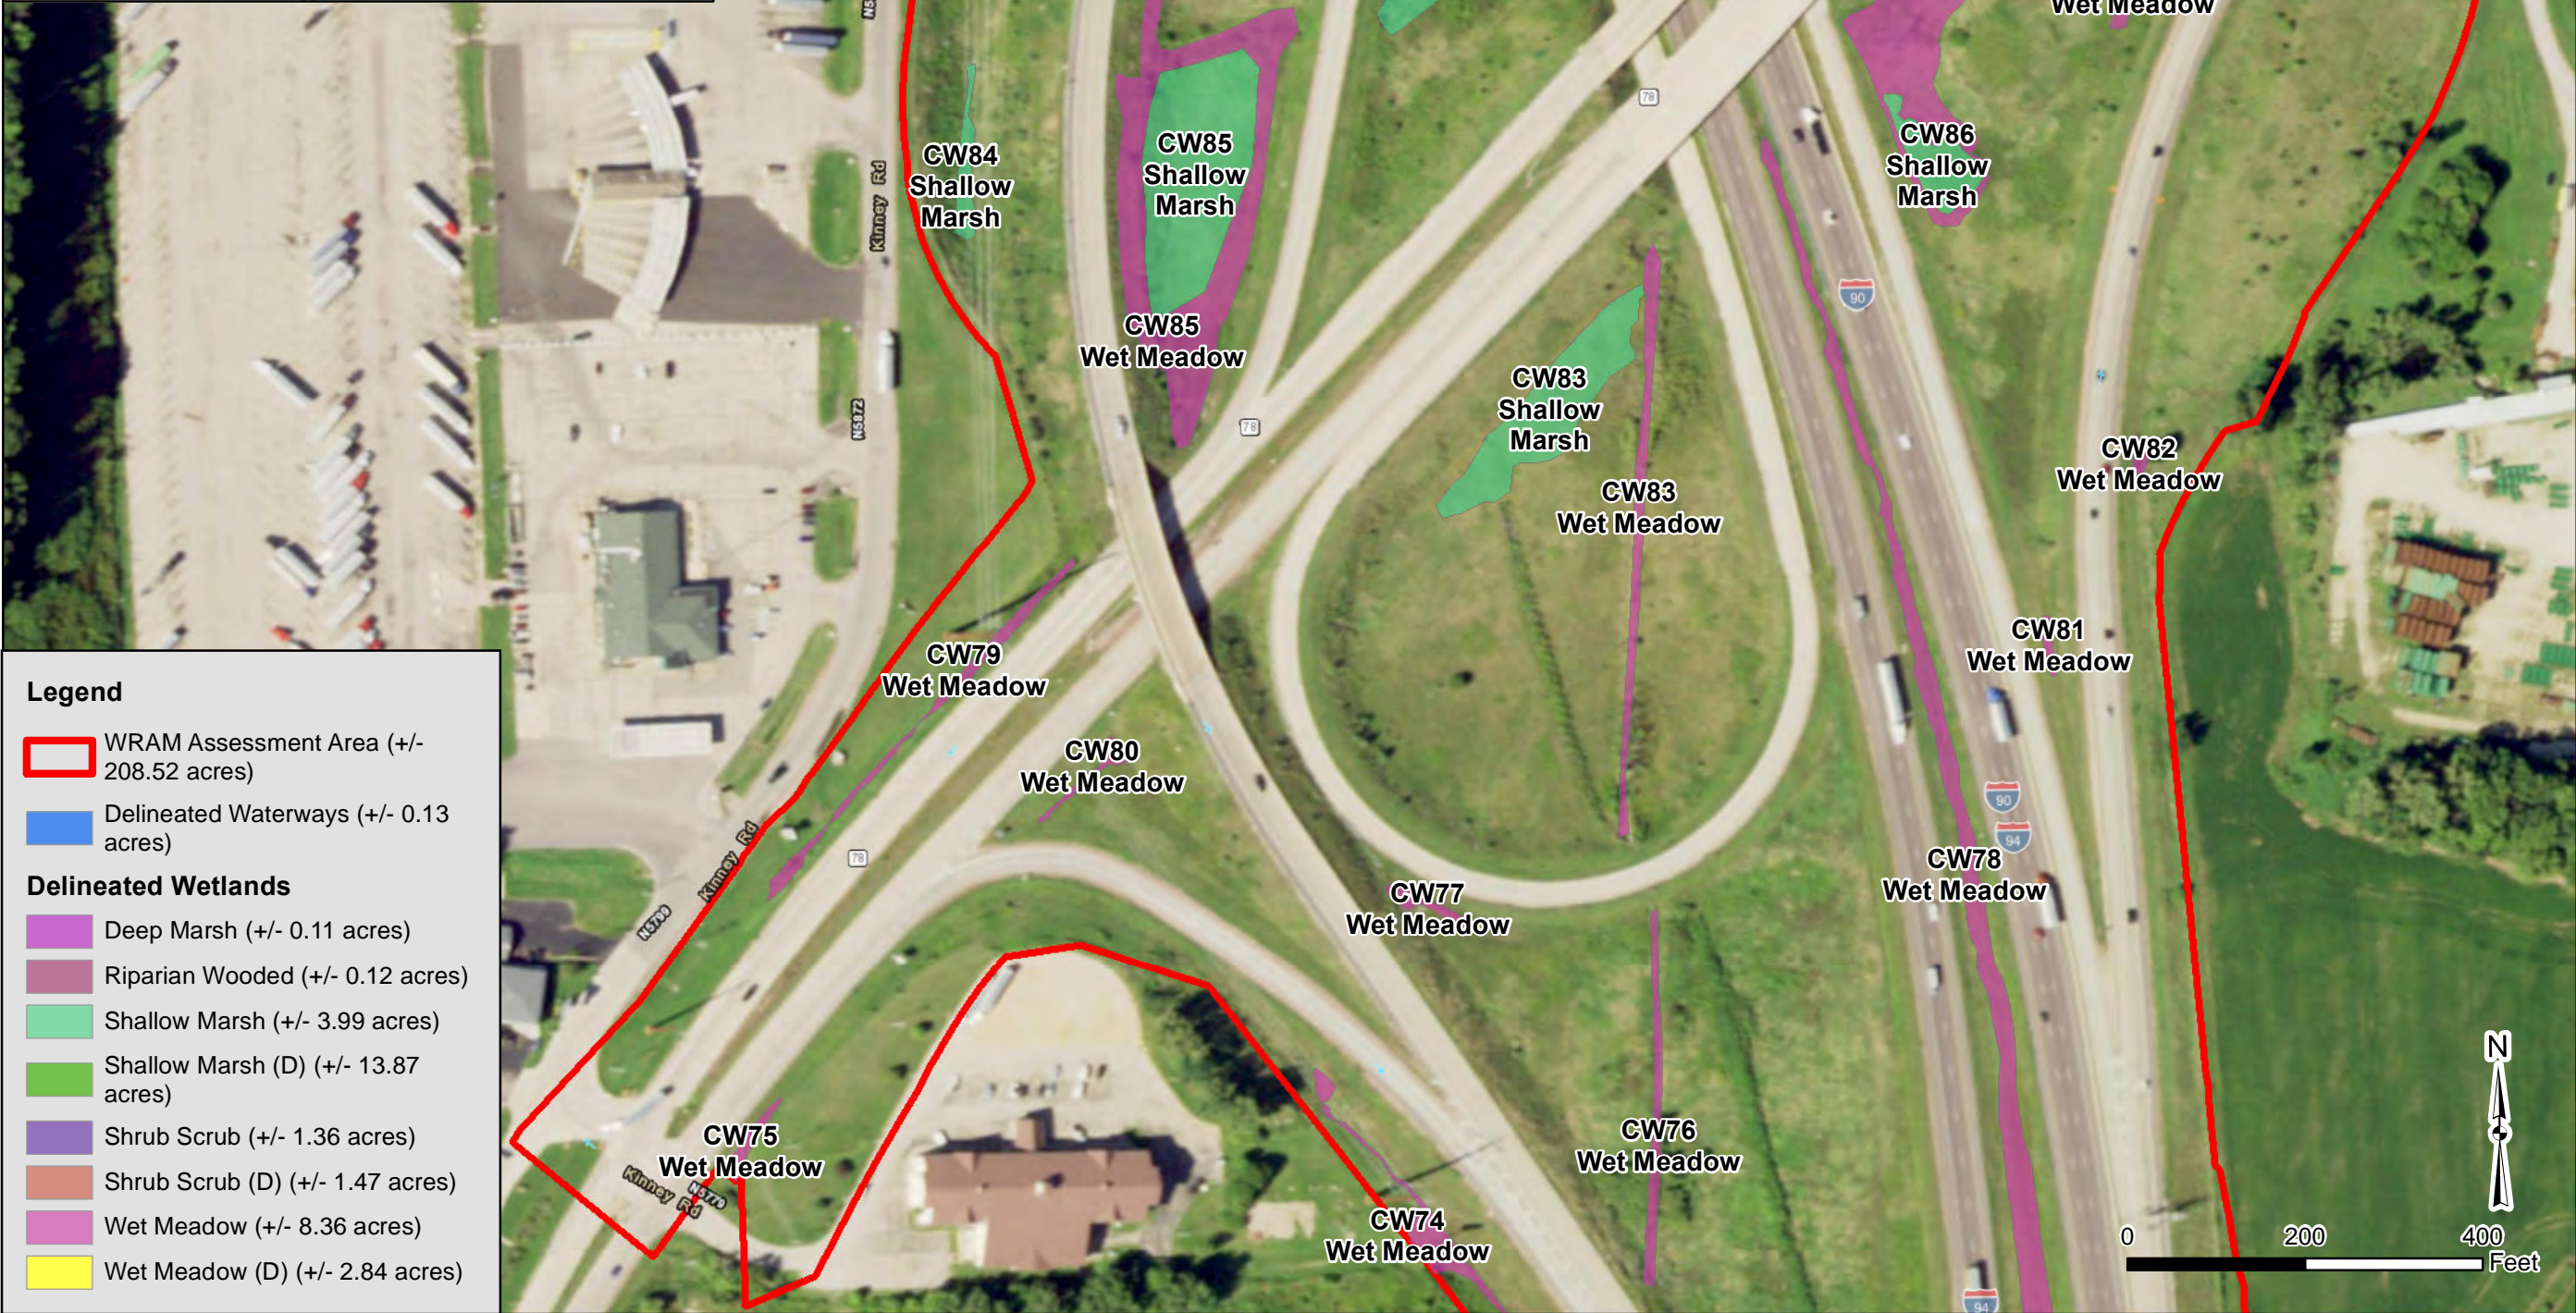
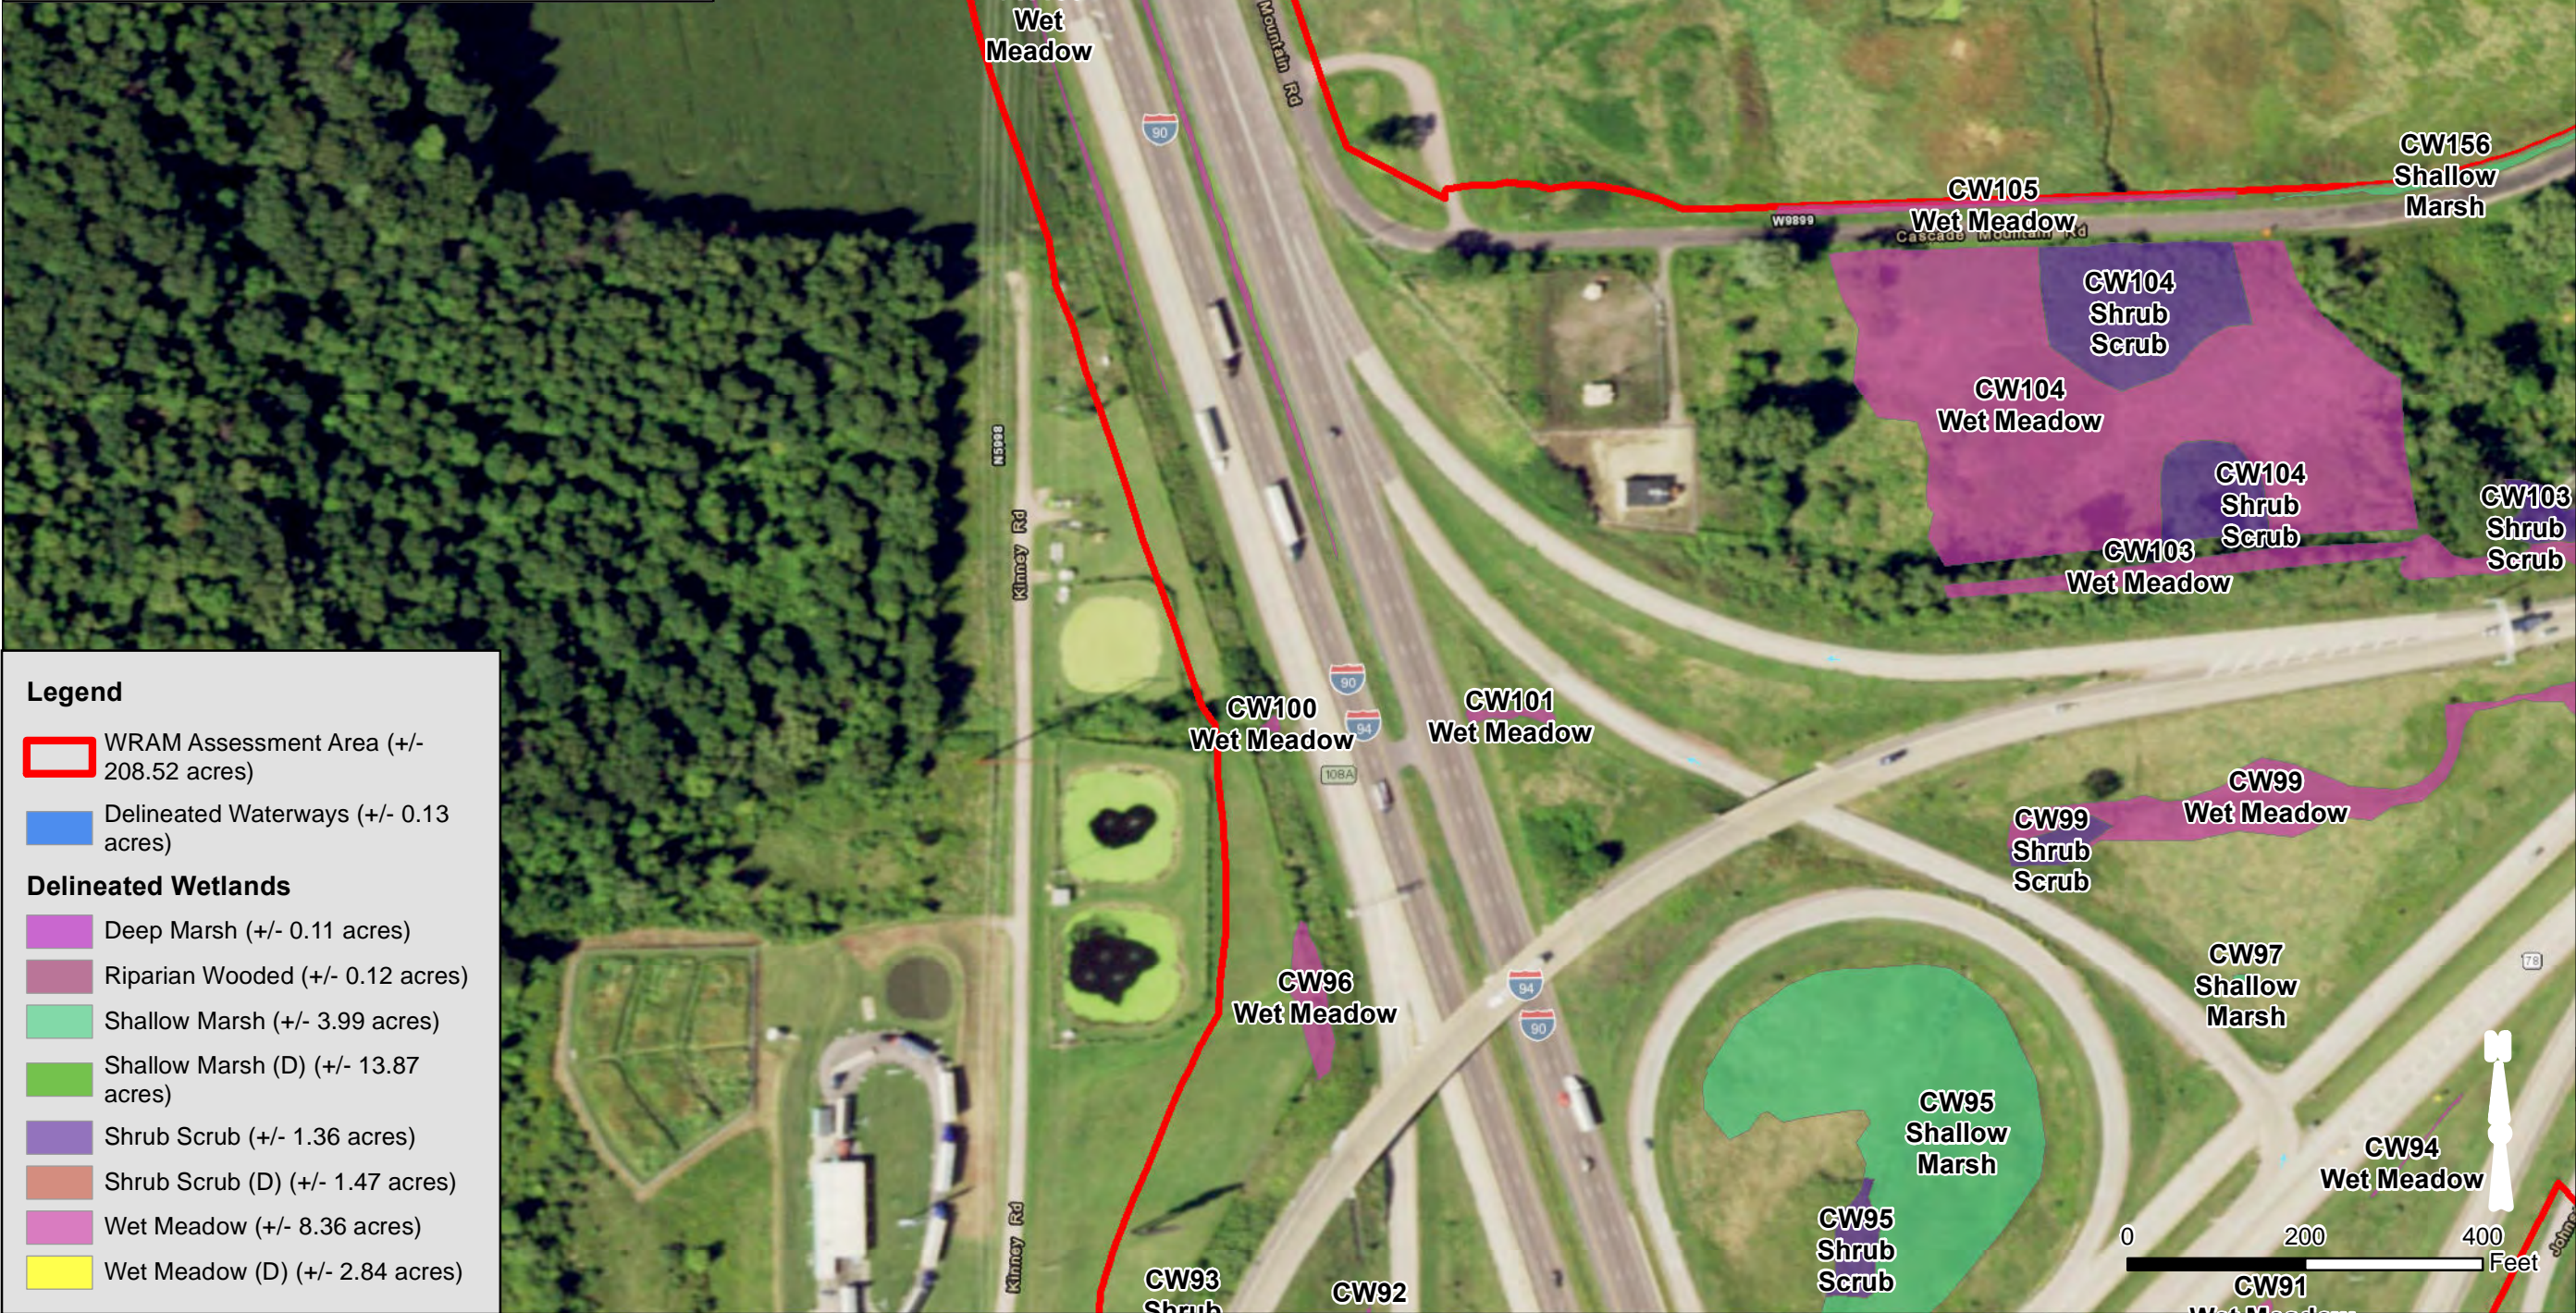
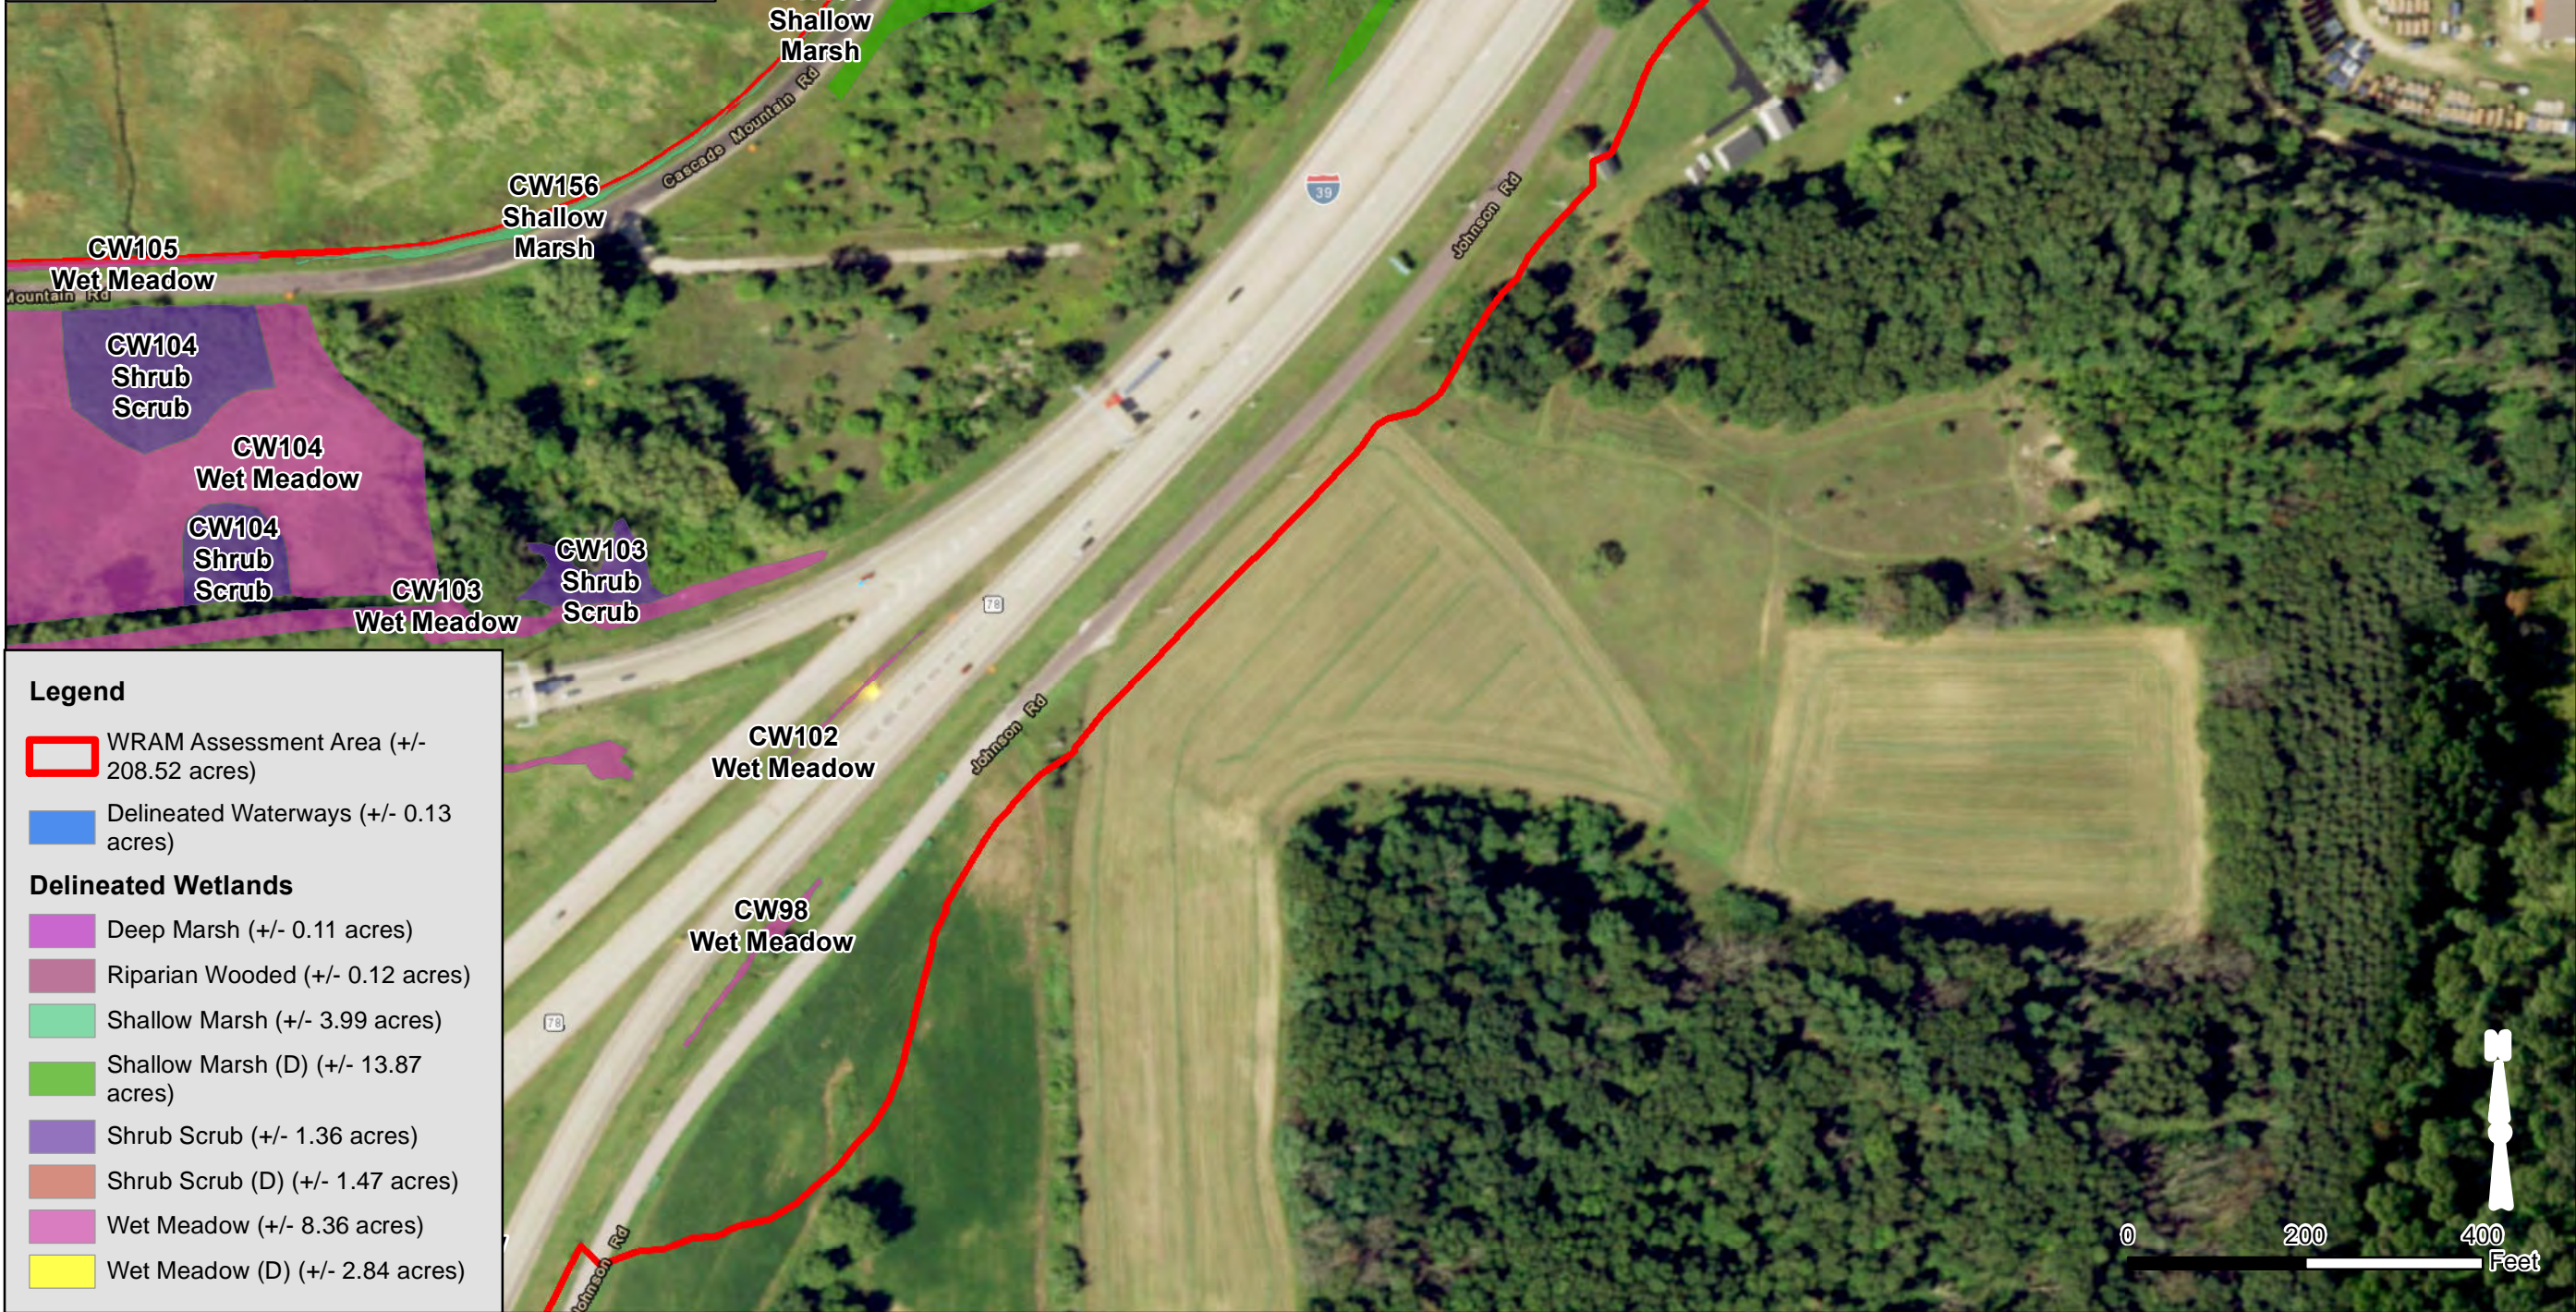
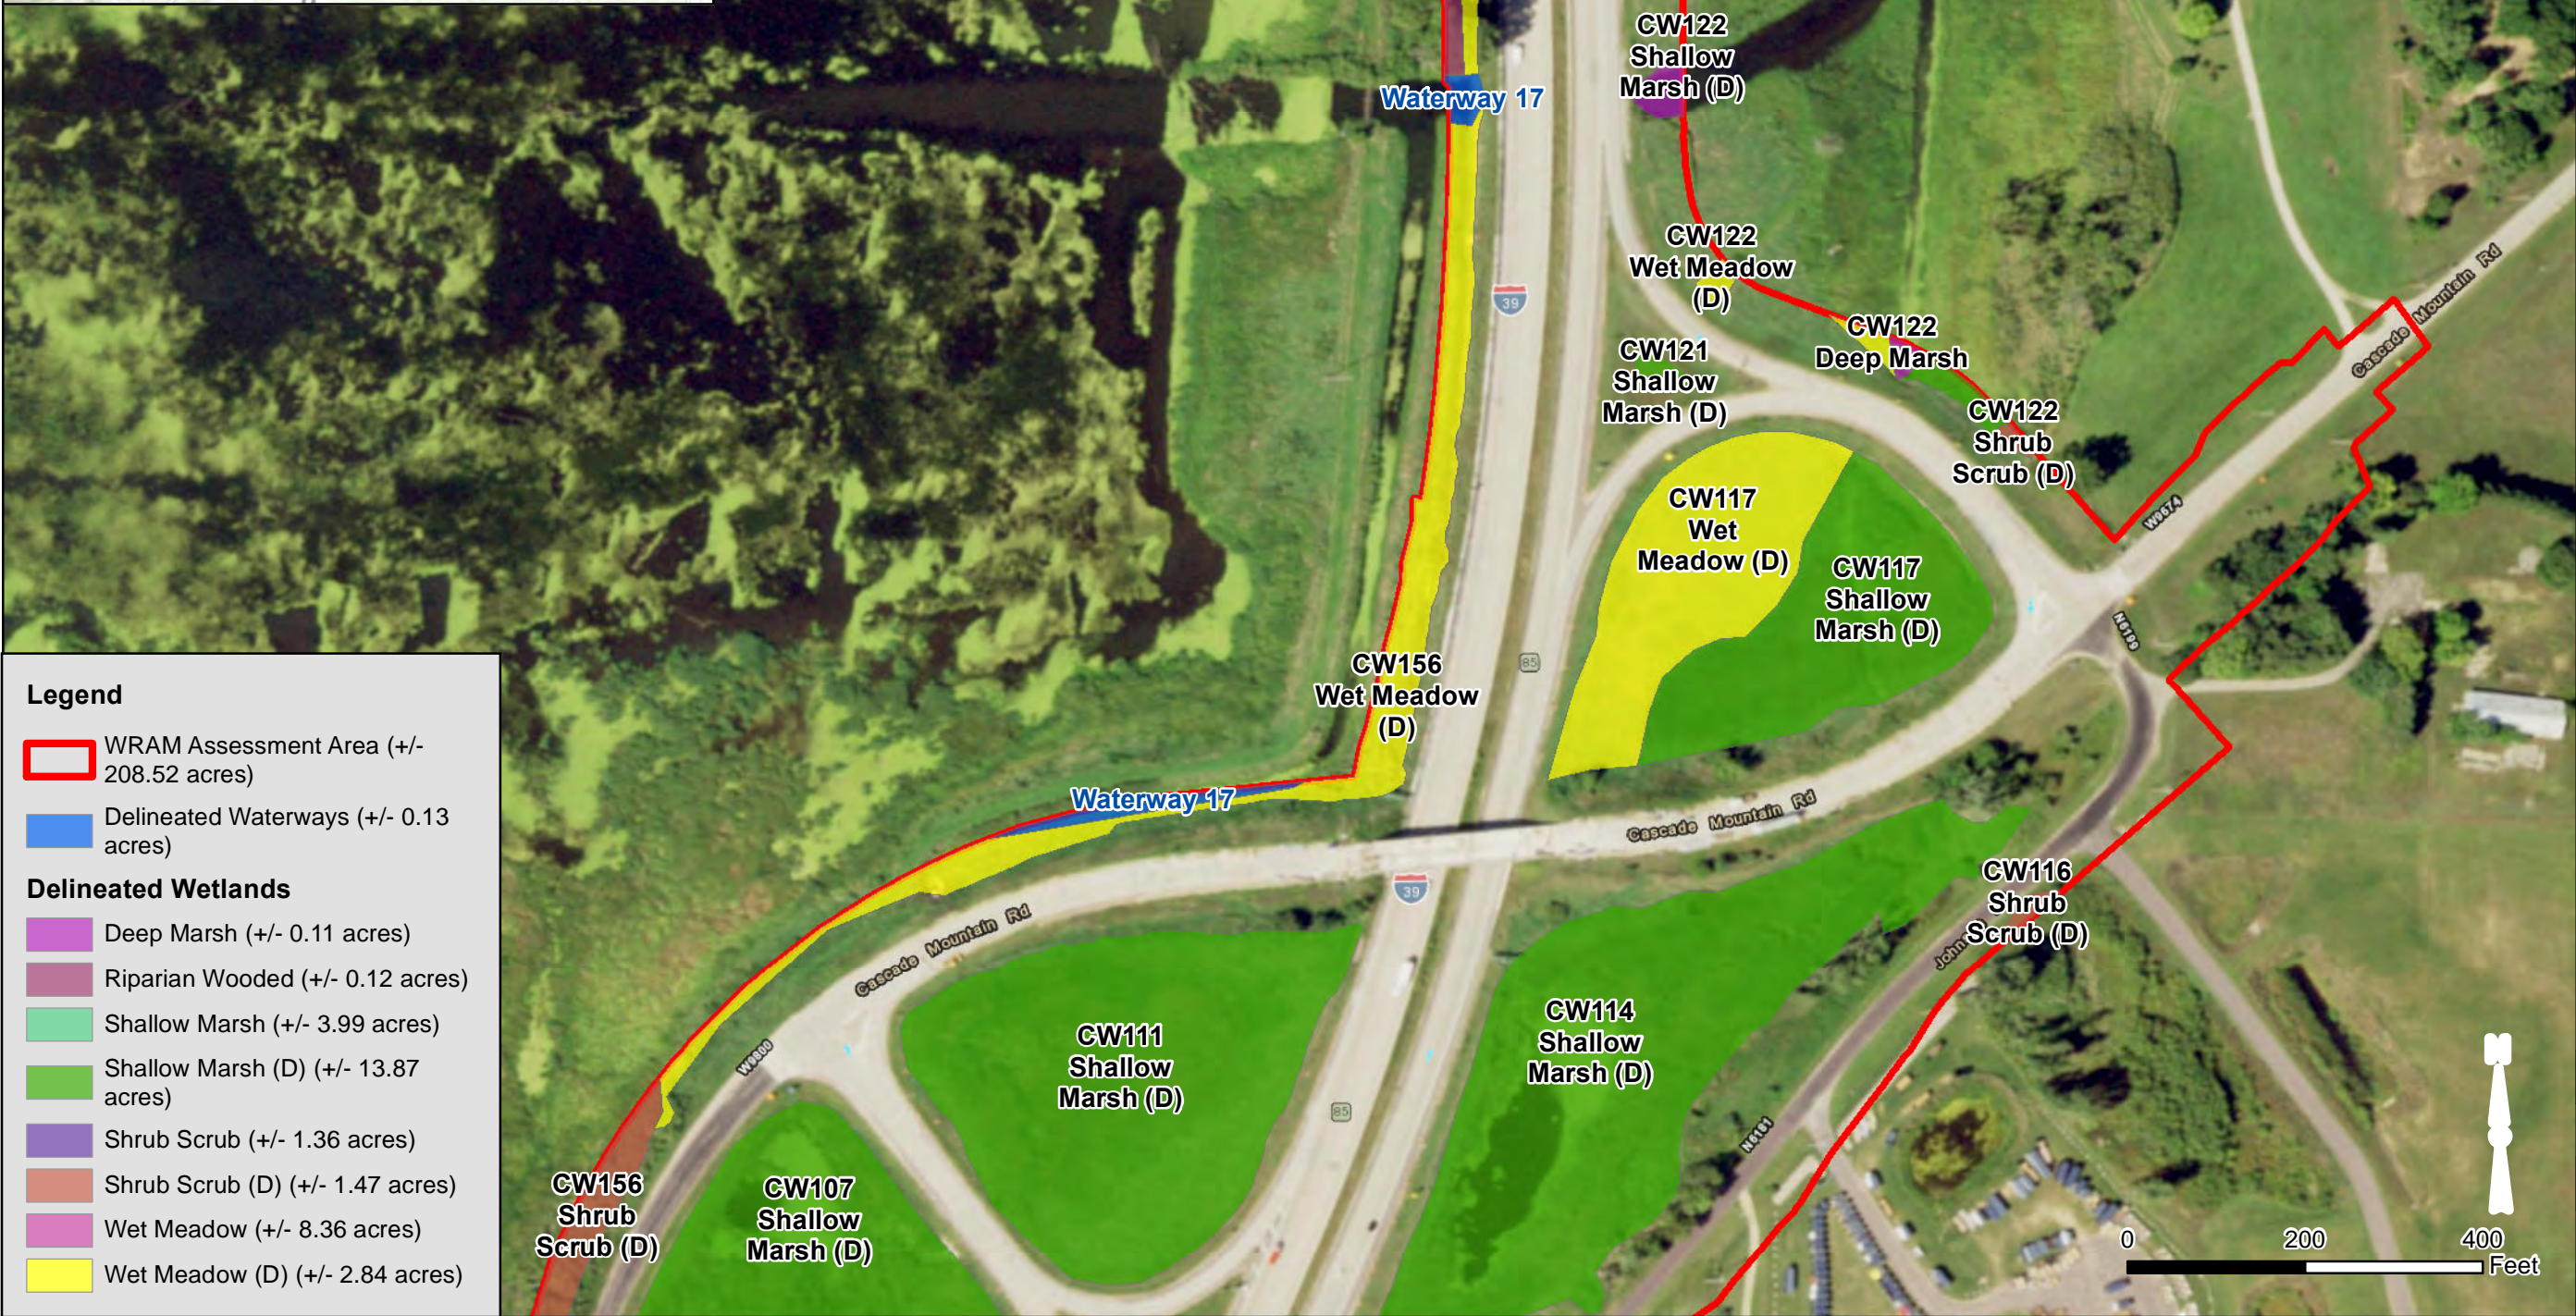
FIGURE 5
WETLAND COMMUNITIES MAP
WISCONSIN DEPARTMENT OF TRANSPORTATION
WISDOT PROJECT ID: 1015-05-00
IH 39 90 94 WRAM - I-39 AND I-90/94 SPLIT INTERCHANGE
TOWN OF CALEDONIA
COLUMBIA COUNTY, WISCONSIN

- Legend**
- WRAM Assessment Area (+/- 208.52 acres)
 - Delineated Waterways (+/- 0.13 acres)
 - Delineated Wetlands**
 - Deep Marsh (+/- 0.11 acres)
 - Riparian Wooded (+/- 0.12 acres)
 - Shallow Marsh (+/- 3.99 acres)
 - Shallow Marsh (D) (+/- 13.87 acres)
 - Shrub Scrub (+/- 1.36 acres)
 - Shrub Scrub (D) (+/- 1.47 acres)
 - Wet Meadow (+/- 8.36 acres)
 - Wet Meadow (D) (+/- 2.84 acres)

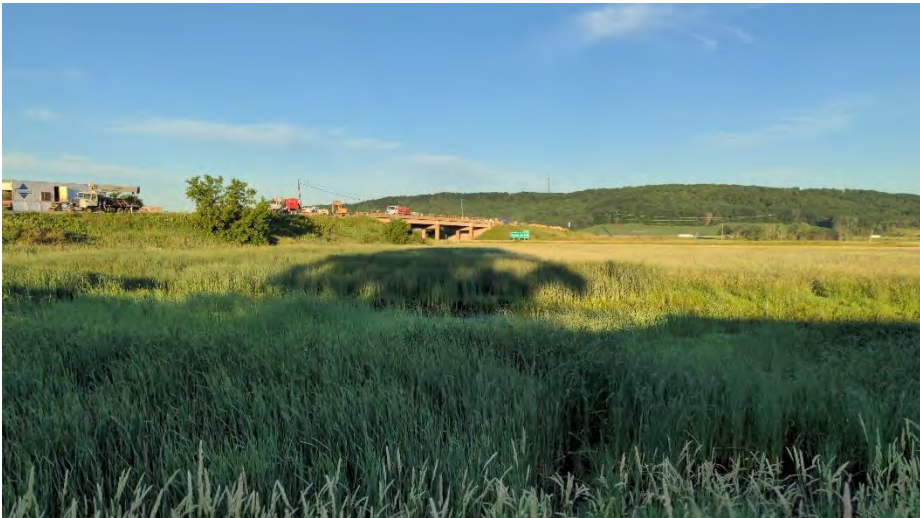
PHOTOGRAPH No: 2	DATE: June 23, 2022	LATITUDE: 43.49731565	LONGITUDE: -89.48205435
DIRECTION: West	SITE LOCATION: I-39 and I-90/94 Split Interchange		
DESCRIPTION: Wetland CW117, Shallow Marsh - D (foreground)

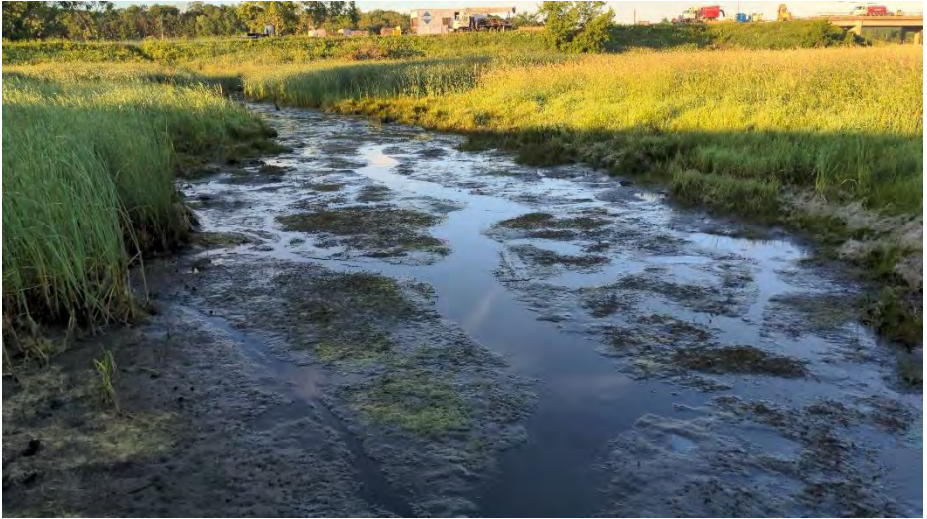
PHOTOGRAPH No: 3	DATE: June 23, 2022	LATITUDE: 43.49747157	LONGITUDE: -89.48240504
DIRECTION: South	SITE LOCATION: I-39 and I-90/94 Split Interchange		
DESCRIPTION: Wetland CW117, Shallow Marsh - D (foreground)
