Appendix O. Wetland Rapid Assessment Methodology Reports

Wetland Rapid Assessment Methodology
US 151/High Crossing Interchange
WisDOT Project ID: 1015-05-00
Dane County, Wisconsin

GEI Consultants, Inc.
3159 Voyager Drive
Green Bay, WI 54311
920.455.8200

May 30, 2024
Project 2404021

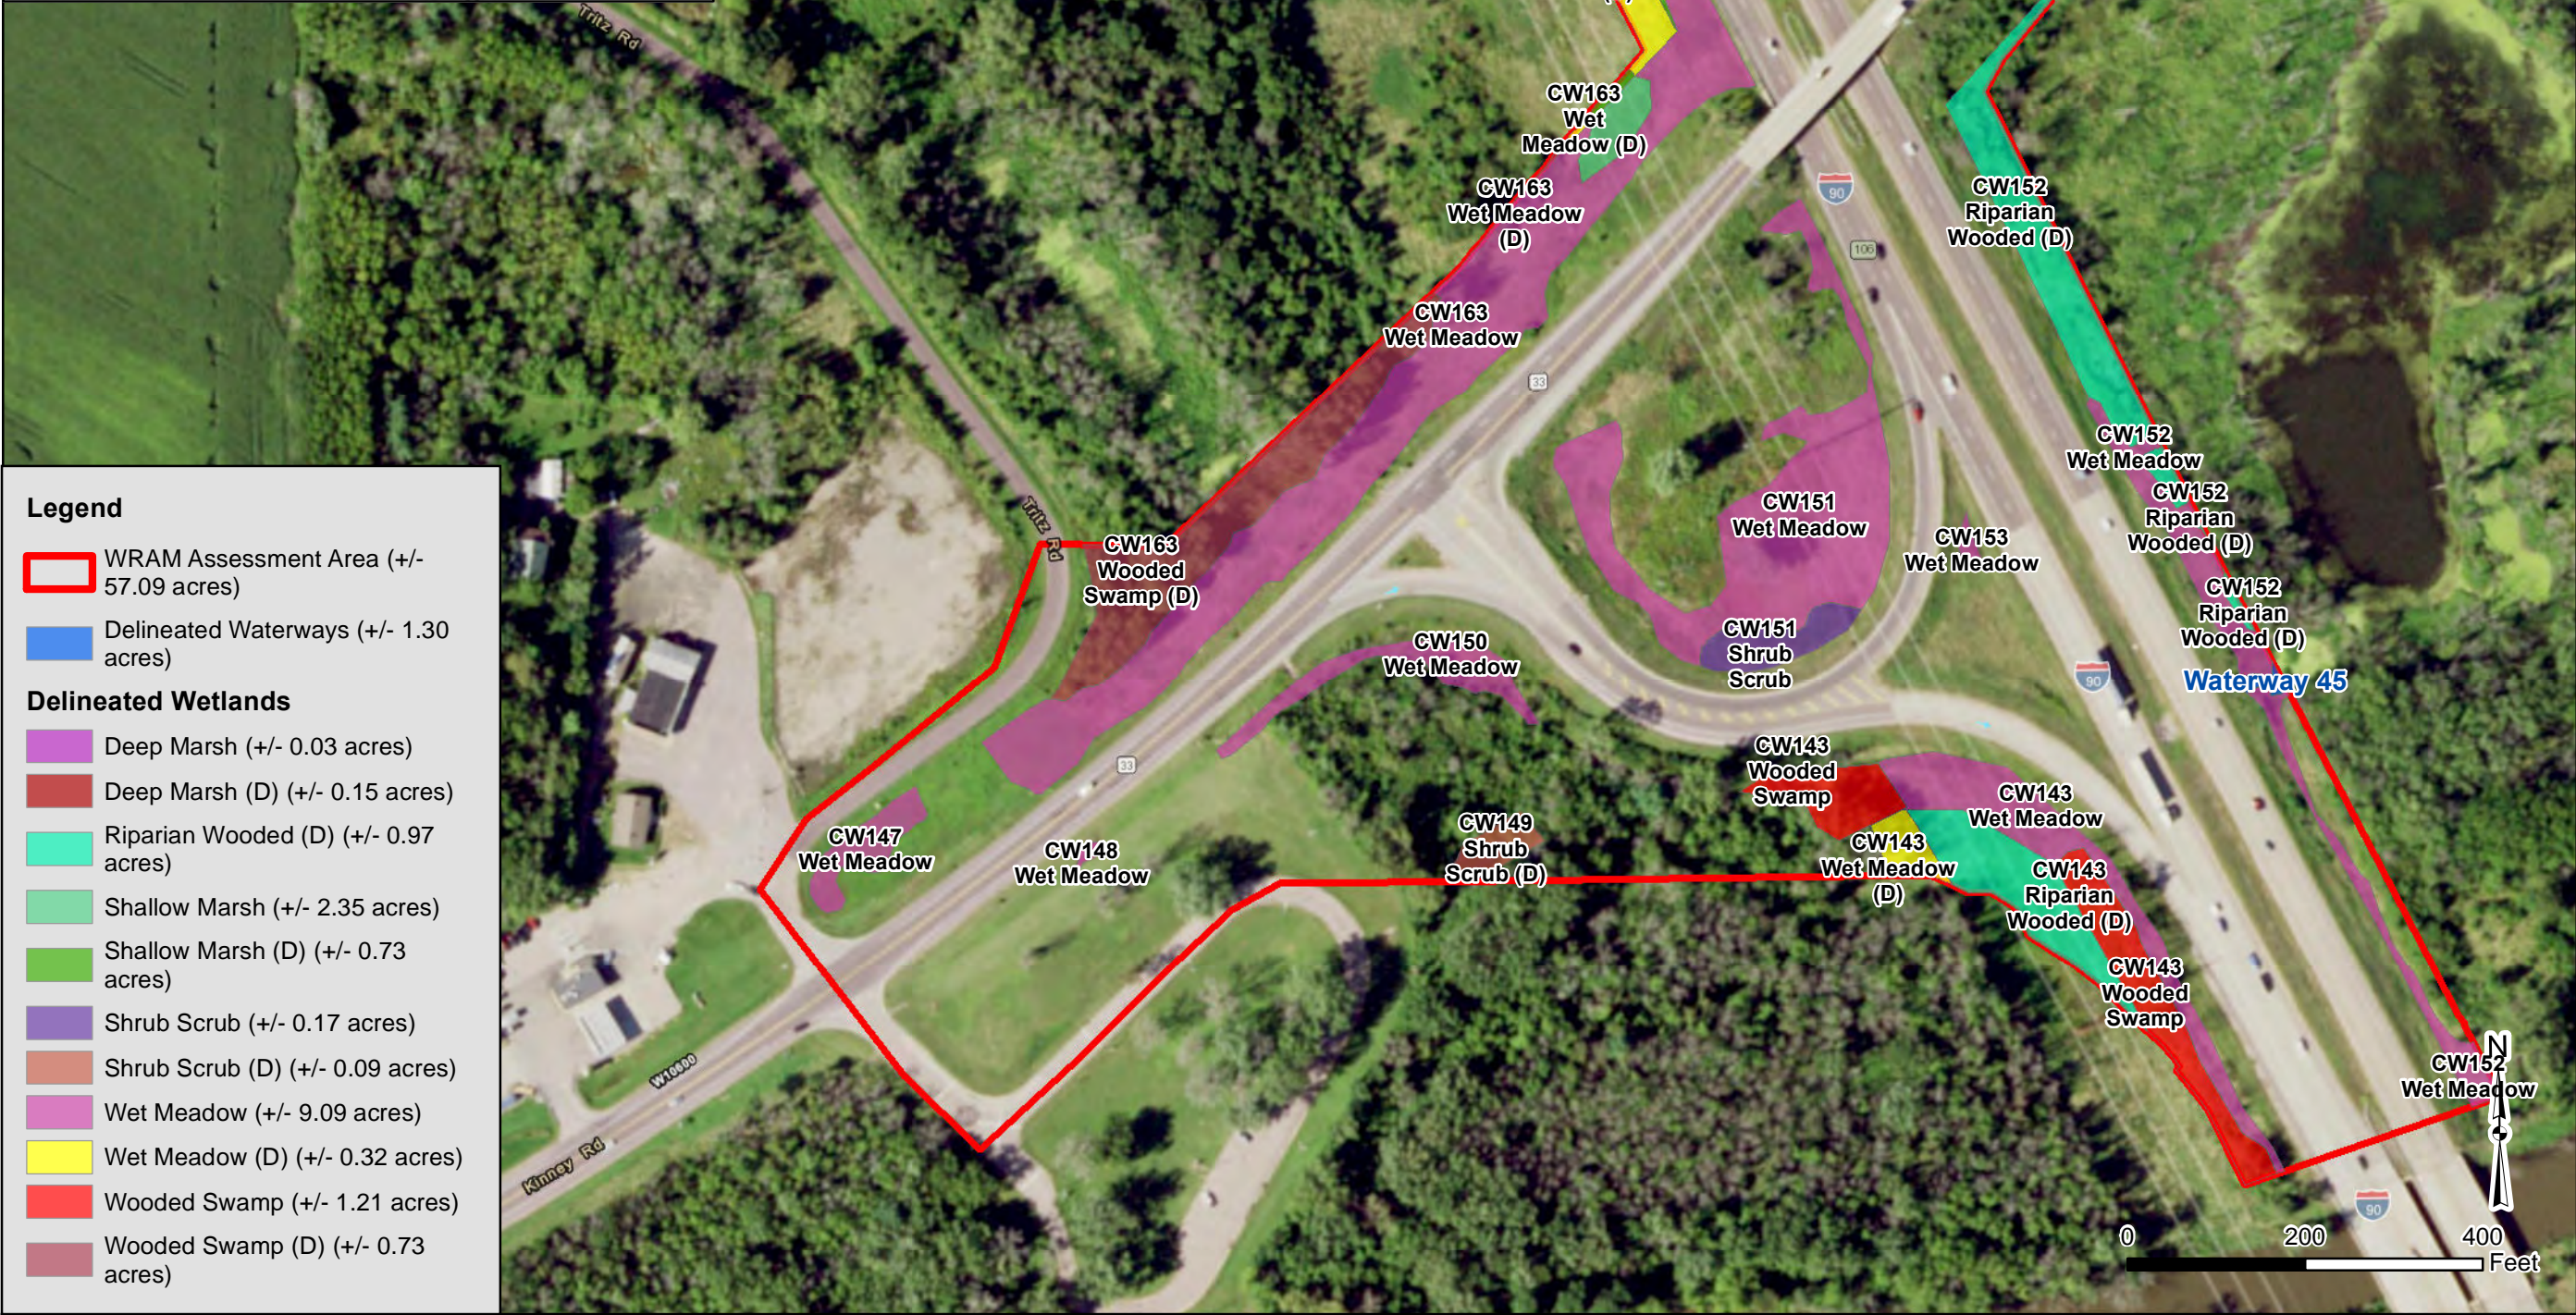
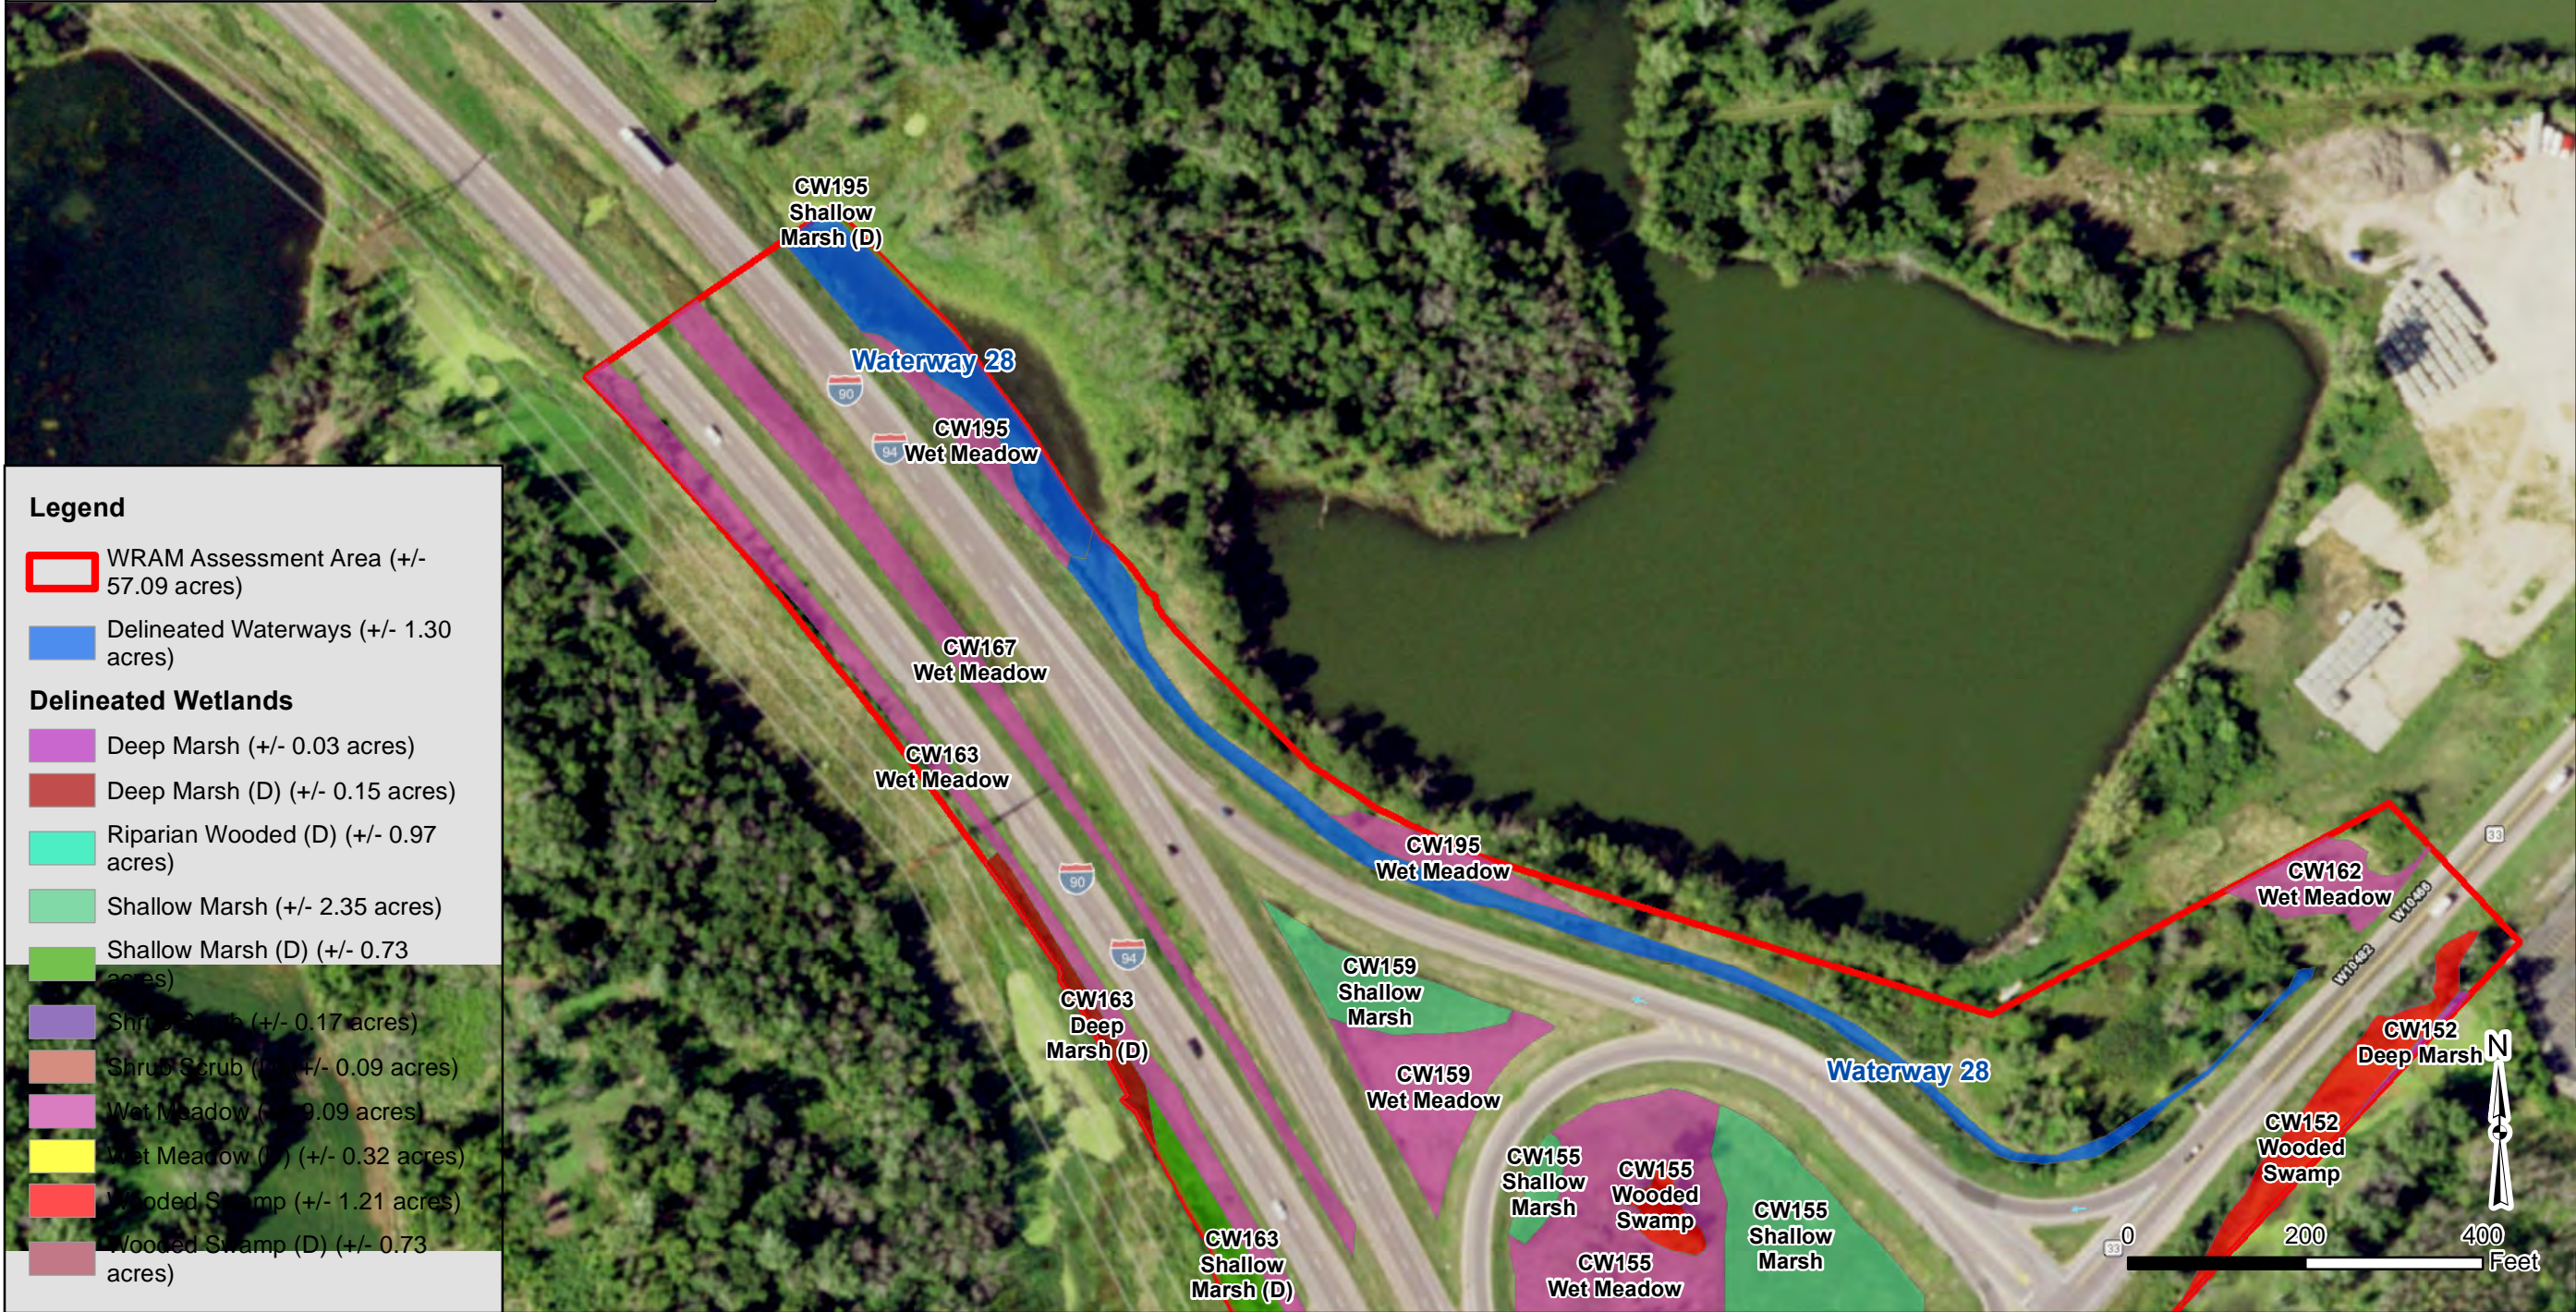
FIGURE 5
WETLAND COMMUNITIES MAP
WISCONSIN DEPARTMENT OF TRANSPORTATION
WISDOT PROJECT ID: 1015-05-00
IH 39 90 94 WRAM - WIS 33 AT I-90/94 INTERCHANGE
TOWN OF CALEDONIA
COLUMBIA COUNTY, WISCONSIN

- Legend**
- WRAM Assessment Area (+/- 57.09 acres)
 - Delineated Waterways (+/- 1.30 acres)
 - Delineated Wetlands**
 - Deep Marsh (+/- 0.03 acres)
 - Deep Marsh (D) (+/- 0.15 acres)
 - Riparian Wooded (D) (+/- 0.97 acres)
 - Shallow Marsh (+/- 2.35 acres)
 - Shallow Marsh (D) (+/- 0.73 acres)
 - Shrub Scrub (+/- 0.17 acres)
 - Shrub Scrub (D) (+/- 0.09 acres)
 - Wet Meadow (+/- 9.09 acres)
 - Wet Meadow (D) (+/- 0.32 acres)
 - Wooded Swamp (+/- 1.21 acres)
 - Wooded Swamp (D) (+/- 0.73 acres)

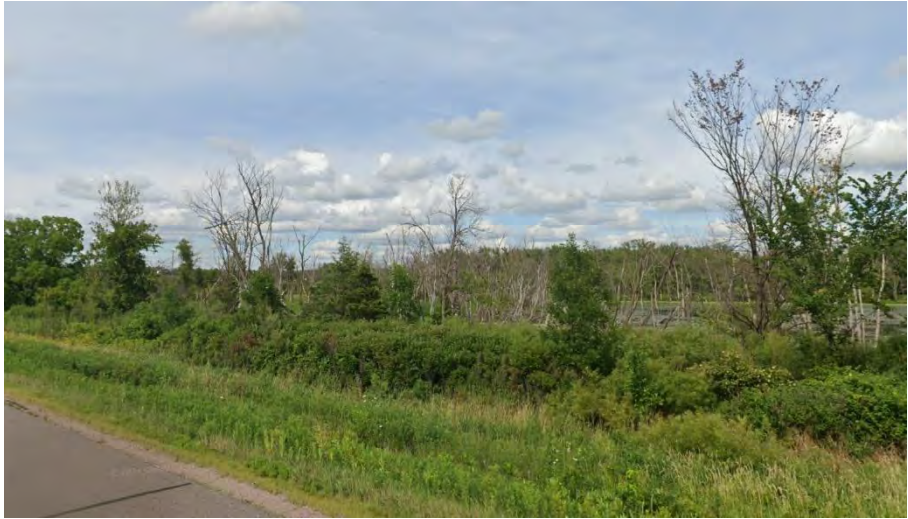
PHOTOGRAPH No: 1	DATE: June 23, 2022	LATITUDE: 43.510971	LONGITUDE: -89.521628
DIRECTION: Northeast	SITE LOCATION: WIS 33 at I-90/94 Interchange		
DESCRIPTION: Wetland CW152, Riparian Wooded – D.

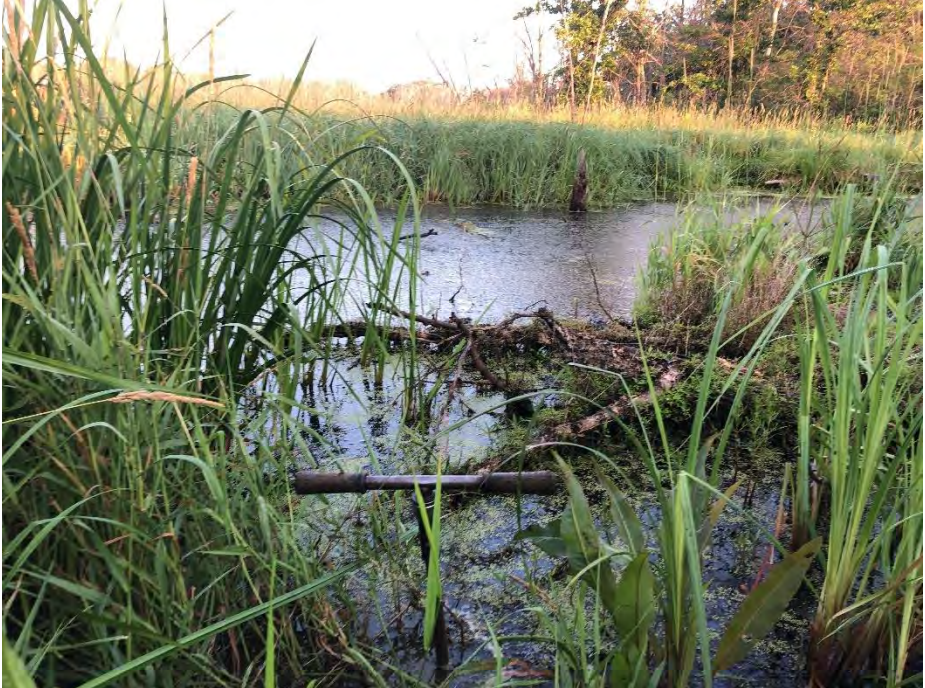
PHOTOGRAPH No: 1	DATE: June 28, 2022	LATITUDE: 43.52148291	LONGITUDE: -89.48902234
DIRECTION: West	SITE LOCATION: WIS 33 and I-39 Interchange		
DESCRIPTION: Wetland CW156, Shallow Marsh (foreground)

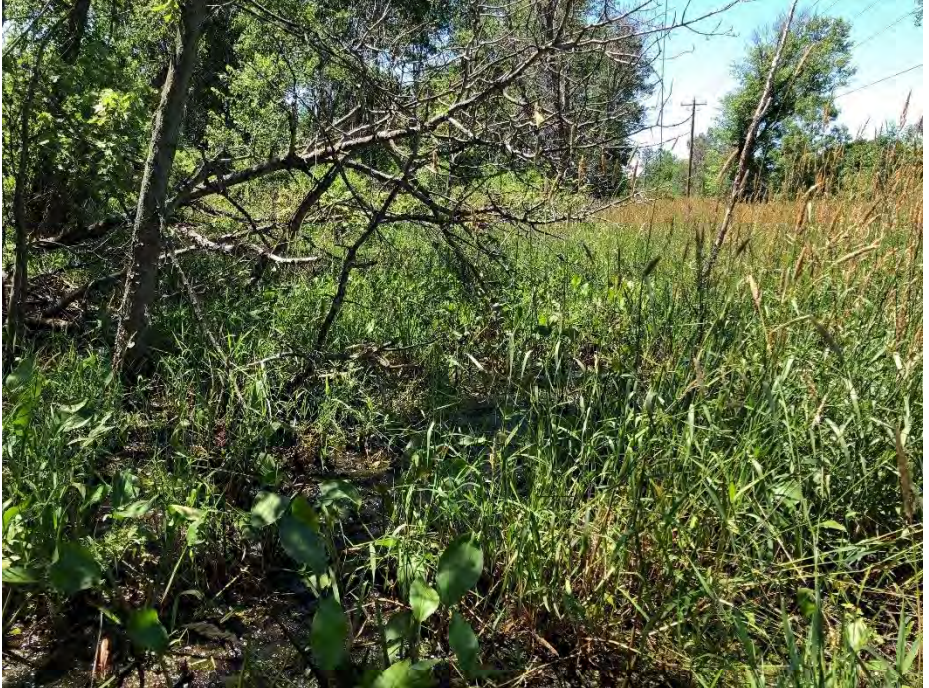
PHOTOGRAPH No: 5	DATE: June 27, 2022	LATITUDE: 43.52455261	LONGITUDE: -89.49154998
DIRECTION: West	SITE LOCATION: WIS 33 and I-39 Interchange		
<p>DESCRIPTION:</p> <p>Wetland CW156, Wooded Swamp, Wet Meadow - D (foreground)</p>
