Appendix N. County CS Interchange USACE Stream Features Worksheet

**Re: USACE Stream Features Worksheet
IH39/90/94 CS Interchange
Columbia County, Wisconsin**

GEI Consultants, Inc. (GEI) was contracted by Wisconsin Department of Transportation (WisDOT) to conduct a US Army Core of Engineers stream features assessment for different portions of the CS interchange. These assessments will aid in Section 404 permitting.

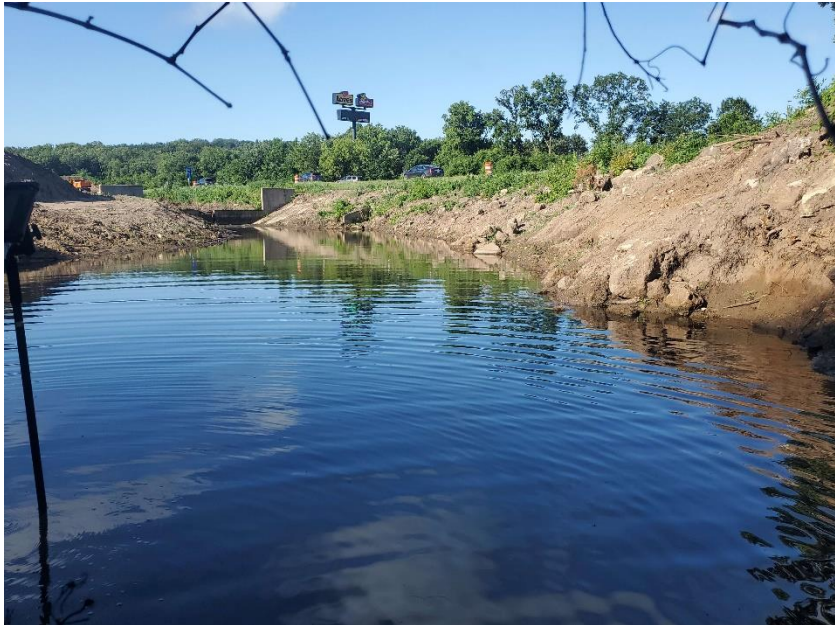
PHOTOGRAPH No: 2	DATE: July 13, 2022	LATITUDE: 43.38970409	LONGITUDE: -89.46642098
DIRECTION: West	SITE LOCATION: COLUMBIA COUNTY		
DESCRIPTION: Assessment Area 2: Stormwater conveyance feature.

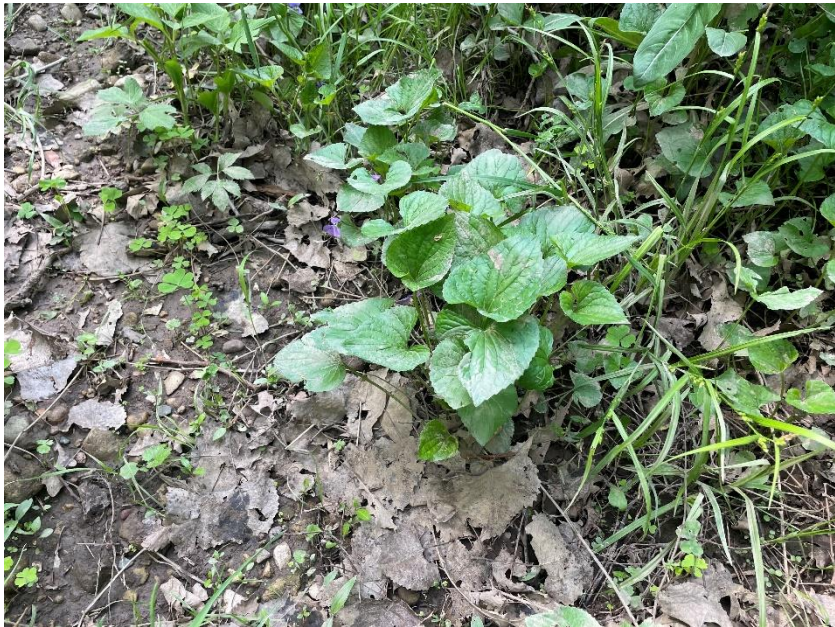
PHOTOGRAPH No: 6	DATE: May 14, 2024	LATITUDE: 43.382778	LONGITUDE: -89.463091
DIRECTION: North-west	SITE LOCATION: COLUMBIA COUNTY		
DESCRIPTION: Assessment Area 3: Unnamed ephemeral stream. Evidence of sediment deposition.

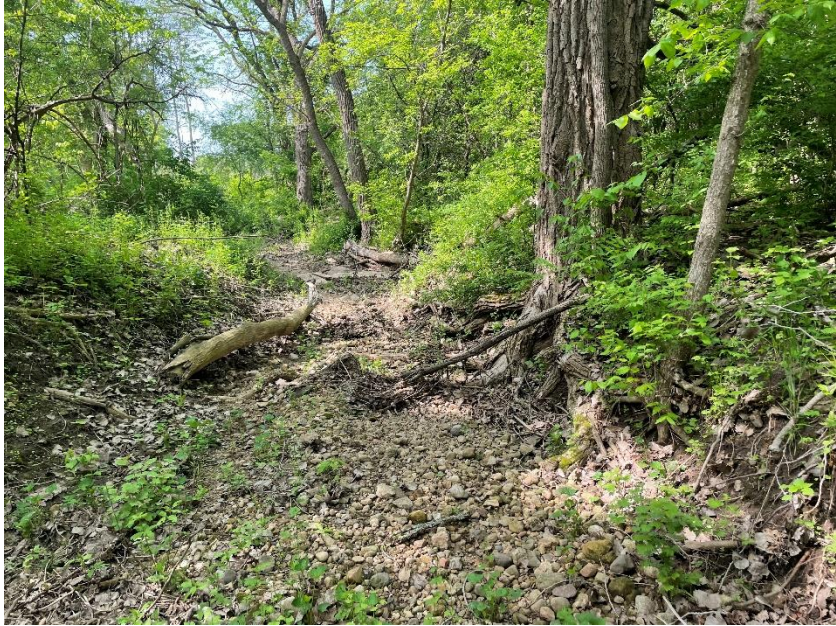
PHOTOGRAPH No: 7	DATE: May 14, 2024	LATITUDE: 43.382434	LONGITUDE: -89.462807
DIRECTION: North	SITE LOCATION: COLUMBIA COUNTY		
DESCRIPTION: Assessment Area 3: Unnamed ephemeral stream. Evidence of erosion and defined bed and bank.

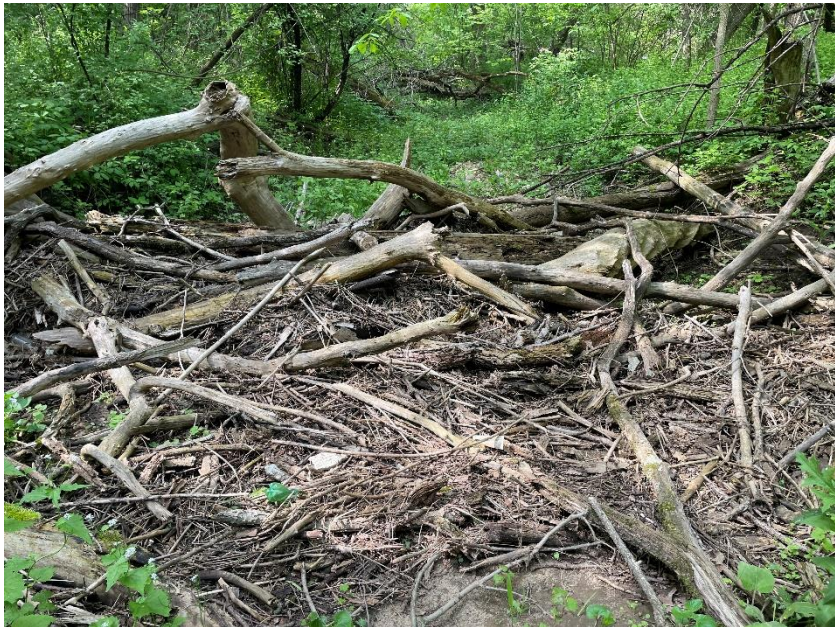
- **Assessment Area 1:** Bridge/culvert (North of photo 1).
- **Assessment Area 2:** None (Photo 3, 4).
- **Assessment Area 3:** Bridge/culvert, Erosion, large woody debris, undercut banks (Photo 8, 10).
- **Assessment Area 4:** Bridge/culvert (Photo 13).

PHOTOGRAPH No: 8	DATE: May 14, 2024	LATITUDE: 43.381756	LONGITUDE: -89.462807
DIRECTION: North	SITE LOCATION: COLUMBIA COUNTY		
DESCRIPTION: Assessment Area 3: Unnamed ephemeral stream. Presence of large woody debris.

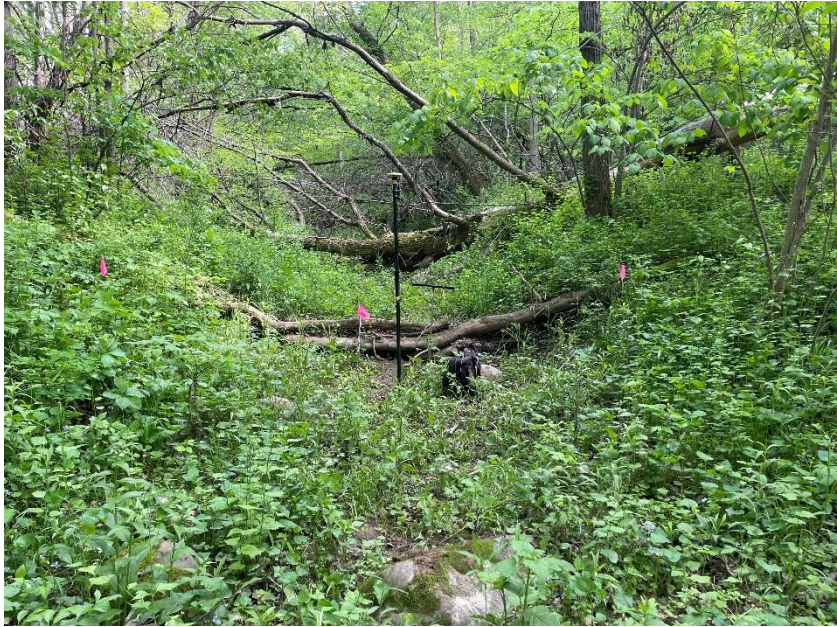
PHOTOGRAPH No: 9	DATE: May 14, 2024	LATITUDE: 43.381173	LONGITUDE: -89.462502
DIRECTION: South	SITE LOCATION: COLUMBIA COUNTY		
DESCRIPTION: Assessment Area 3: Unnamed ephemeral stream with approximate ordinary high-water level and waterway centerline.

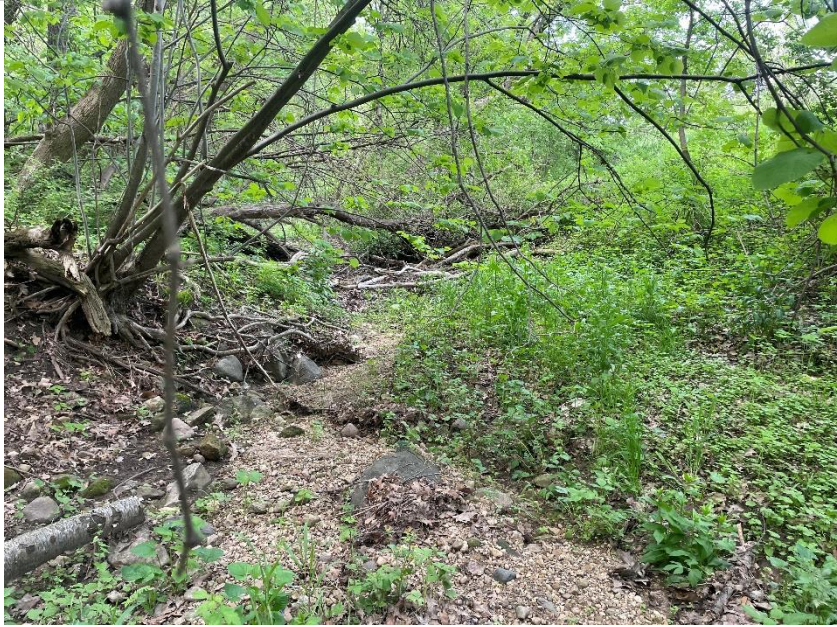
PHOTOGRAPH No: 11	DATE: May 14, 2024	LATITUDE: 43.3801	LONGITUDE: -89.461755
DIRECTION: North	SITE LOCATION: COLUMBIA COUNTY		
DESCRIPTION: Assessment Area 3: Unnamed ephemeral waterway. Presence of large woody debris and litter piling up, as well as scouring under tree roots.

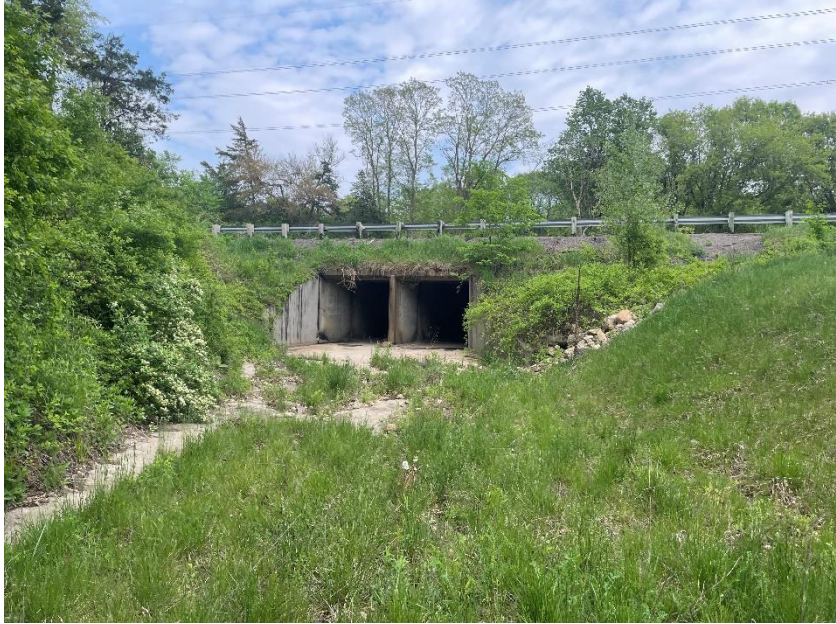
PHOTOGRAPH No: 13	DATE: May 14, 2024	LATITUDE: 43.379189	LONGITUDE: -89.461274
DIRECTION: East	SITE LOCATION: COLUMBIA COUNTY		
DESCRIPTION: Assessment Area 4: Stormwater conveyance feature extending from culvert.

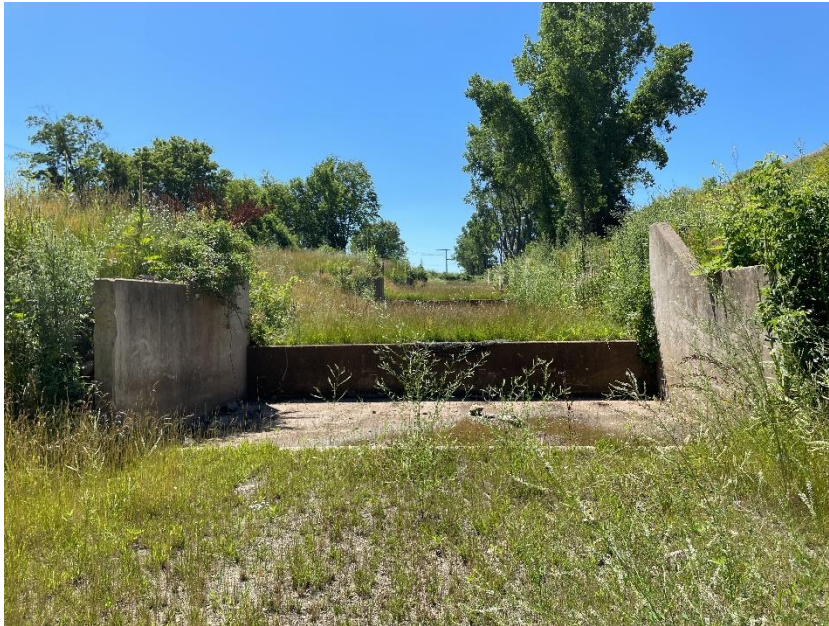
- **Assessment Area 1:** Sediment sorting, presence of litter or debris
- **Assessment Area 2:** No OHWM was able to be determined and therefore was considered to be absent. Area was reconstructed as a stormwater conveyance feature (Photo 3, 4).
- **Assessment Area 3:** Vegetation matted down, bent, or absent, sediment deposition, sediment sorting, presence of litter or debris, leaf litter disturbed or washed away (Photo 6, 7).
- **Assessment Area 4:** No OHWM was able to be determined and therefore was considered to be absent. Area was reconstructed as a stormwater conveyance feature (Photo 15-18).

PHOTOGRAPH No: 17	DATE: July 12, 2022	LATITUDE: 43.37866966	LONGITUDE: -89.46172182
DIRECTION: South	SITE LOCATION: COLUMBIA COUNTY		
DESCRIPTION: Assessment Area 4: Stormwater conveyance feature.

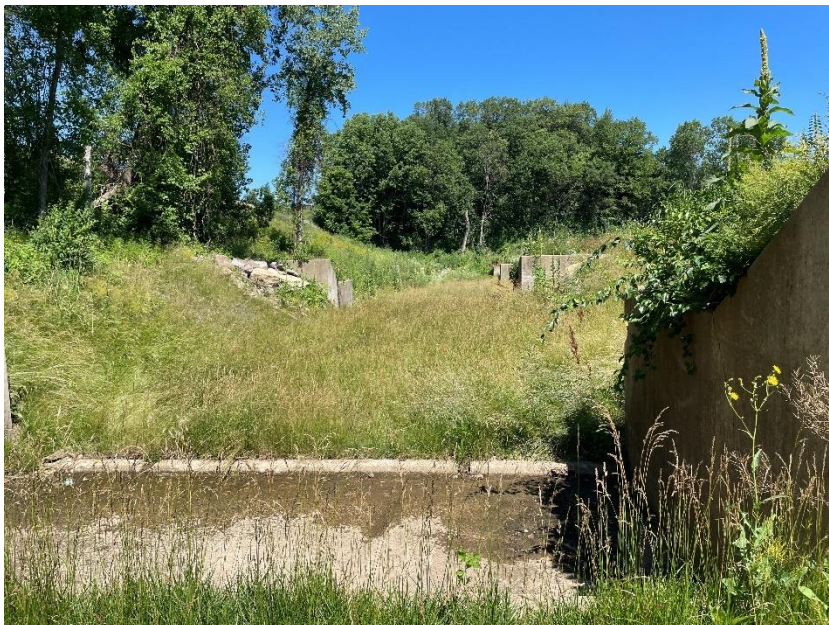
PHOTOGRAPH No: 18	DATE: July 12, 2022	LATITUDE: 43.37801309	LONGITUDE: -89.46139848
DIRECTION: North	SITE LOCATION: COLUMBIA COUNTY		
DESCRIPTION: Assessment Area 4: Stormwater conveyance feature.
