**Division Of State Patrol
Informational Memorandum**

6-99-1

**Manual Tab 4
School Bus Inspection Manual**

Topic: Allowable placement of wheel chairs in a school bus

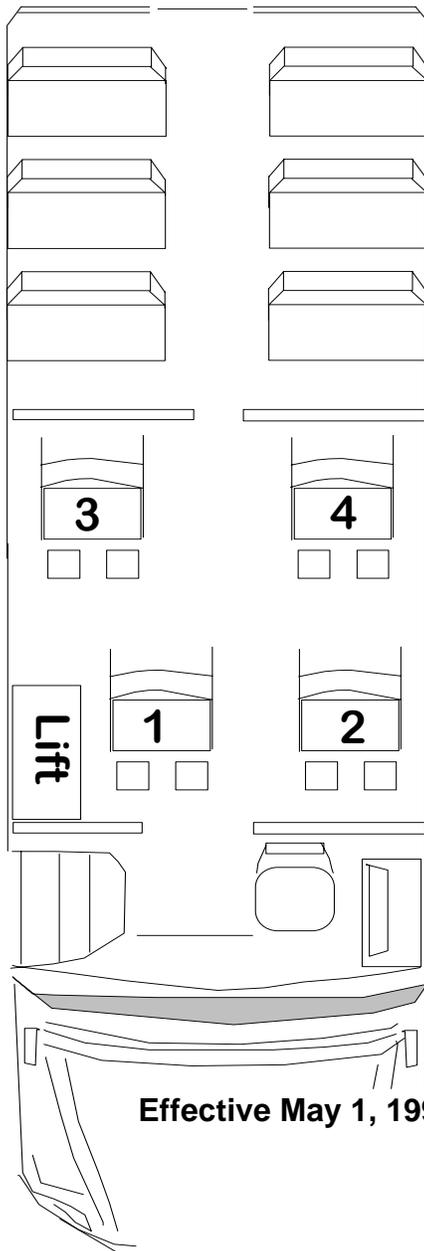
Not allowed because of placement of wheel chair 1. Wheelchairs 2,3, and 4 may remain.

Decision: In order to address these safety issues and create uniformity in the inspection process the following interpretation will be effective May 1, 1999. Wheel chairs will not be allowed next to the lift unless the lift is in the passenger side rear of the school bus. If this location is used a **padded cover** will be enclosing all components of the wheel chair lift which may cause injury in the event of an accident. Remember that all anchorages and wheel chairs cannot enter into the required parallelepiped of the rear emergency exit found under FMVSS 217. In clarifying, one must measure a box around the emergency door 45 inches tall by 24 inches wide by 12 inches deep for school buses with a GVWR over 10000 pounds and 45 inches tall by 22 inches wide by 6 inches deep on school buses under 10000 pounds.

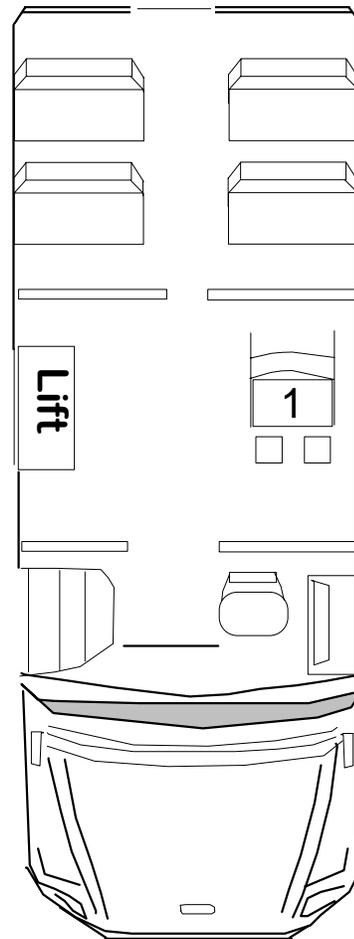
Allowed.

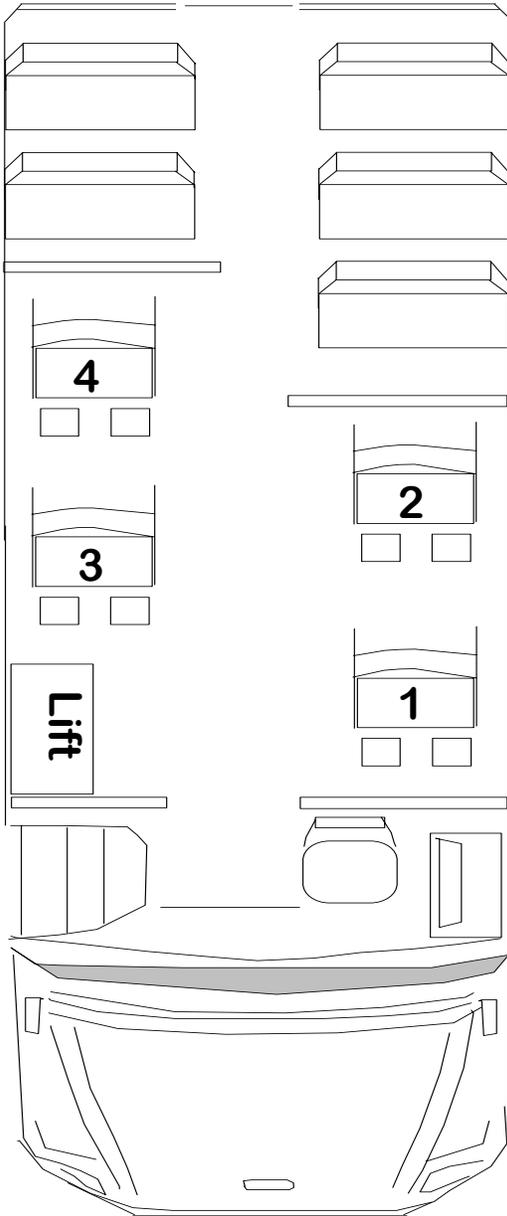
Allowed

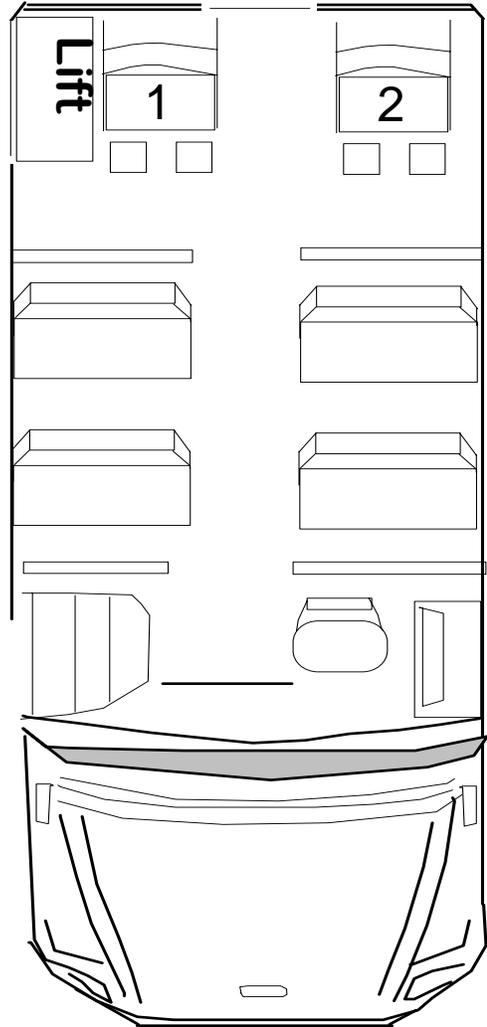
Recommended
