# Thermal Integrity Profiling for Detecting Flaws in Drilled Shafts

Andrew Boeckmann, P.E. and J. Erik Loehr, Ph.D., P.E.

University of Missouri

WisDOT ID no. 0092-16-07

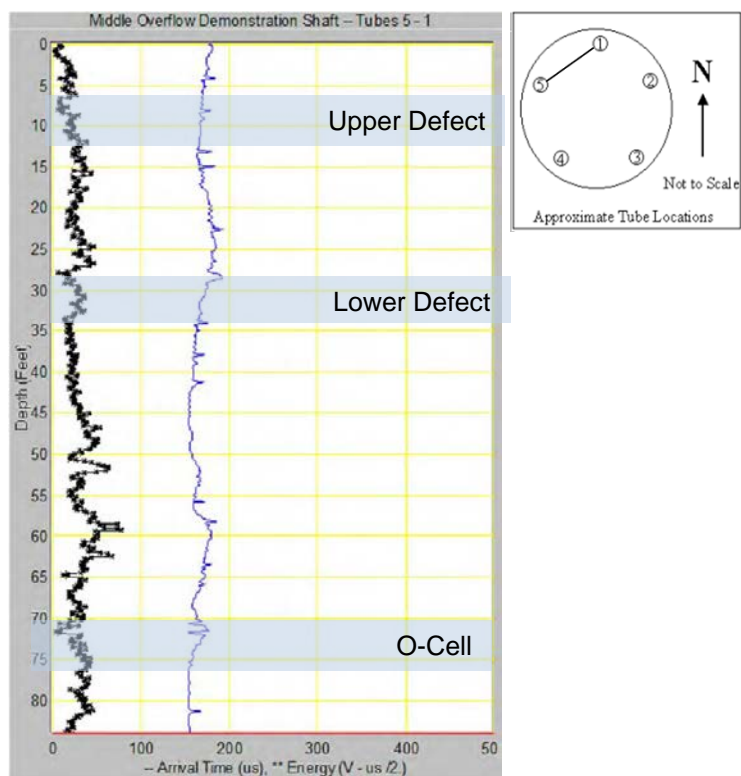
Figure 15: CSL results for Test Shaft 2 from Ashlock and Fotouhi (2014).

CSL results from Ashlock and Fotouhi (2014) are presented in Figure 15 for Test Shaft 1 and in Figure 16 for Test Shaft 2. CSL results for Test Shaft 1 showed no significant increase in arrival time for either defect. For Test Shaft 2, an increase in arrival time of approximately 25% was observed for both defects. Such an increase straddles the line between questionable and actionable, depending on acceptance criteria (Table 2).

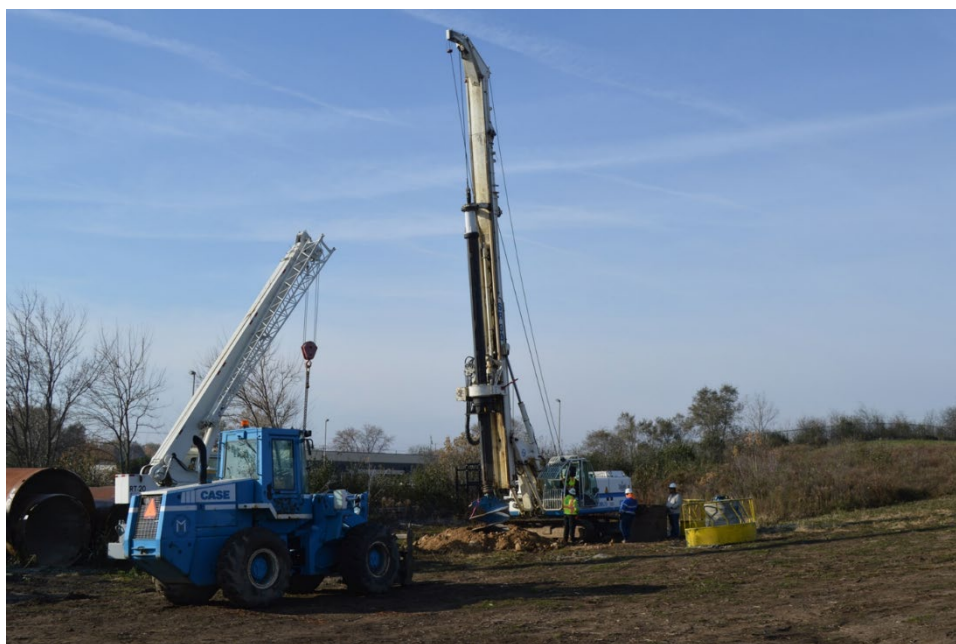
Figure 19: Overview of test site with crane, loader, and drill rig in operation.

Photographs of the drilling process are shown in Figure 19 and Figure 20. The shafts were excavated with a 48 in. auger. Groundwater was not encountered for any of the shafts, but the sandy material was prone to raveling. Temporary casing was used to reduce raveling and improve hole stability, but the casings were not placed until after the material had been excavated (rather than driving the casing ahead of drilling), so the excavated shaft diameter is likely somewhat greater than the diameter of the casings. Below a depth of approximately 10 ft, cobbles were occasionally encountered in each of the shafts. The cobbles complicated drilling and casing placement, slowed progress, and likely increased the degree of overexcavation. The temporary casing was telescoped to reduce side friction and facilitate removal of the casing as concrete was placed. The diameter of the outer (upper) casing was 58 in., and the diameter of the inner casing was 52 in. The casings were placed in the holes after excavating to the depths shown in the as-built drawings.

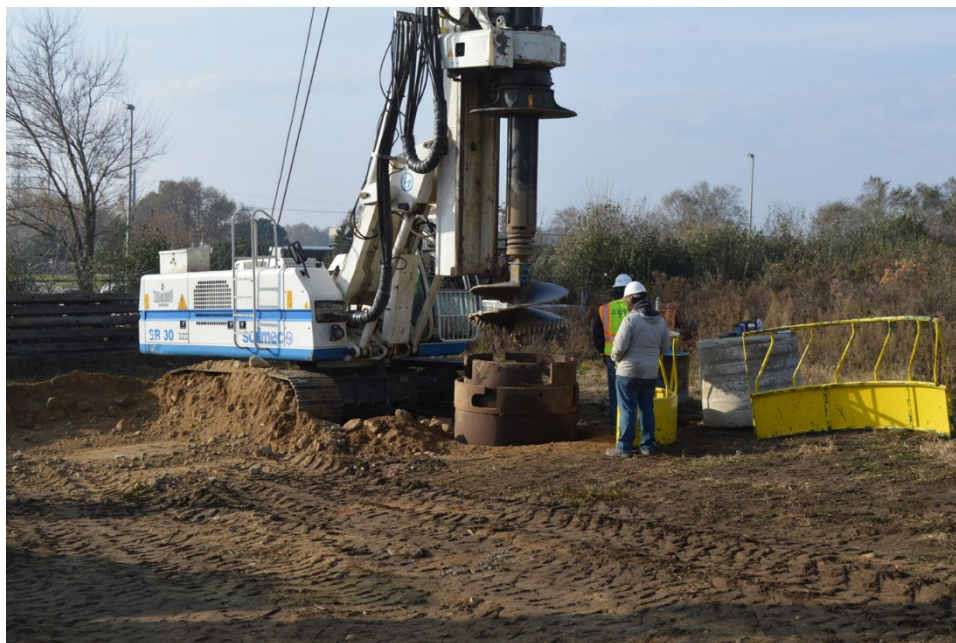
**Figure 20: Excavation of shaft with 48 in. auger through telescoping casing.**

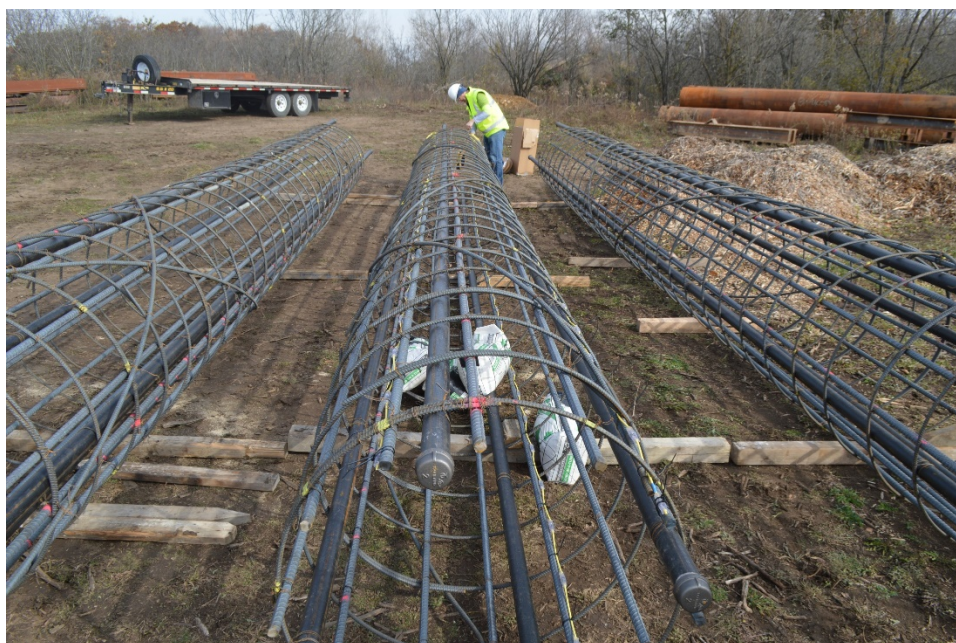
**Figure 21: Reinforcing cages prior to installation of most defects.**

Reinforcing cages for the drilled shafts are shown in Figure 21. Longitudinal reinforcement consisted of twelve No. 8 reinforcing bars; transverse steel consisted of No. 4 stirrups on 12 in. centers. The reinforcing cages also included four 2 in. diameter Sch. 40 steel pipes for CSL testing and TIP testing by the probe method. The integrity testing pipes were installed on the inside of the cages, spaced evenly at 90 deg. As shown in Figure 21, additional steel was included around the outside of the reinforcing cages to improve cage stability. Reinforcing cages were lowered into the shafts with wheel spacers to keep the cages centered within the hole and with chairs to support the cages on the bottom of the hole.

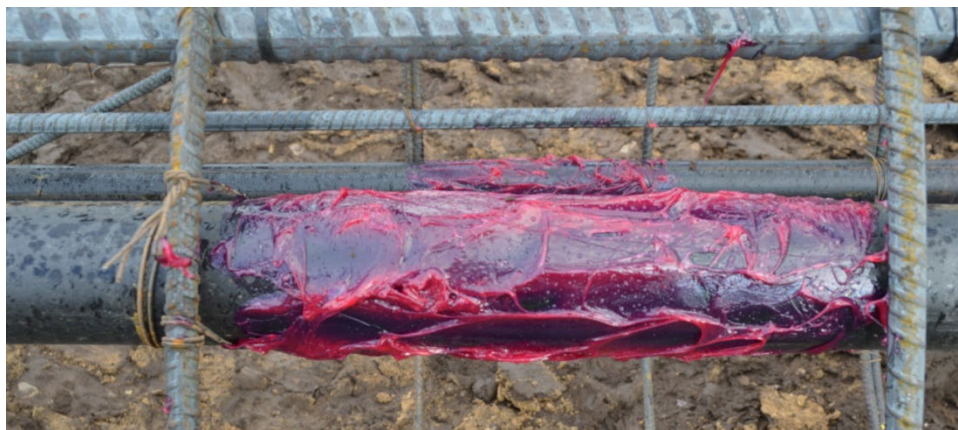
**Figure 25: Defect 4 consisted of wheel bearing grease applied around the outside of the access tubes for a length of 1 ft. Defect 4 was installed in two locations: at a depth of 16.5 ft in Test Shaft 1 and a depth of 4.5 ft in Test Shaft 2.**

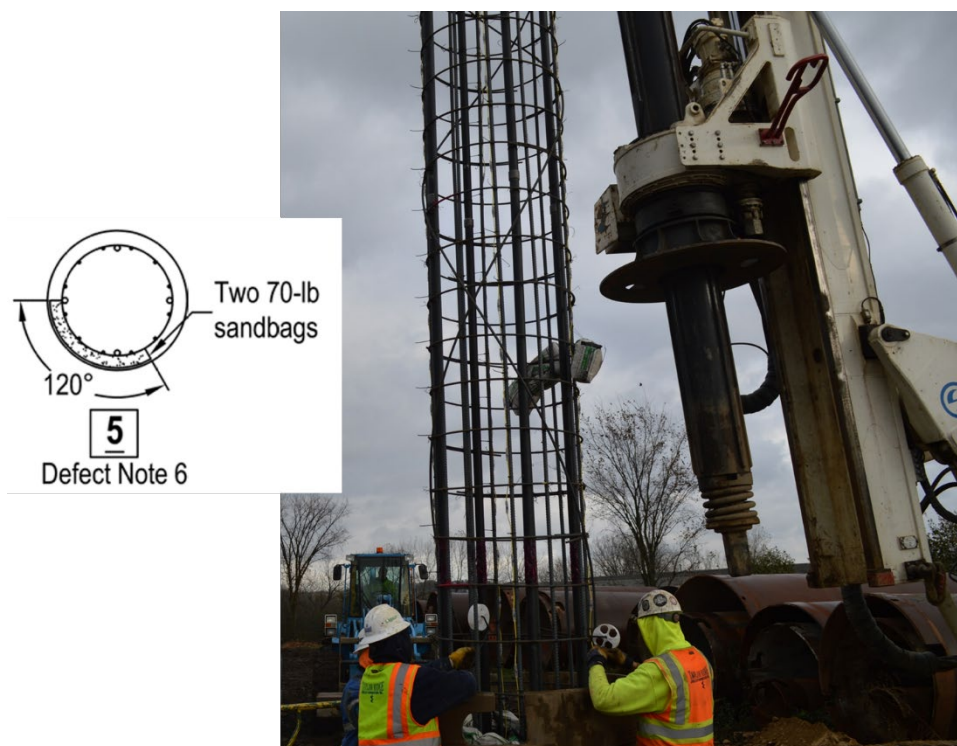
**Figure 26: Defect 5 consisted of two 70 lb sandbags outside one side of the reinforcing cage for Test Shaft 1 at a depth of 12 ft.**

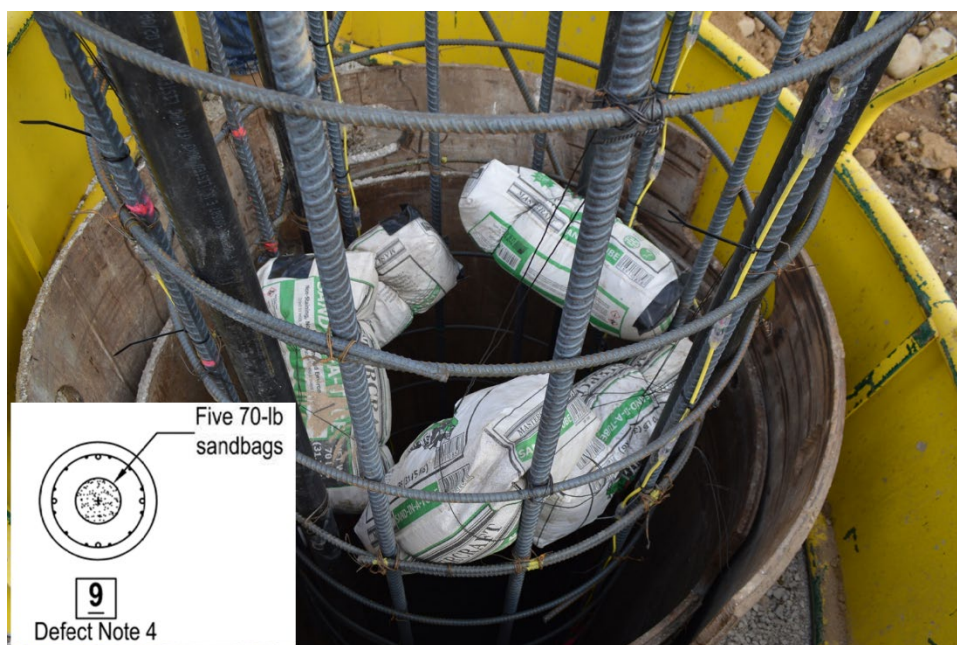
**Figure 27: Defect 9 consisted of five 70 lb sandbags placed inside the reinforcing cage for Test Shaft 2 at a depth of 12 ft. Defects 6, 7, and 8 are presented in the next section.**

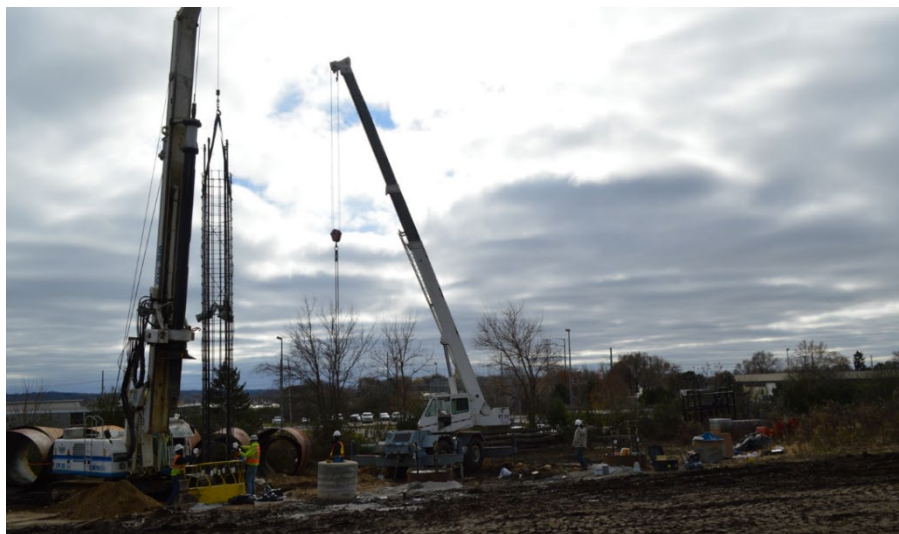
**Figure 28: Reinforcing cage is lowered into the hole for Test Shaft 2. Sandbags for Defect 9 are visible near the cage mid-height.**

Defects 1 through 5 and 9 were affixed to the reinforcing cages prior to lowering the cages into the excavated shafts. Photographs of the defects affixed to the cages are shown in Figure 22 through Figure 28. The figure captions list details of the defects, which are also described in Table 7 and shown in the as-built drawings of Appendix B. Defects were tied to the reinforcing cages using rebar tie wire. For the inside-cage defects (Defects 1 and 9), sandbags were tied with extra tie wire length between the cage and the sandbags. The extra length was approximately equal to the reinforcing cage radius. The intention for including the extra tie wire length was for the sandbags to float toward the center of the reinforcing cage, thus creating a center-of-shaft defect for evaluation with TIP and CSL. The reinforcing cages were observed carefully as they were lowered into the excavated shafts; no defects were compromised.

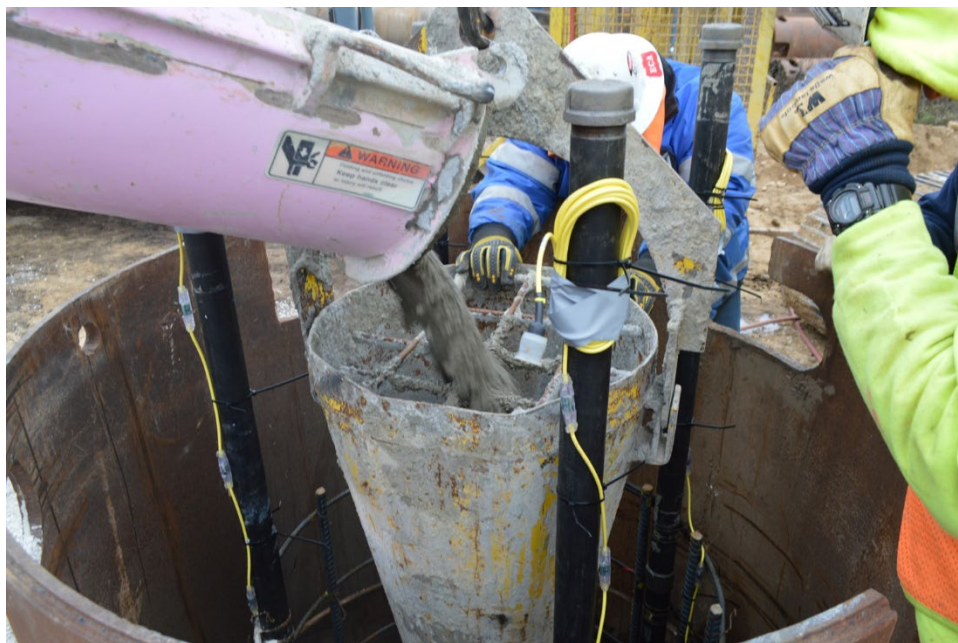
**Figure 29: Placement of concrete from the concrete truck to the tremie pipe.**

Detailed descriptions of concrete placement are included in the logs of Appendix D. As shown in Figure 29, concrete was placed in the dry holes using a tremie pipe supported by a crane. Concrete slump was tested per ASTM C143 for each truck, and cylinders were also cast for subsequent compressive strength testing per ASTM C39. A photograph of slump testing is shown in Figure 30. Except for concrete from one truck, slump values were all 10 to 11 in., which is above the target range of 7 to 9.5 in. However, the fluid concrete appeared cohesive and stable without signs of segregation or bleed. Quality assurance personnel from the concrete plant visited the test site to observe the delivered concrete during the concrete pour for Test Shaft 2. The following truck delivered concrete with a slump value of 7.5 in. (the lone value less than 10 in. referenced previously). The placement temperature of the fresh concrete ranged from 52 to 68° F.

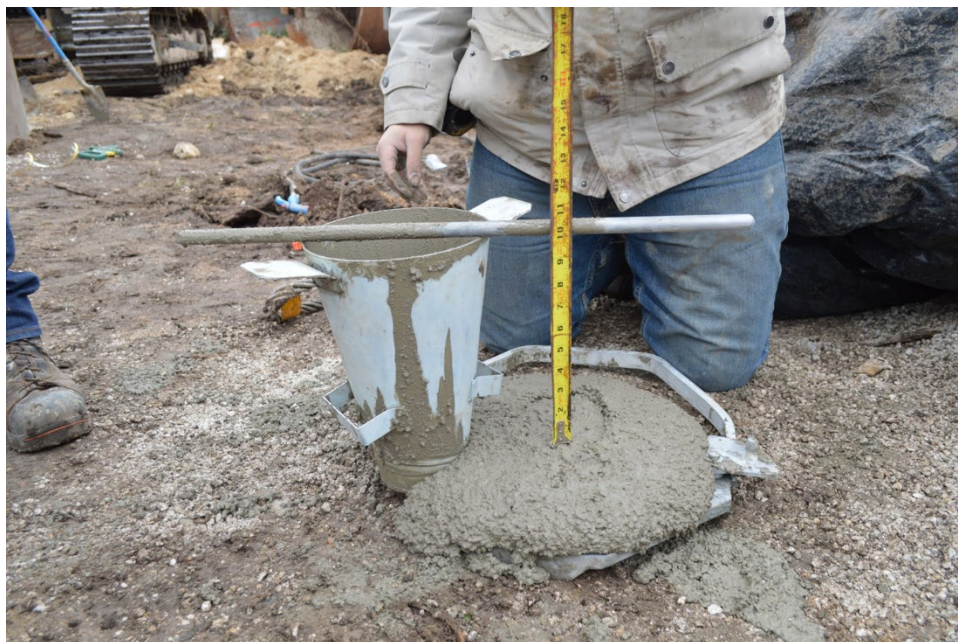
**Figure 30: Concrete slump test.**

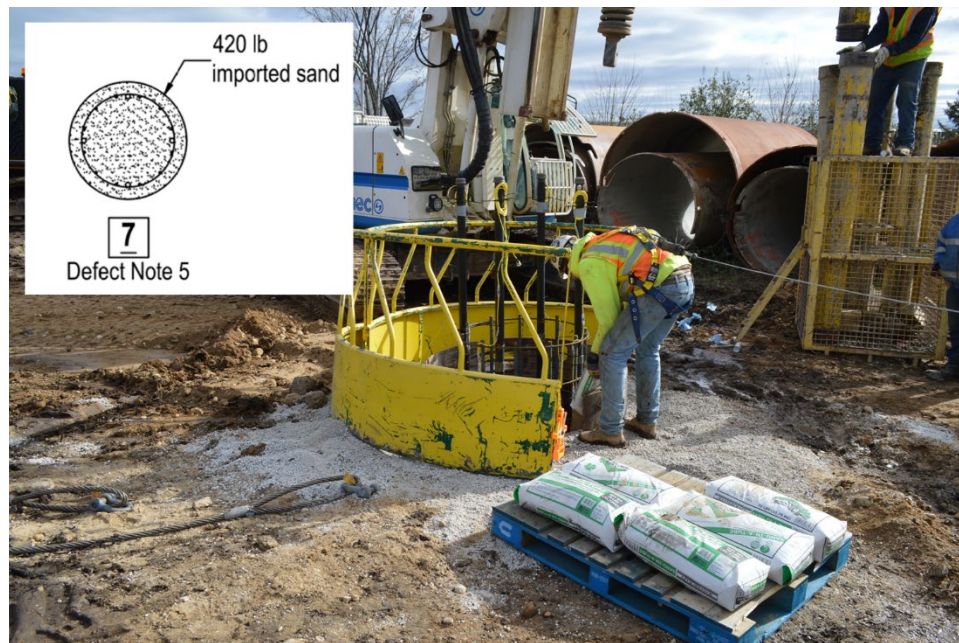
**Figure 32:** After placing the reinforcing cage but prior to placing concrete for Test Shaft 2, 420 lbs of sand was poured into the bottom of the excavated shaft to simulate a soft bottom for Defect 7.

Defects 6, 7, 8, and 10 were installed during concrete placement, whereas the other defects were attached to the reinforcing cages. Photographs of the concrete placement defects are shown in Figure 32 through Figure 35. Defect 7 was intended to mimic soft bottom conditions. Similar to Defect 2, it consisted of 420 lb of sand at the bottom of the shaft, but the sand for Defect 7 was poured from the surface both inside and outside the reinforcing cage (Figure 32) whereas Defect 2 consisted of sandbags tied around the outside of the bottom of the reinforcing cage. Defect 8 was intended to mimic a tremie breach, which caused problems for the Zoo Interchange project. Since the shafts for this project were dry, the effect of a tremie breach was simulated by removing the tremie and then pouring 30 gallons of water and 70 lb of sand in the hole. After placing the water and sand for Defect 8, the remaining concrete was placed with the tremie suspended above the top of concrete surface. Defects 6 and 10 consisted of zones of weak concrete at the top of Test Shaft 1 and Test Shaft 2, respectively. To achieve weak concrete, the concrete placement by tremie was terminated when the top of concrete was 3 ft below the ground surface. The volume of concrete remaining in the truck was estimated from the yield plots (Figure 31), and water was added to the concrete in the truck to achieve a water-cement ratio of 0.6 for Defect 6 and 0.52 for Defect 10. The concrete was mixed in the truck after adding the water prior to placing the concrete by free fall. As shown in Figure 34, the weakened concrete was significantly more fluid than the normal concrete. The weakened concrete also produced significant bleed water, as shown in Figure 35.

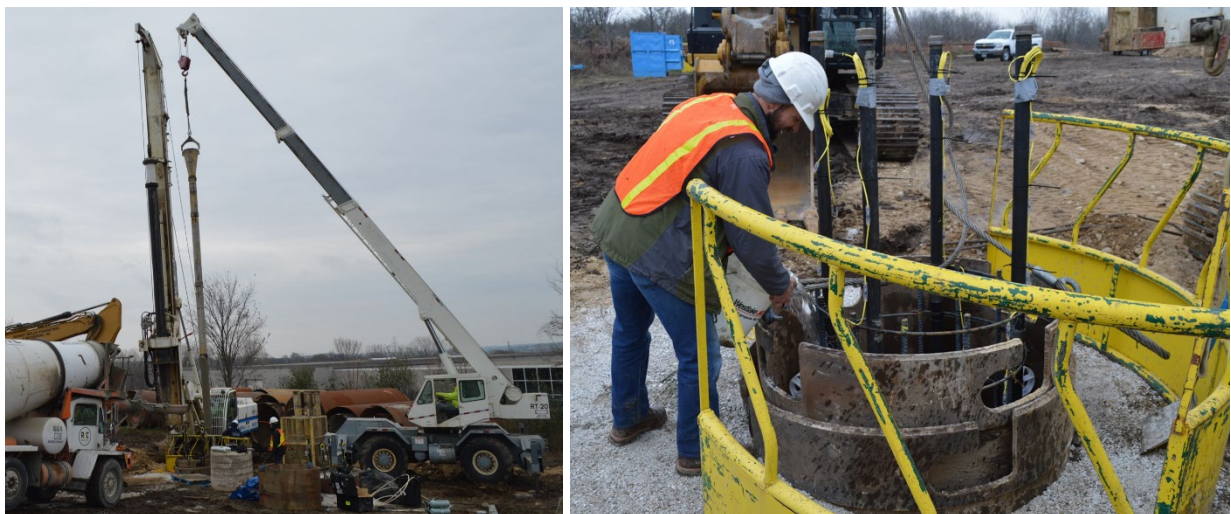
**Figure 33:** To simulate a tremie breach for Defect 8: (a) the tremie was removed from the shaft prior to (b) placing 30 gallons of water and 70 lbs of sand into the shaft (to simulate a tremie breach in a wet shaft).

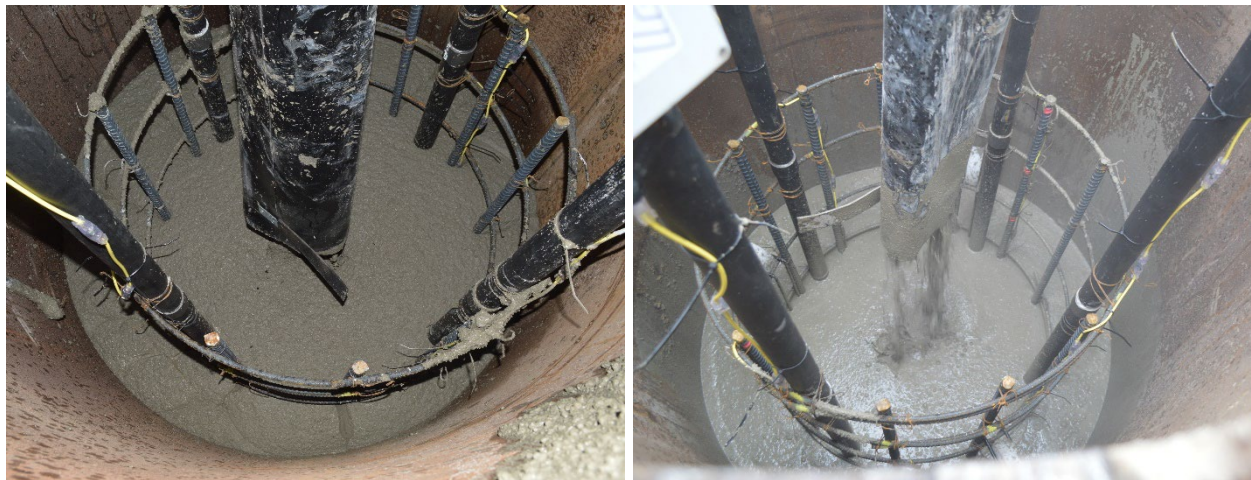
**Figure 34: Concrete placement near the top of shaft: (a) normal concrete in Control Shaft and (b) weak concrete for Defect 6 in Test Shaft 1.**

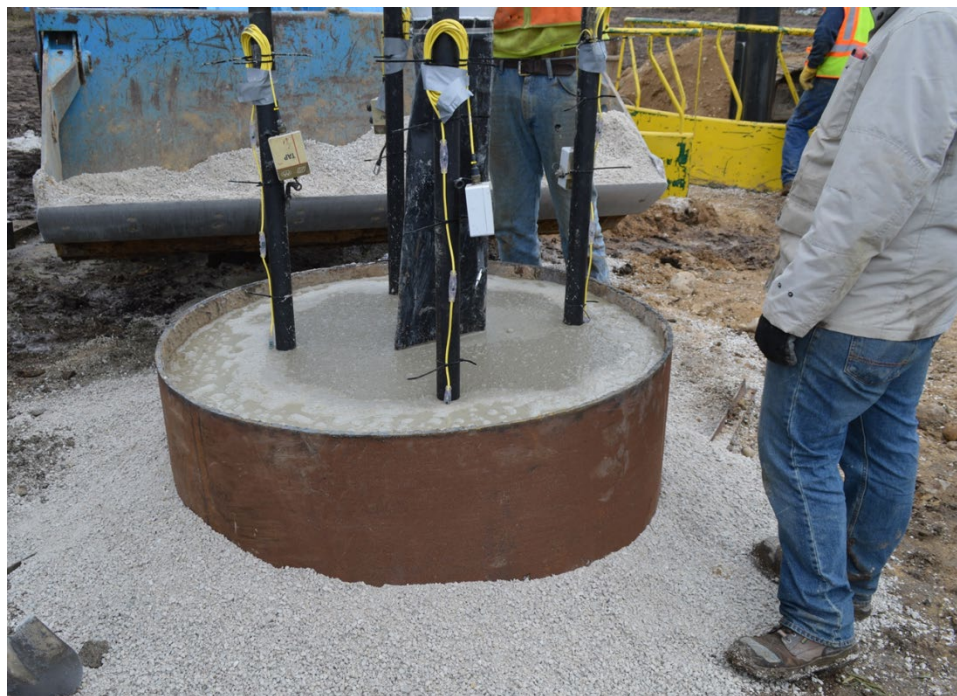
**Figure 35: Completed Test Shaft 1 shortly after completion of concrete placement. Bleed water from the weak concrete of Defect 6 is evident at the top of the shaft.**

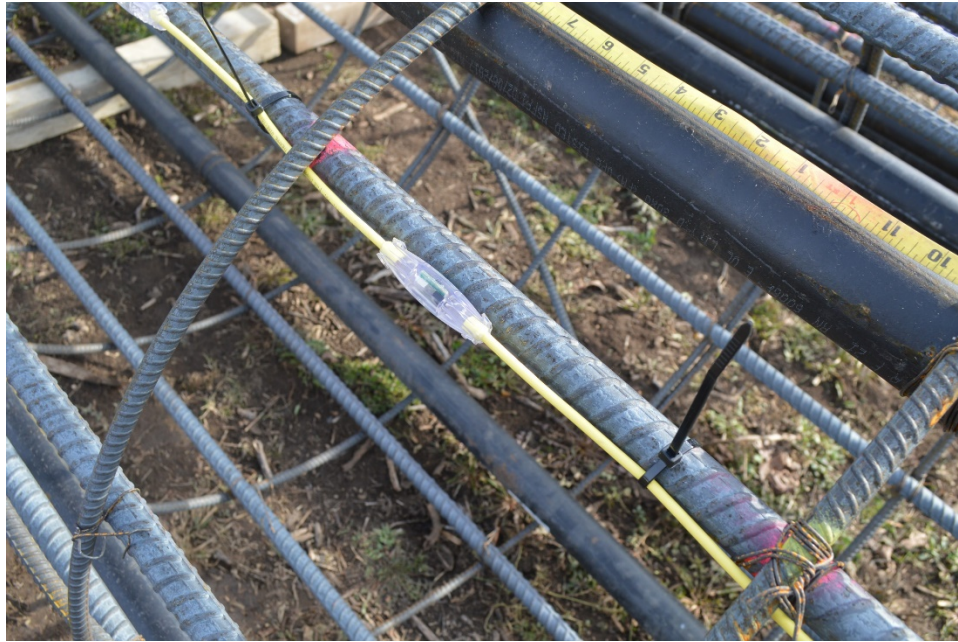
**Figure 36: Close view of a TIP wire with sensor.**

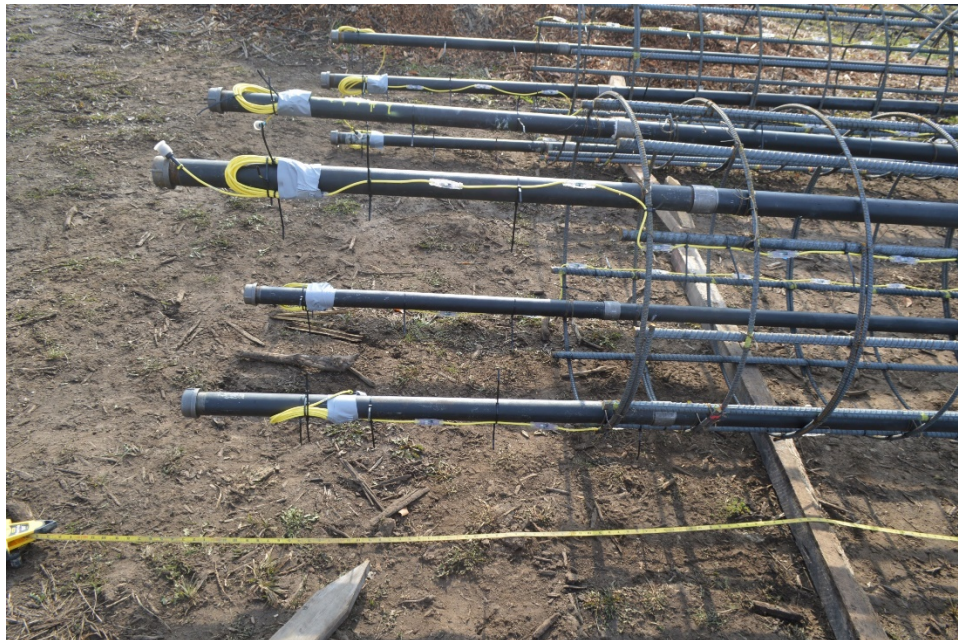
**Figure 37: TIP wires exiting the top of the reinforcing cages. Two sensors were above the top of the shaft to measure ambient temperature.**

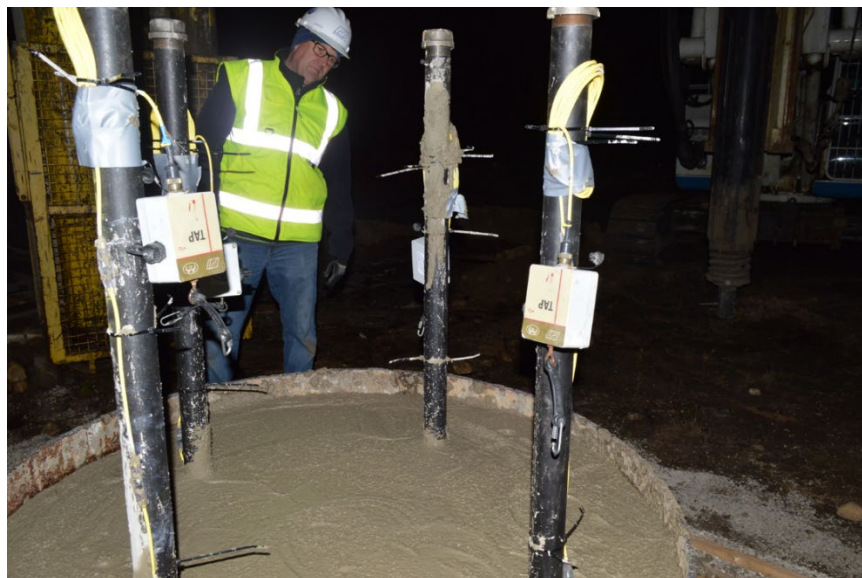
Figure 38: One TAP box was connected to each TIP wire to collect and store temperature data.

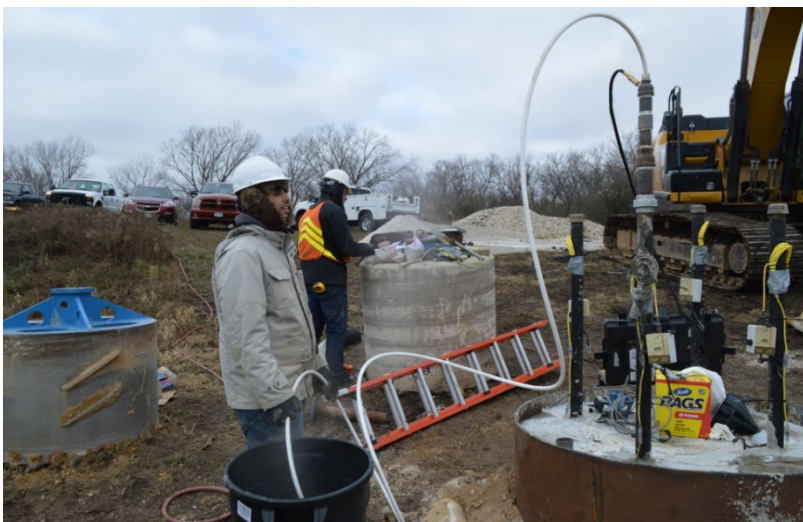
**Figure 40: The access tubes were dewatered prior to performing TIP test via probe method.**

TIP data was also collected using the probe method. The probe tests were performed by first dewatering the access tube (Figure 40) and then lowering a temperature probe to the bottom of the access tube (Figure 41). As the probe was lowered, temperature data were read and recorded, as was the depth of the probe for each measurement. Depths were automatically recorded using a depth encoder pulley. The rate of lowering the probe was limited to 6 in. per second to produce stable measurements. The process was repeated for each access tube. The water that was removed from each access tube was stored in a large plastic container and returned to the access tube upon completion of the probe run. Storage and reuse of the access tube water is recommended in ASTM D7949 (2014). The access tube water is typically warm due to cement hydration; replacement with cool water could result in access tube debonding. The temperature probe and depth encoder pulley used for testing were manufactured by PDI.

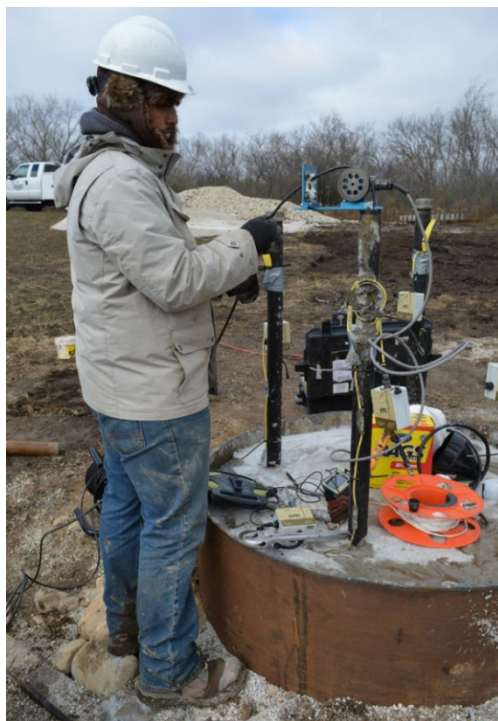
**Figure 41: TIP testing via the probe method utilizes a depth encoder pulley that logs the probe depth as it is raised from the bottom of the access tube.**

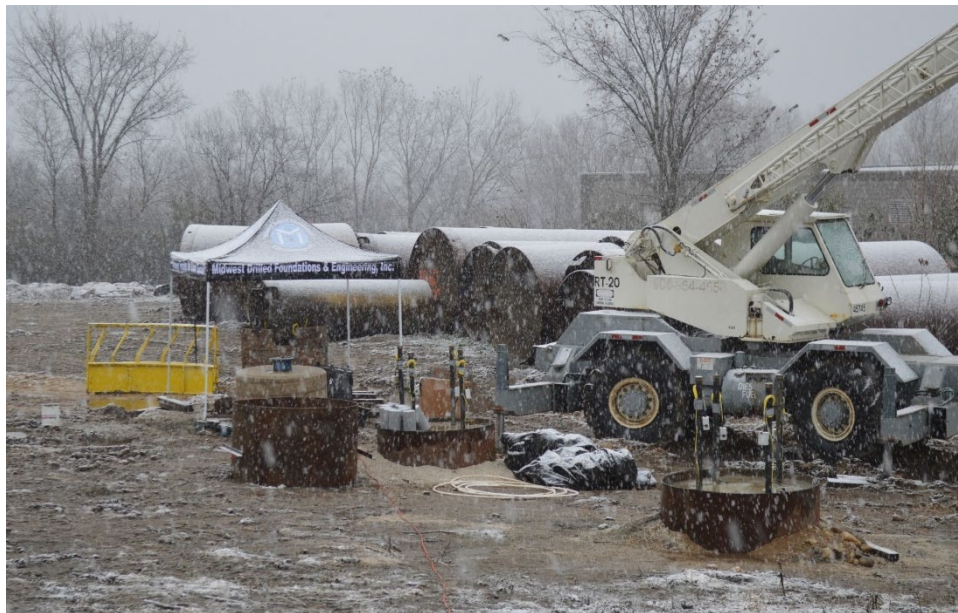
**Figure 42: TIP testing by probe method for Test Shaft 2 was completed with ambient temperatures near 30° F.**

For all shafts, the probe tests were performed one day after concrete placement. Weather during the week of concrete placement was relatively cold. Daytime temperatures were between 40 and 45° F for most of the week, including when TIP testing was performed by probe method for the Control Shaft and Test Shaft 1. The weather was particularly cold the day TIP testing was performed by the probe method for Test Shaft 2. The temperature during Test Shaft 2 testing was approximately 30° F, with snow falling as shown in Figure 42. It is likely the probe readings were impacted by the ambient temperature. The probe likely should have been allowed to acclimate to the temperature inside the access tubes for a longer period of time. The temperature inside the tubes was approximately 80° F warmer than the outside air temperature, based on wire measurements.

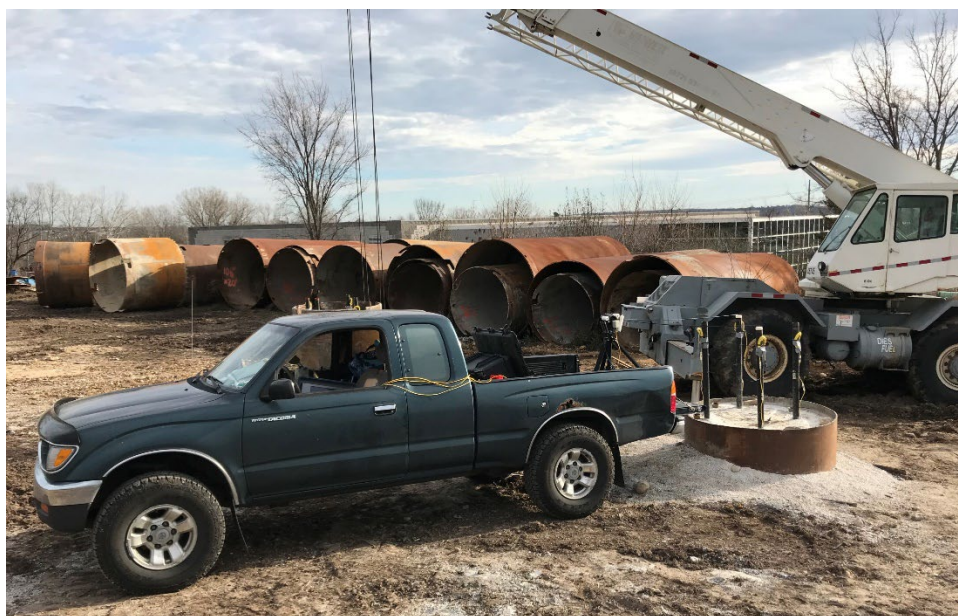
**Figure 43: CSL testing included all pairs of access tubes.**

CSL tests were performed on all three shafts approximately three weeks after concrete placement. Photographs of the CSL testing are shown in Figure 43 and Figure 44. The tests were conducted by lowering the source and receiver probes to the bottom of different water-filled access tubes and then raising the probes simultaneously using a dual pulley. As the probes are raised, ultrasonic pulses are transmitted from the source to receiver and the time records are logged by the recording device. For all shafts, all possible access tube pairings were tested, resulting in six pairings per shaft. All test equipment used for the CSL tests was manufactured by Olson Instruments, Inc.

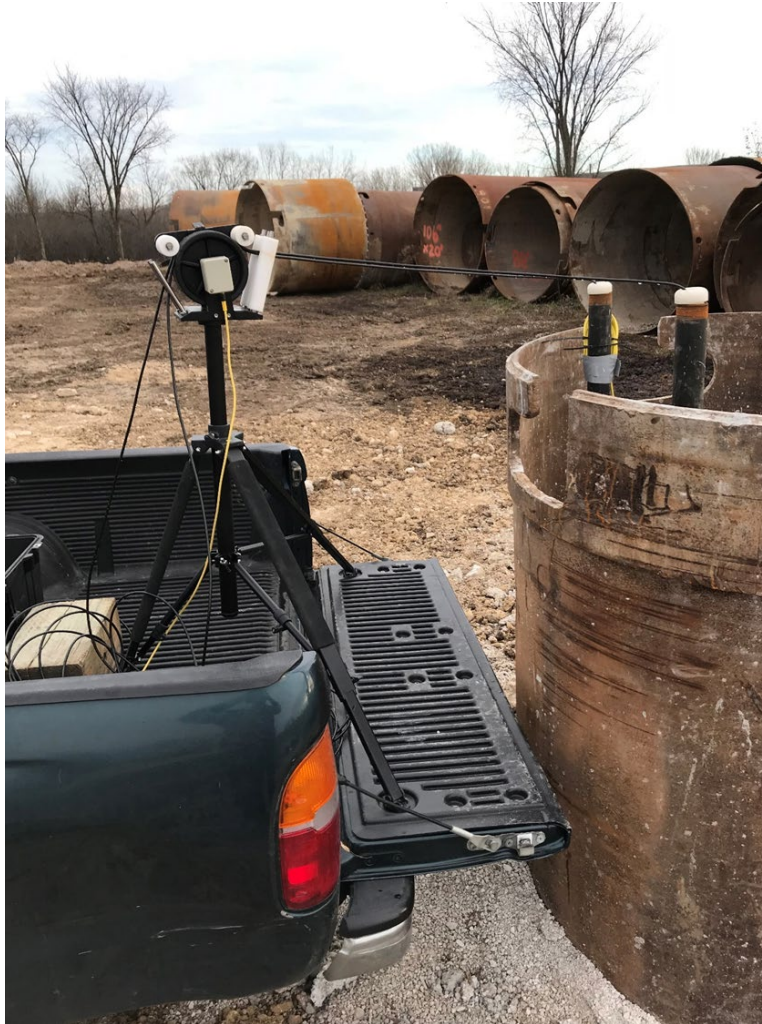
**Figure 44: CSL testing utilized equipment by Olson Instruments, Inc., including a dual depth encoder pulley used to lower the source and receiver probes down two access tubes simultaneously.**

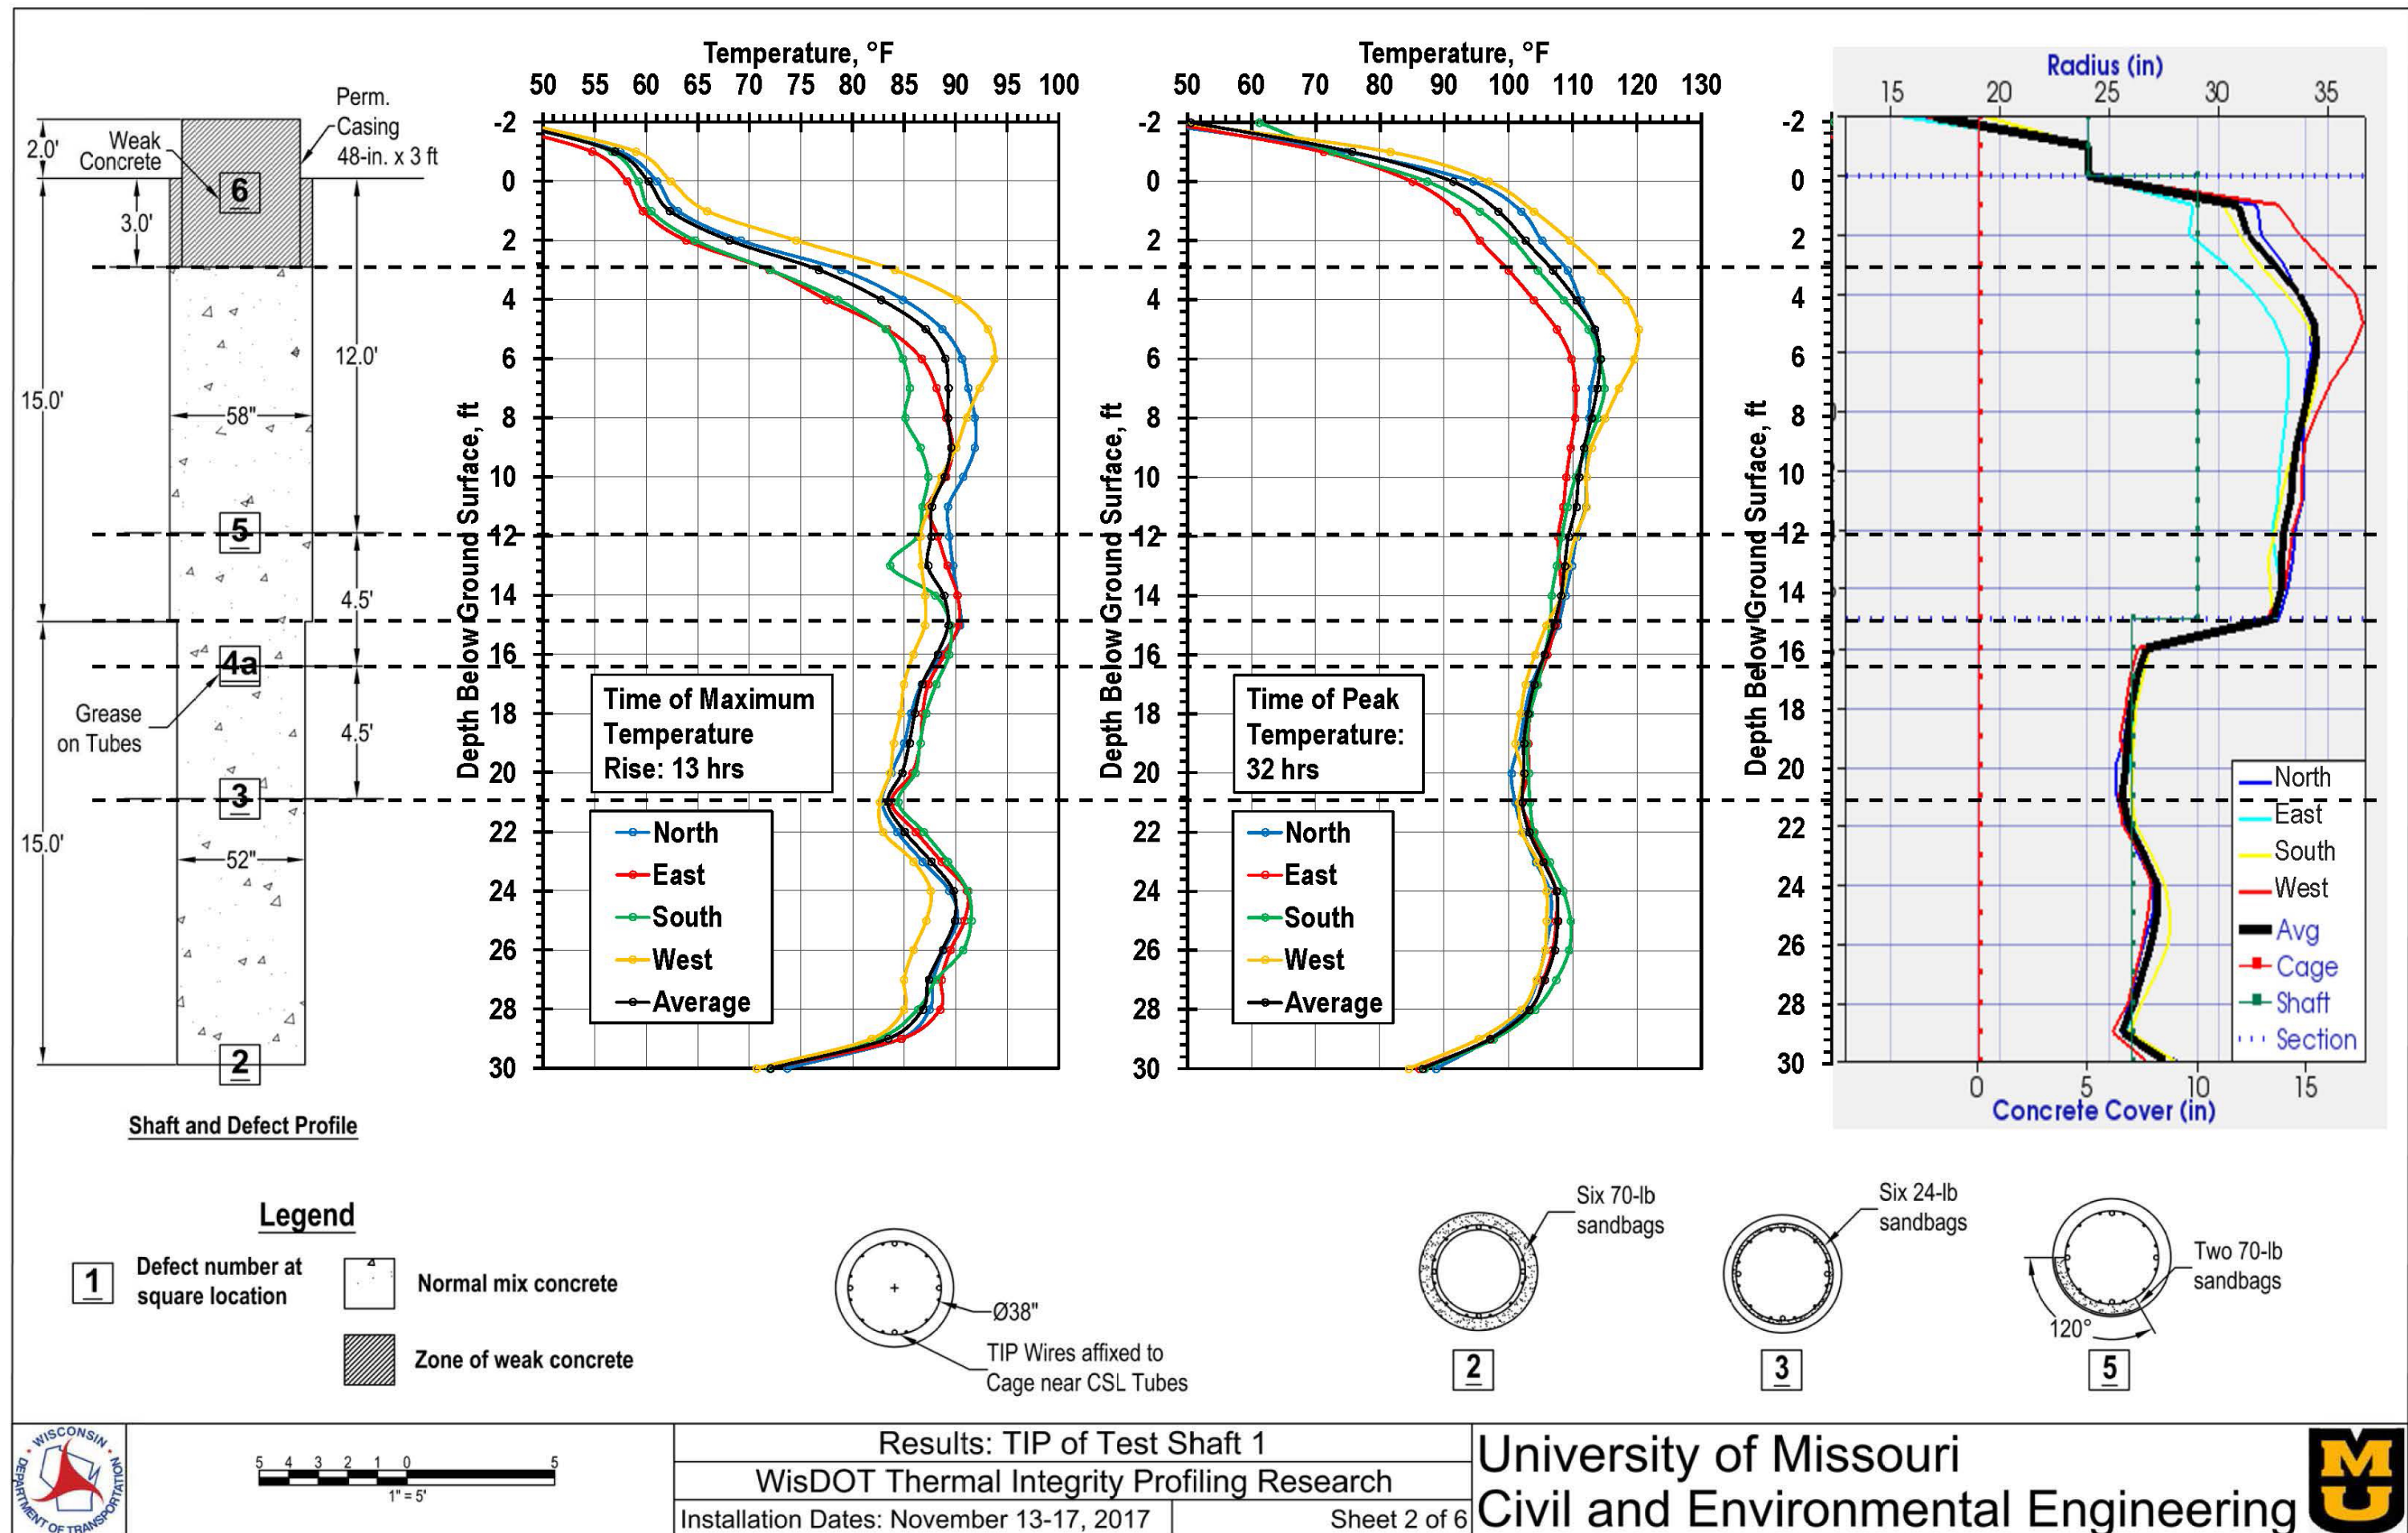
Figure 47: Results of TIP testing of Test Shaft 1, with effective radius from PDI software.
