# Thermal Integrity Profiling for Detecting Flaws in Drilled Shafts

Andrew Boeckmann, P.E. and J. Erik Loehr, Ph.D., P.E.

University of Missouri

WisDOT ID no. 0092-16-07

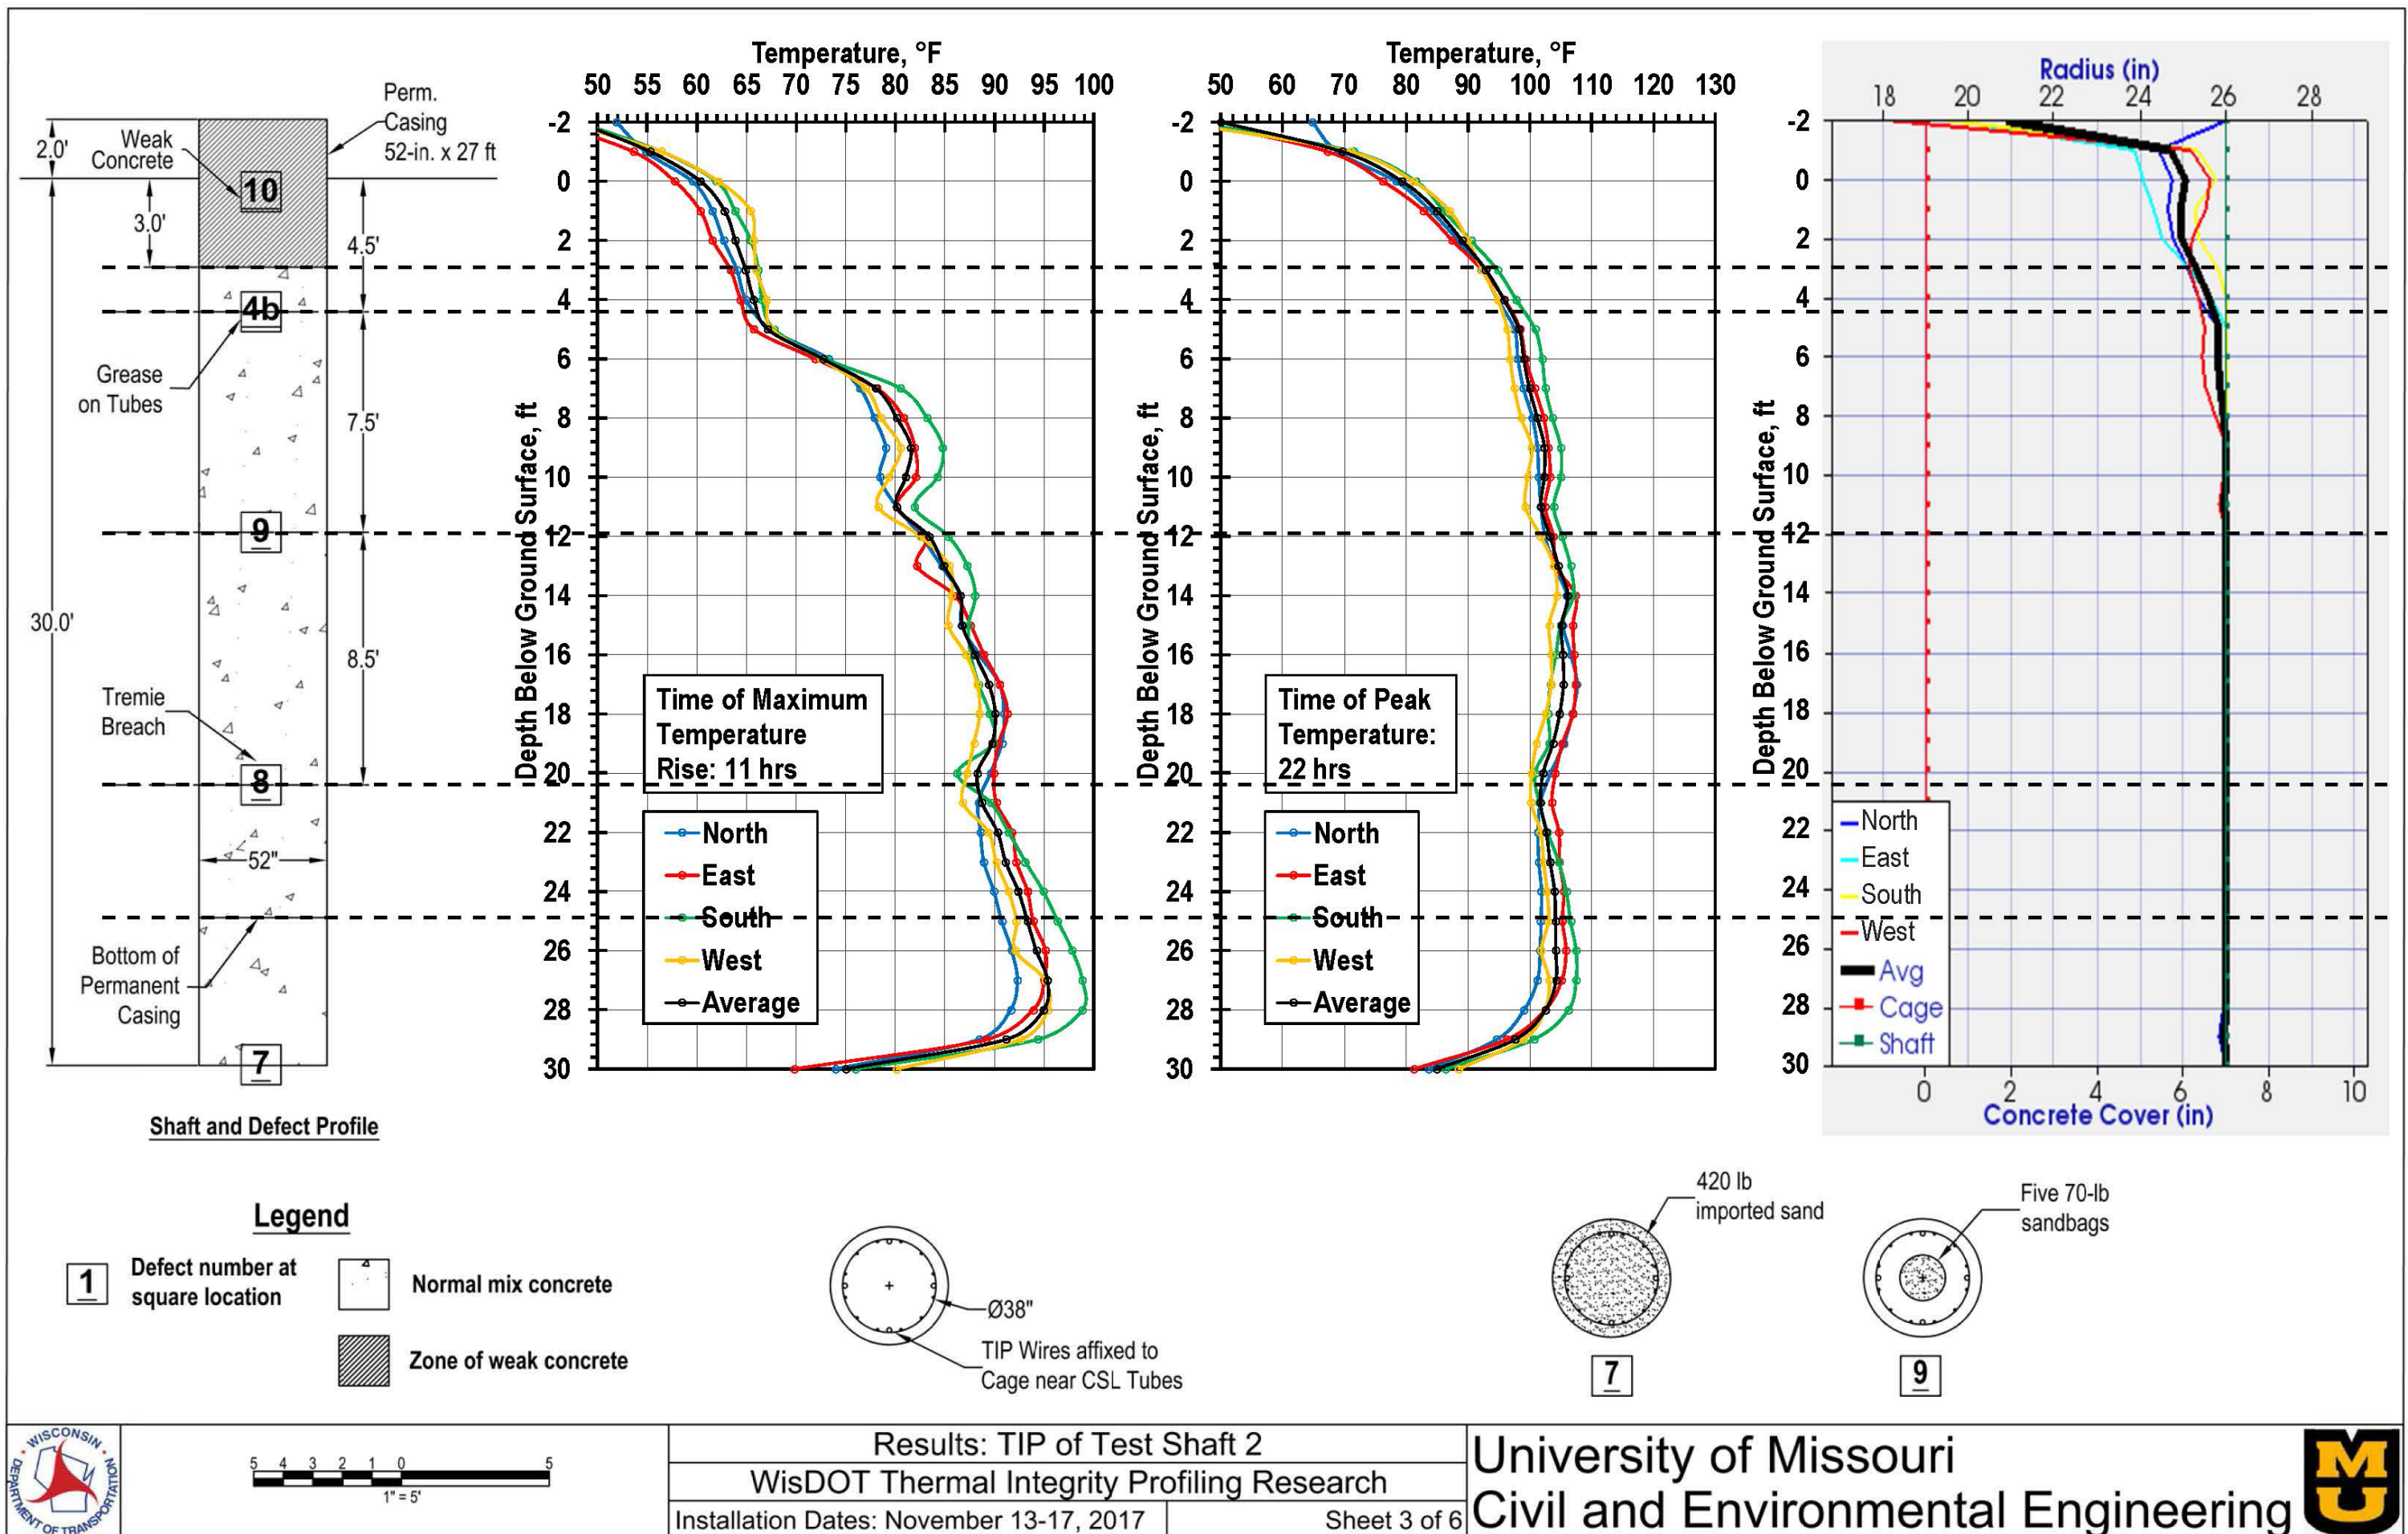
Figure 48: Results of TIP testing of Test Shaft 2, with effective radius from PDI software.

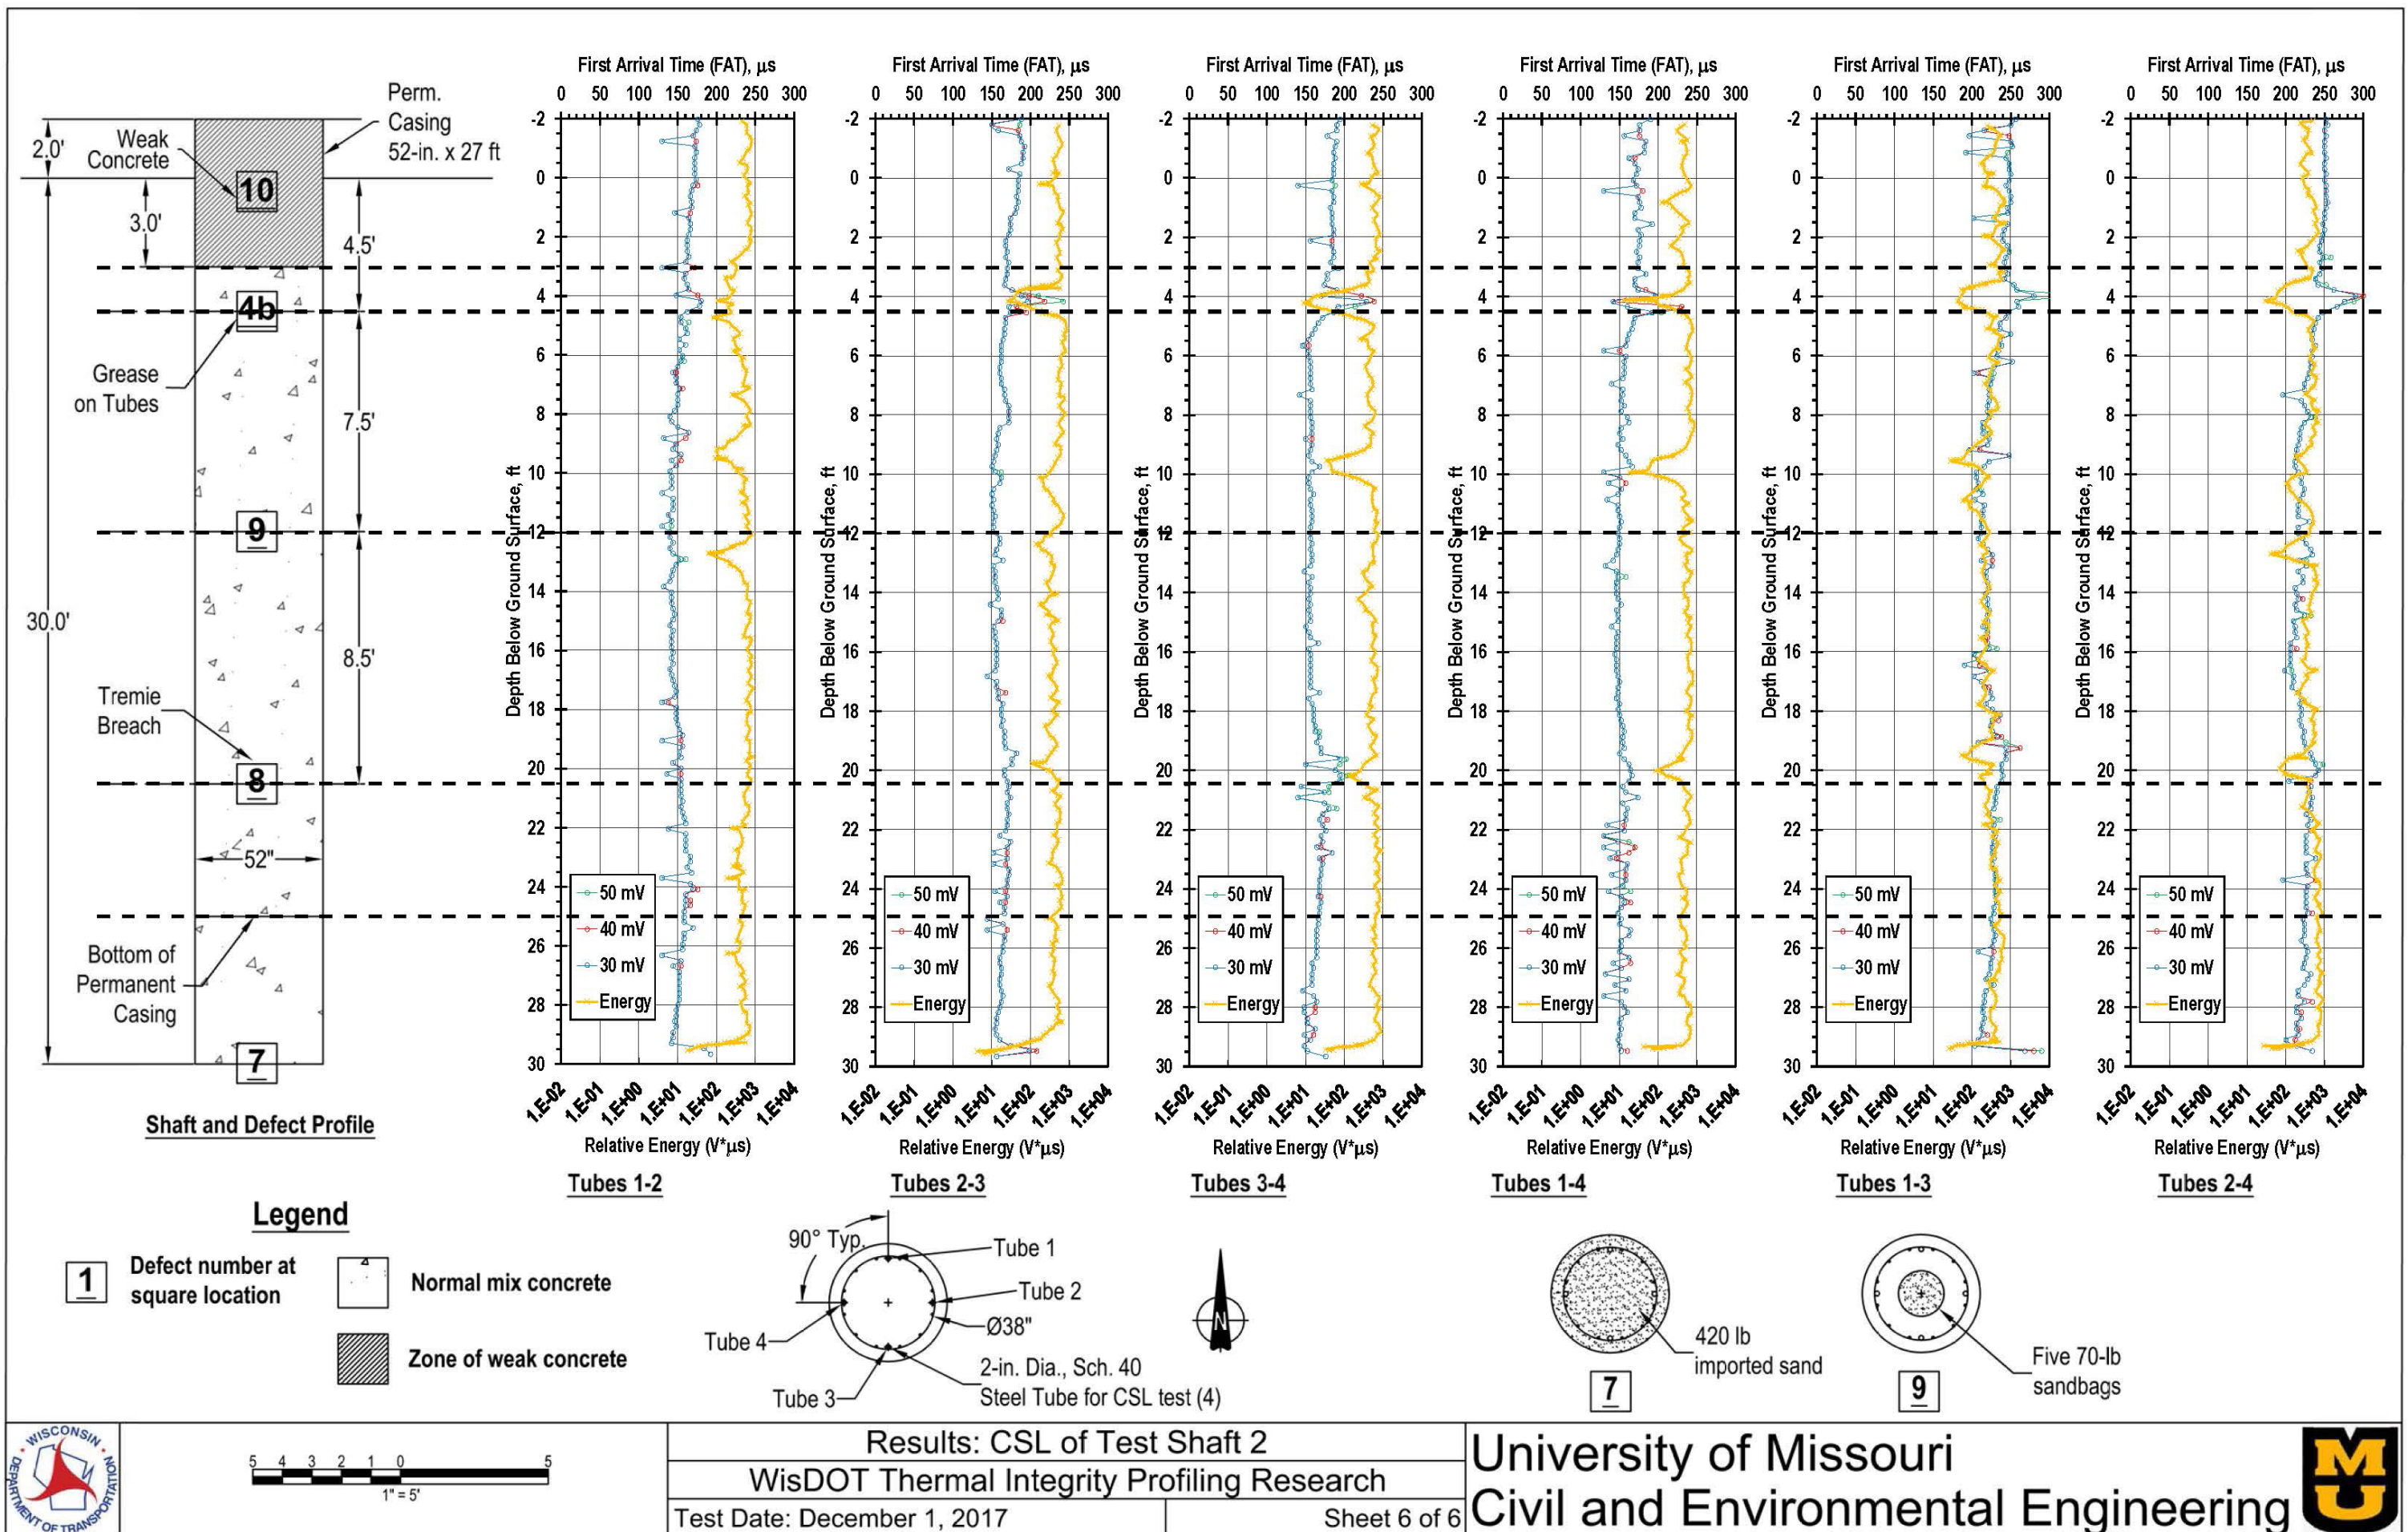
Figure 51: Results of CSL testing of Test Shaft 2.
