Permeability Performance and Lateral Load for Granular Backfill behind Abutments

WISCONSIN HIGHWAY RESEARCH PROGRAM #0092-14-03

PERMEABILITY PERFORMANCE AND LATERAL LOAD FOR GRANULAR BACKFILL BEHIND ABUTMENTS

UPDATED DRAFT FINAL REPORT

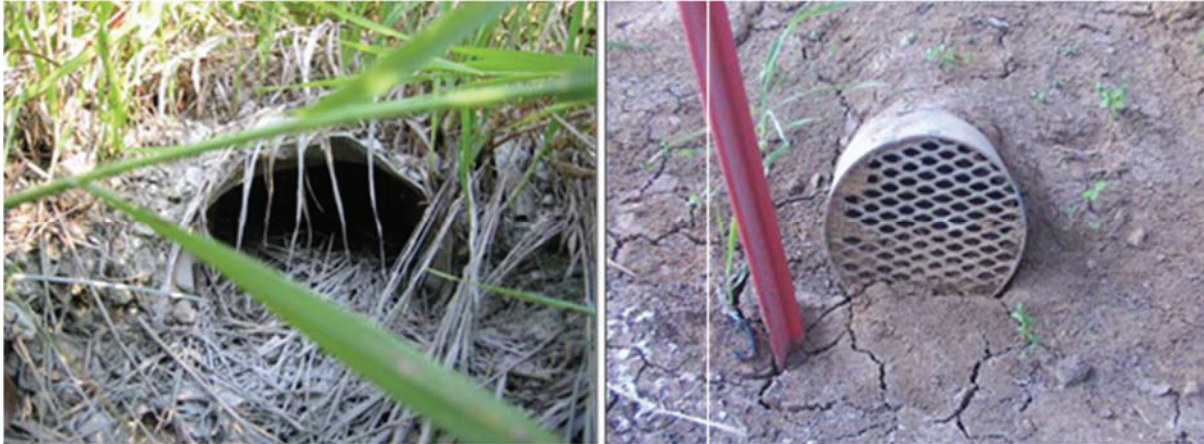
Figure 1. Examples of clogged end drains at I-80 bridge over McPearson Avenue (left) and the bridge on US 218 over South Skunk River (right) (White et al. 2005)

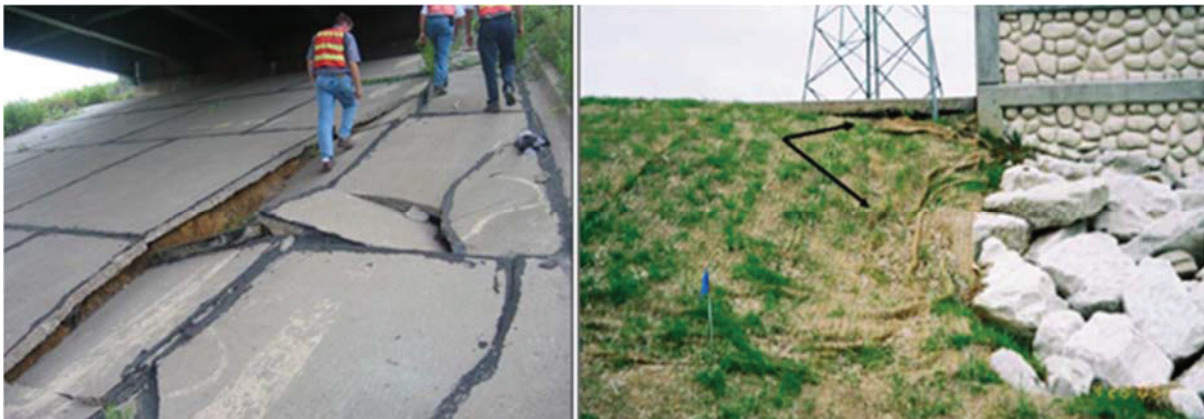
Figure 2. Examples of (left) severe damage of concrete slope protection due to erosion on I-380 bridge over Hwy 6 in Iowa (White et al. 2005), and (right) slope instability on West Beloit Road Bridge over Root River in Wisconsin (Helwany et al. 2007)

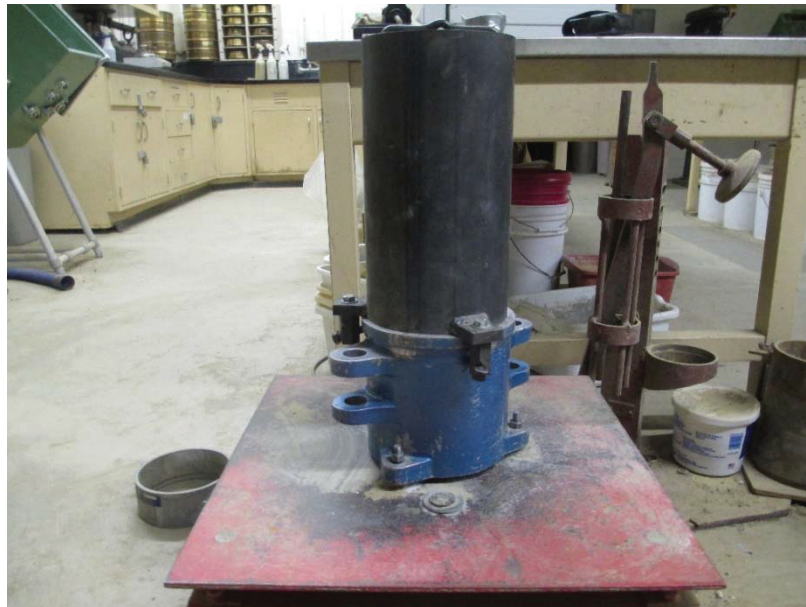
Figure 22. Vibrating table for relative density tests

Vibratory compaction tests were conducted to determine the minimum and maximum dry densities following ASTM D4253 “*Standard test methods for maximum index density and unit weight of soils using a vibratory table*” and ASTM D4254 “*Standard test methods for minimum index density and unit weight of soils and calculation of relative density.*” An electromagnetic vibrating table was used in this study (Figure 22).

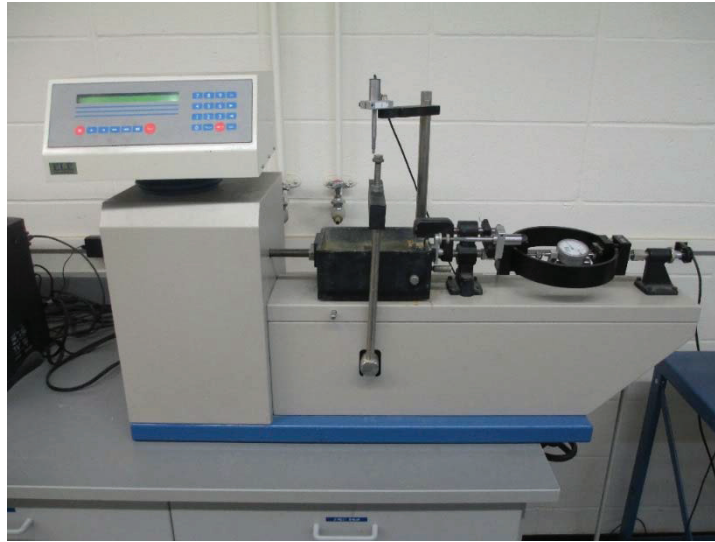
Figure 28. Direct shear test device

conditions.” The material was compacted to 100% standard Proctor dry density and was saturated by adding water during the consolidation stage. The direct shear test apparatus is shown in Figure 28.

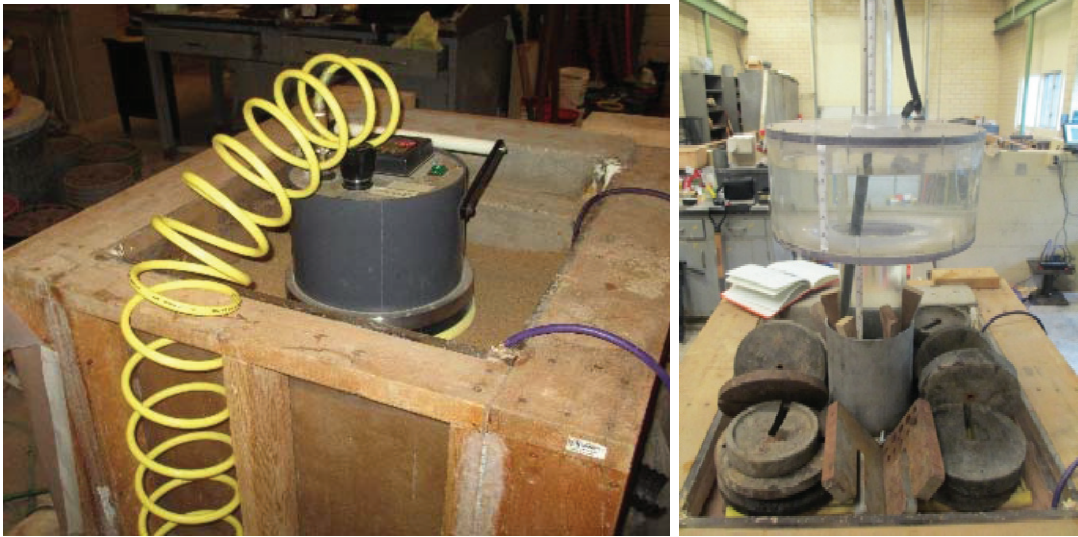
Figure 32. APT test setup (left) and CHP test setup (right)

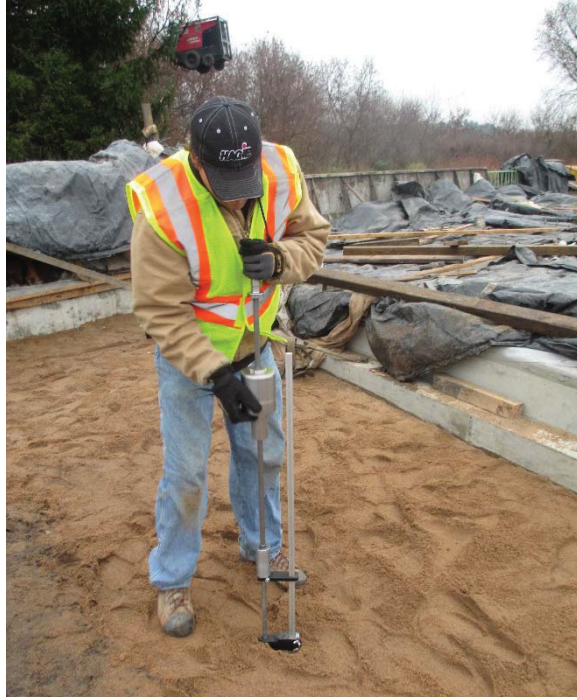
Figure 35. DCP tests at Slovak Valley Creek Bridge

Dynamic Cone Penetrometer (DCP) tests were performed according to ASTM D6951, “*Standard Test Method for Use of the Dynamic Cone Penetrometer in Shallow Pavement Applications.*” (Figure 35). DCP results were used to calculate California Bearing Ratio (CBR) values of the granular backfill. Loose layers of granular backfill can be identified when cumulative number of blows and CBR with depth profiles are plotted. DCP tests were performed to depths of about 1 m (39 in) to 2 m (78 in) using extension rods, below the testing surface. The DCP test was primarily used to identify any loose layers within the compacted backfill material.

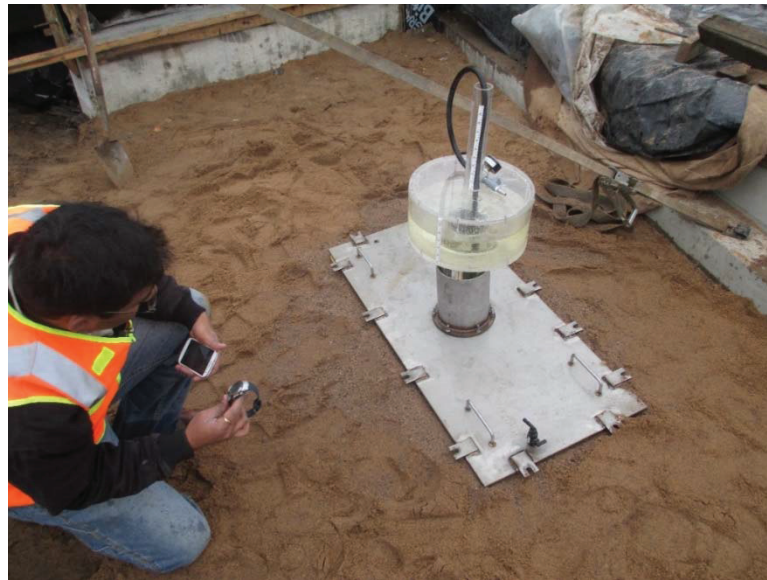
Figure 37. Corehole permeability test setup

The setup involved placing a base plate on a compressible closed-cell foam over the backfill material, to prevent water leakage between the base plate and the material. A core hole sleeve was then attached to the plate. CHP was then inserted in the core hole and was sealed at the bottom of the device and against the interior of the hole. To seal the bottom of the CHP, an open cell foam ring is compressed under the CHP. By inflating a rubber tube between the outside of the CHP ring and the hole wall, the perimeter of the CHP is sealed against the hole wall. About 20 to 25 psi air pressure was used to inflate the rubber tube.

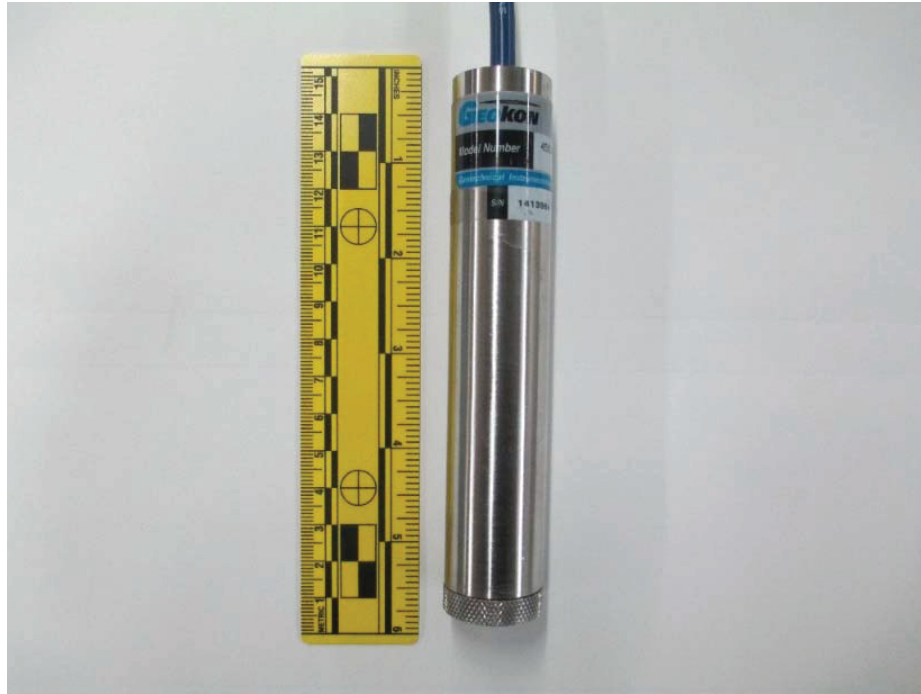
Figure 42. Geokon 4500 piezometer

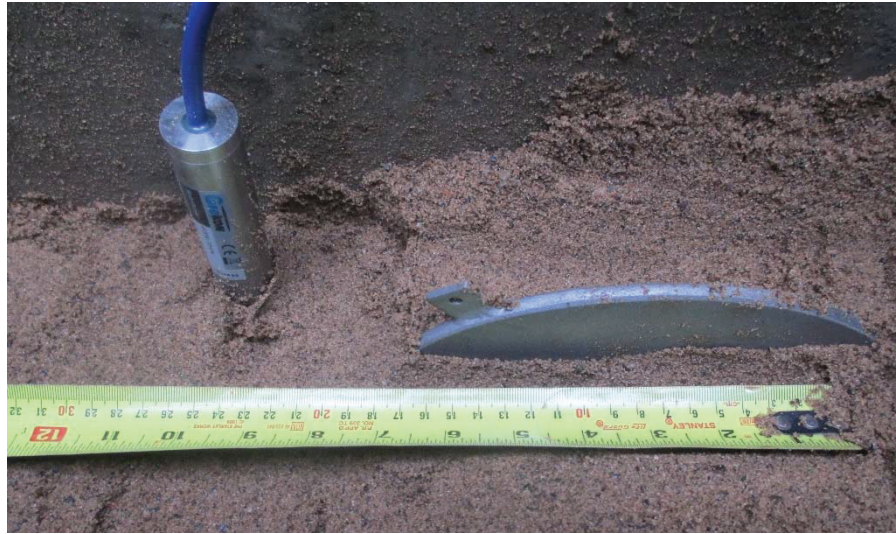
Figure 87. Photograph of an installed PP (left) and EPC (right) sensors
