# HIGHWAY WORK PROPOSAL – RAZING AND REMOVING

COUNTY	STATE PROJECT ID	PROJECT DESCRIPTION	HIGHWAY
Washburn	1197-00-20	Spooner - Minong Trego Interchange	USH 53

Type of Work <b>Razing and Removing</b>	
Notice of award dated	Date guaranty returned

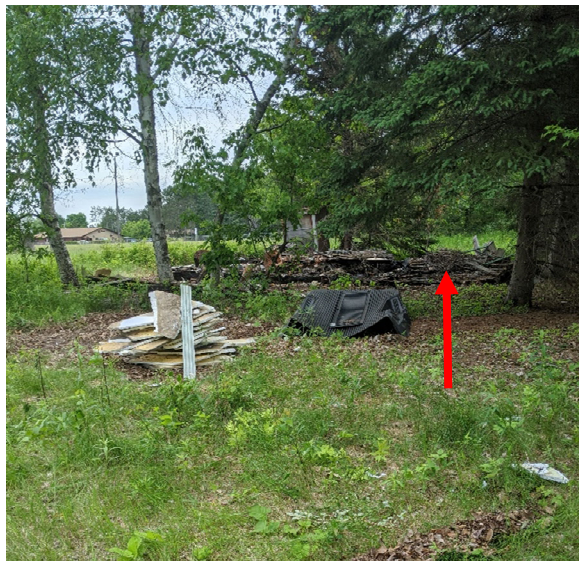
*Figure 5: Building 8B, Burnt Down, Facing East*

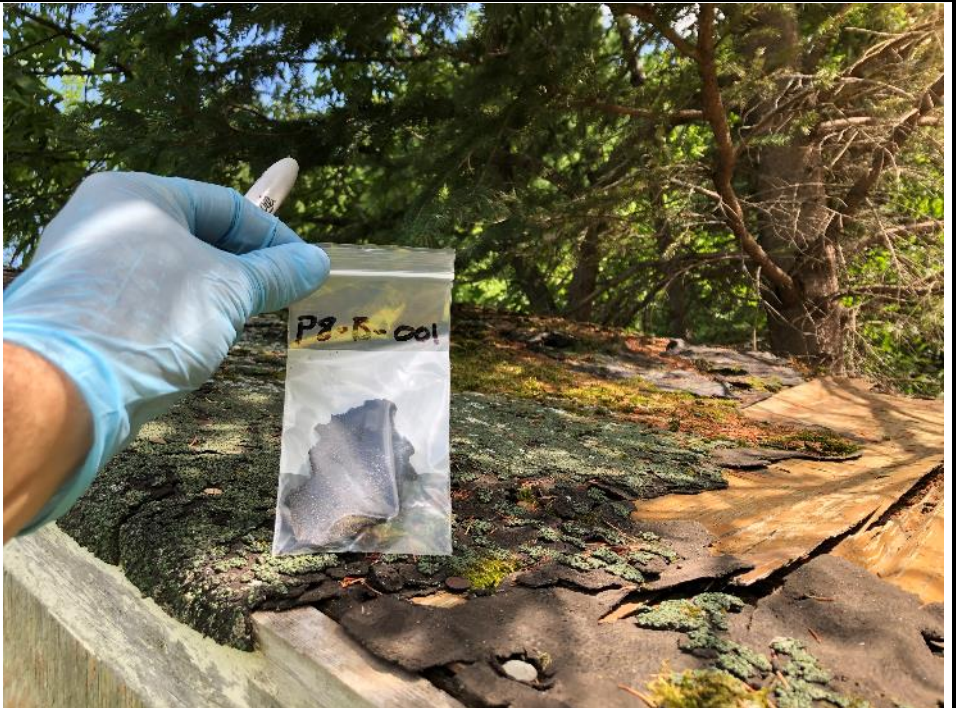
<b>Description</b> 8B, shingles on outhouse and in debris pile, non-detect for ACM

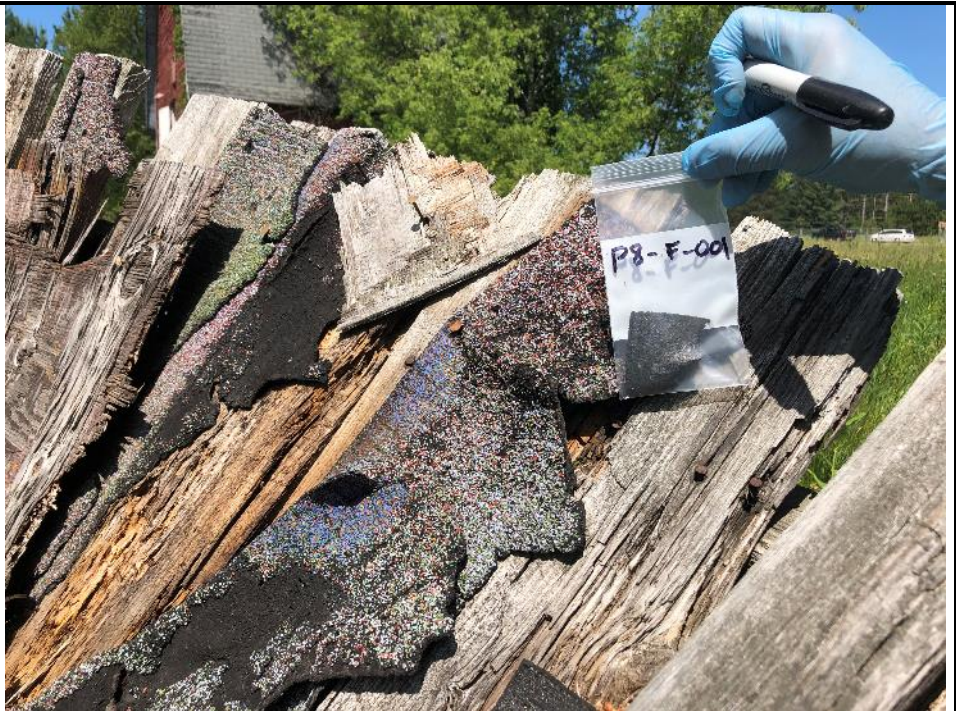
<b>Description</b> 8F, shingles on roof, non-detect for ACM

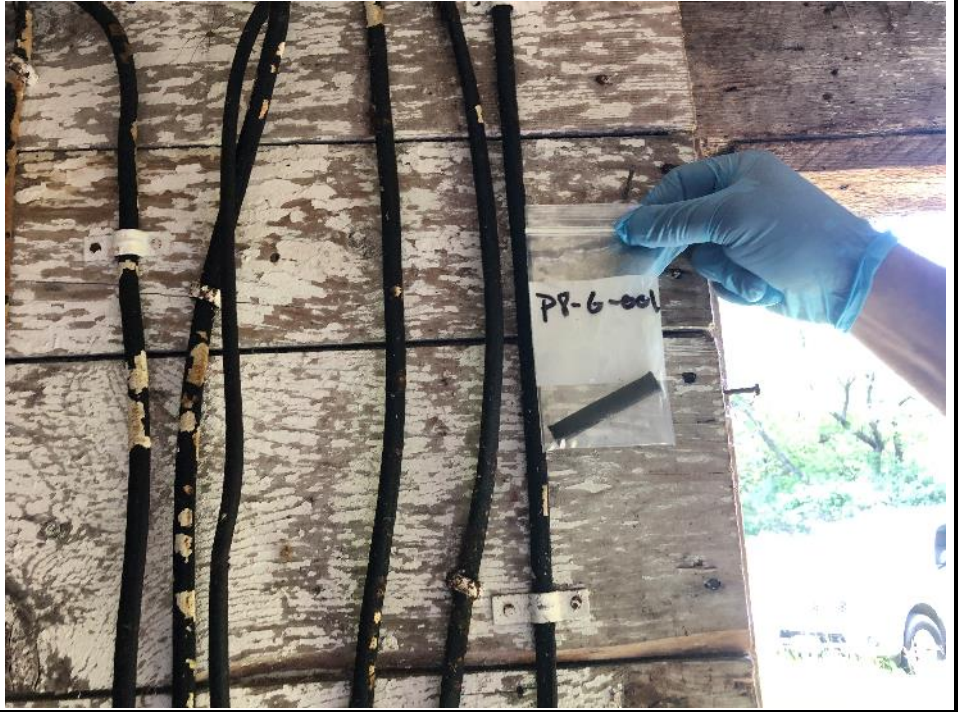
<b>Description</b> 8G, electrical wiring on interior walls & ceiling, non-detect for ACM			
<b>Photo No.</b> 38	<b>Date</b> 7/17/2020

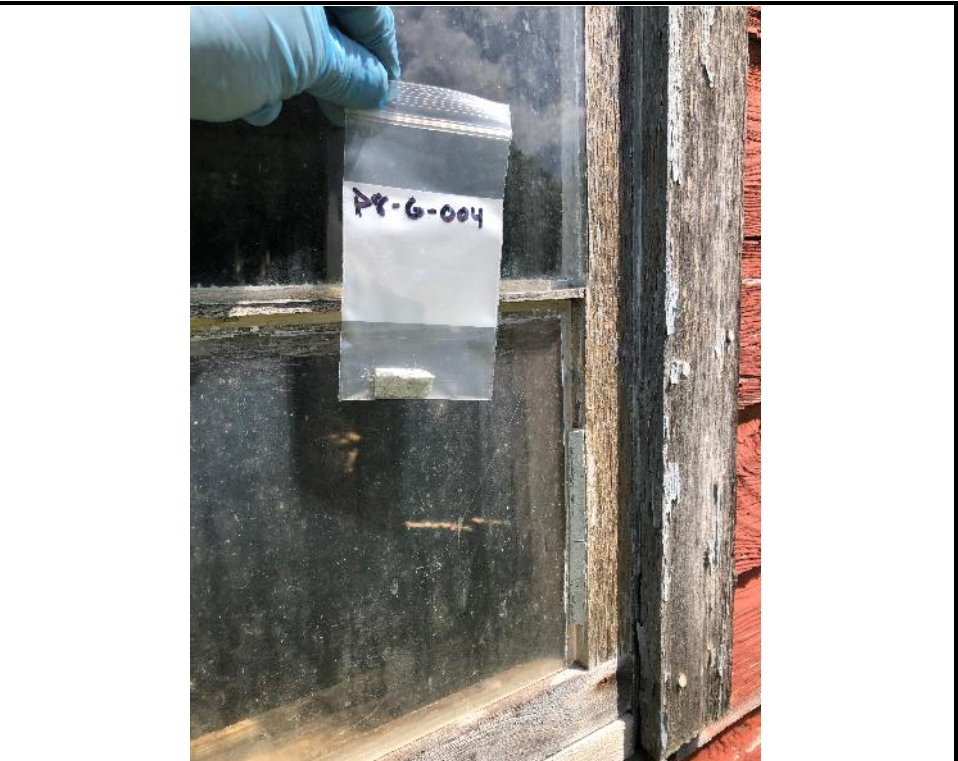
<b>Description</b> 8G, caulk around window exterior, non-detect for ACM

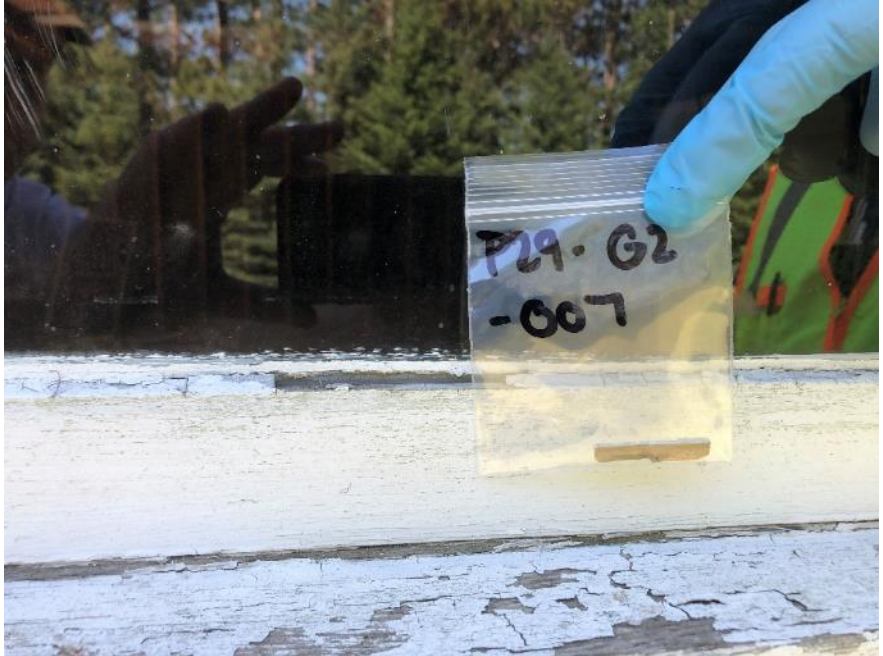
<b>Description</b> Caulk around windows of 2-car garage, non-detect for ACM			
<b>Photo No.</b> 45	<b>Date</b> 7/17/2020

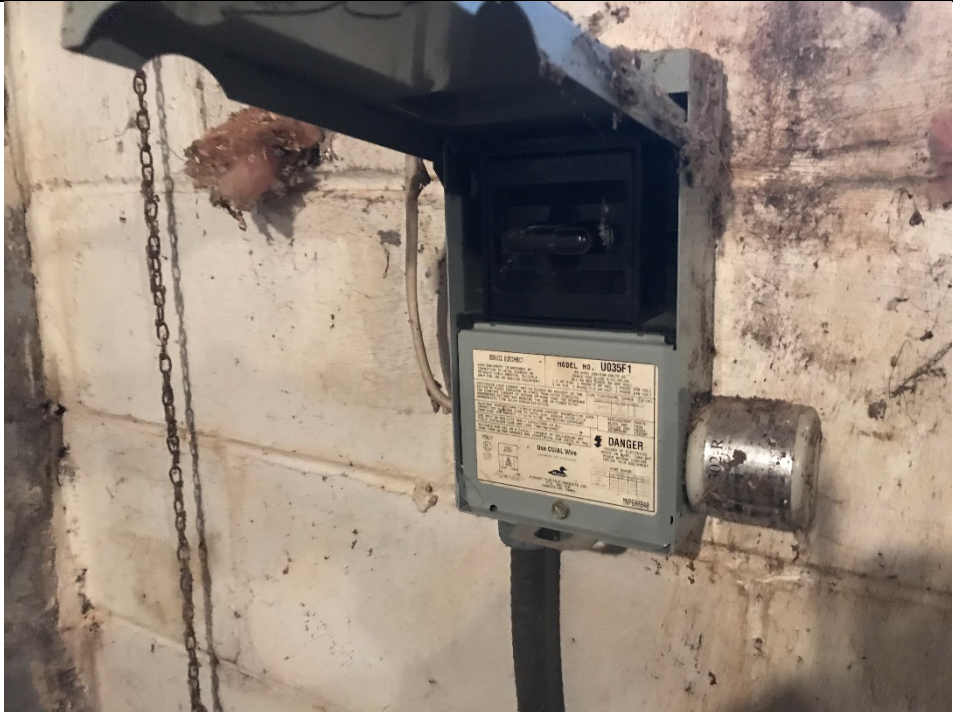
PHOTOGRAPH NO: 6	DATE: JANUARY 23, 2020	GEI PROJECT NO: 2000318	CLIENT: WisDOT
DIRECTION: N/A	SITE LOCATION: W5618 OAK HILL ROAD, TREGO, WISCONSIN		
<p><b>DESCRIPTION:</b></p> <p>Fuel oil AST in basement.</p>

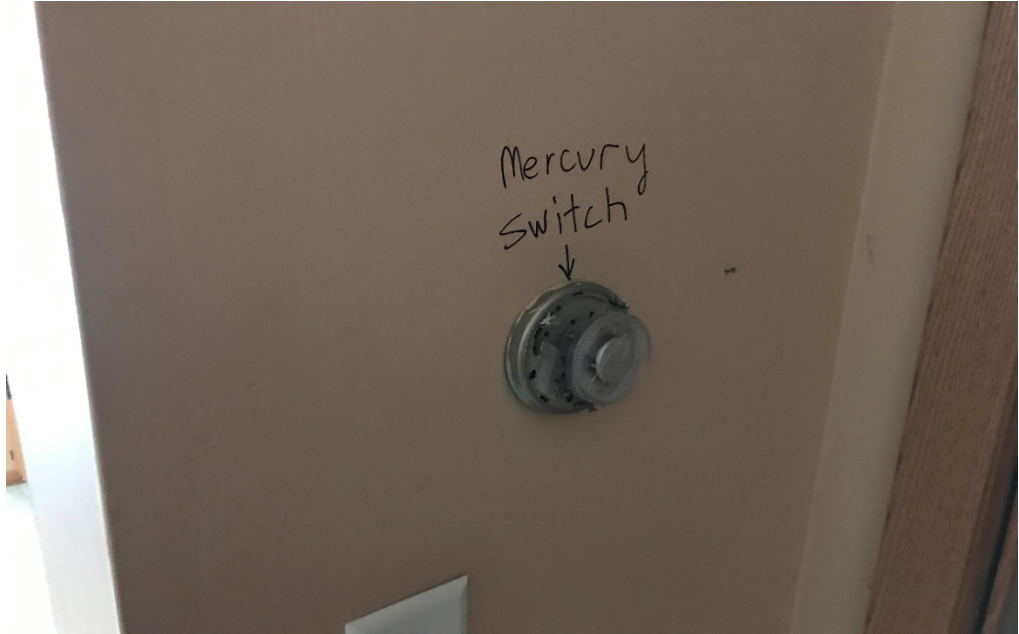
<b>PHOTOGRAPH NO: 7</b>	<b>DATE:</b> JANUARY 23, 2020	<b>GEI PROJECT NO:</b> 2000318	<b>CLIENT:</b> WisDOT
<b>DIRECTION: N/A</b>	<b>SITE LOCATION: W5618 OAK HILL ROAD, TREGO, WISCONSIN</b>		
<b>DESCRIPTION:</b>  Mercury switch in wall mounted thermostat

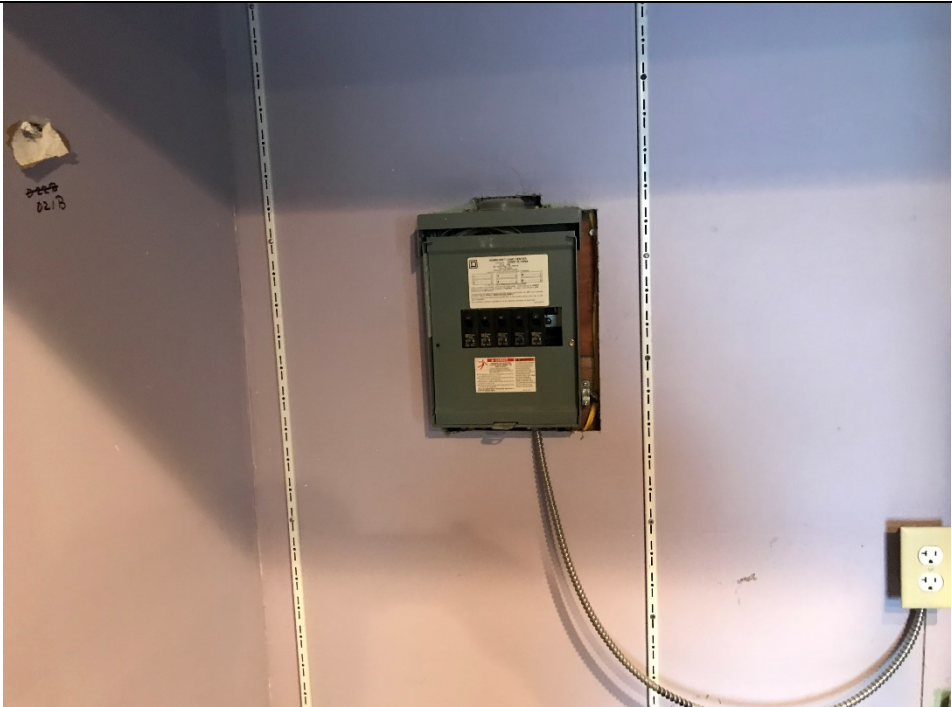
<b>PHOTOGRAPH NO: 8</b>	<b>DATE:</b> JANUARY 23, 2020	<b>GEI PROJECT NO:</b> 2000318	<b>CLIENT:</b> WisDOT
<b>DIRECTION: N/A</b>	<b>SITE LOCATION: W5618 OAK HILL ROAD, TREGO, WISCONSIN</b>		
<b>DESCRIPTION:</b>  Looking at the northwest bath electrical box with black phenolic resin components. <b>The black phenolic resin components in the electrical box are presumed ACM (PACM) and should be managed appropriately.</b>

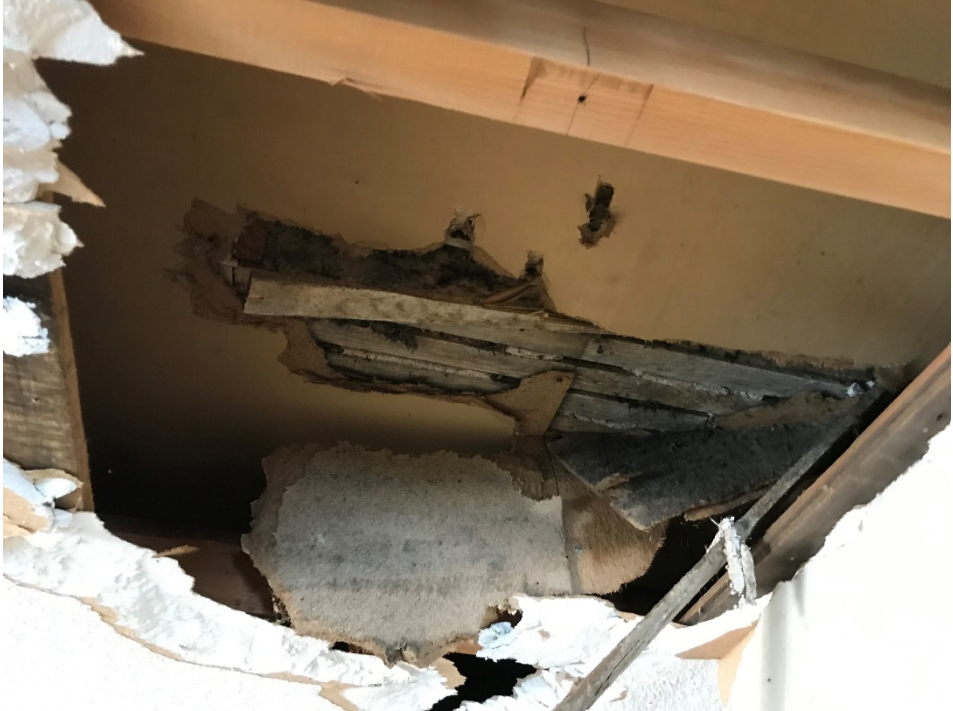
<b>PHOTOGRAPH NO: 9</b>	<b>DATE:</b> <b>JANUARY 23, 2020</b>	<b>GEI PROJECT NO:</b> <b>2000318</b>	<b>CLIENT:</b> <b>WisDOT</b>
<b>DIRECTION: N/A</b>	<b>SITE LOCATION: W5618 OAK HILL ROAD, TREGO, WISCONSIN</b>		
<b>DESCRIPTION:</b>  View of plaster on lath ceiling covered by wallboard with drop drywall ceiling in main living room.

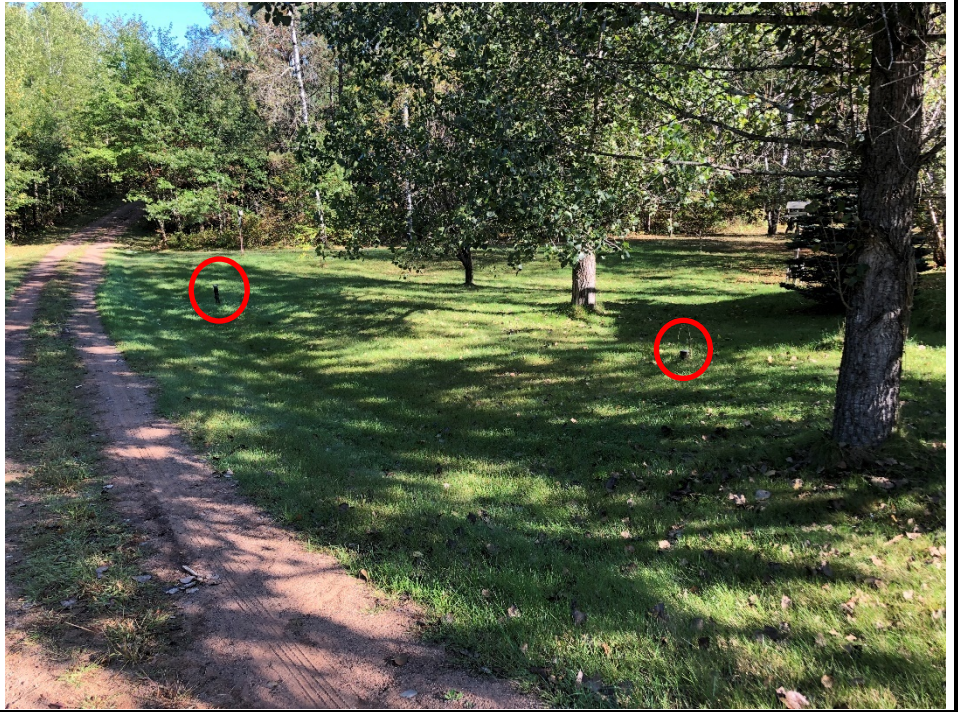
<b>Description</b> Septic pipes in yard along driveway			
<b>Photo No.</b> 6	<b>Date</b> 9/24/2019
