# Bridge Deck Thermography Verification and Policy

**Brady Seston, P.E.**  
NDE Department Manager, AECOM

WisDOT ID no. 0092-23-04

September 2024

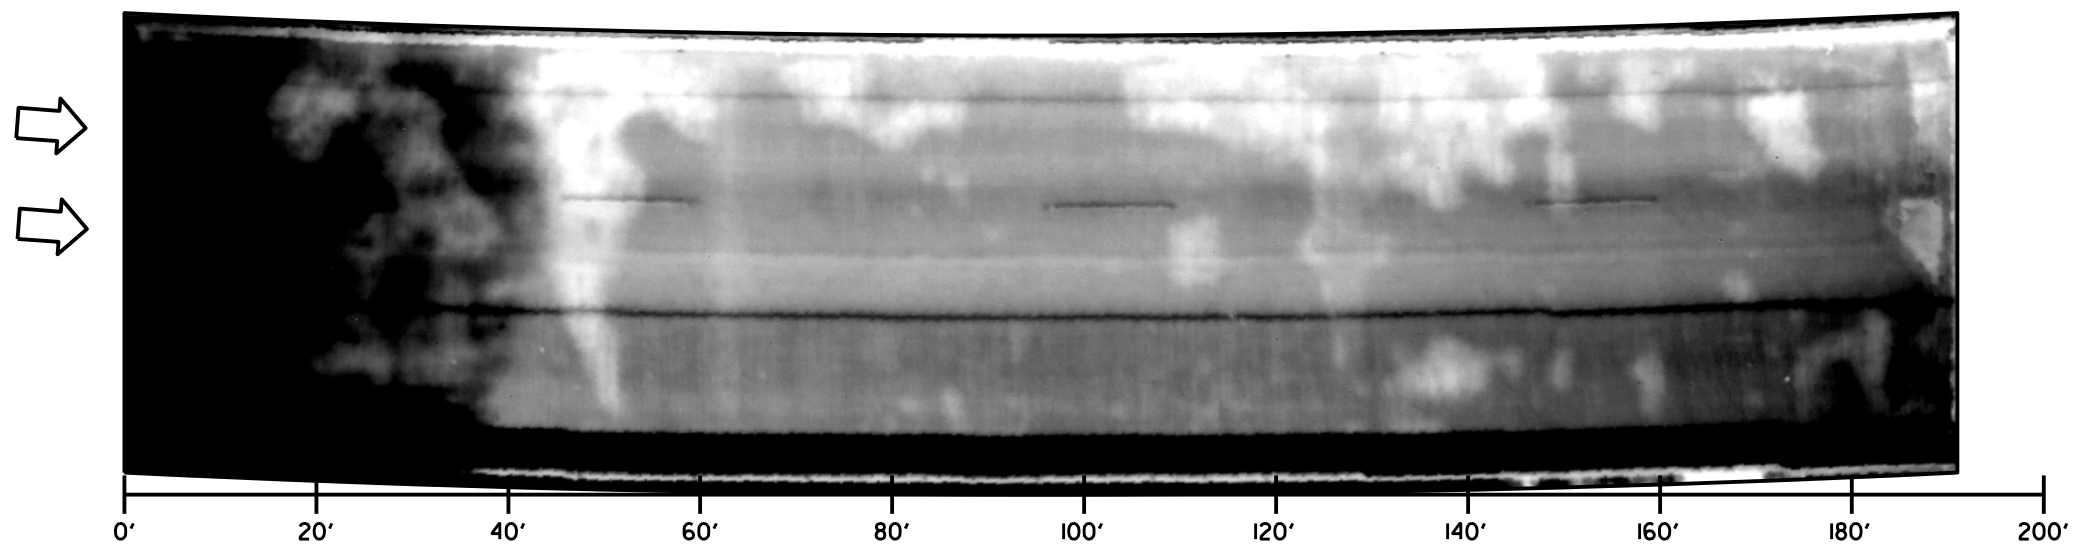
B670152

AERIAL INFRARED THERMOGRAPHIC OVERVIEW

SURFACE TYPE: CONCRETE OVERLAY  
INFRARED INSPECTION DATE: 9/29/22, 1:11 PM

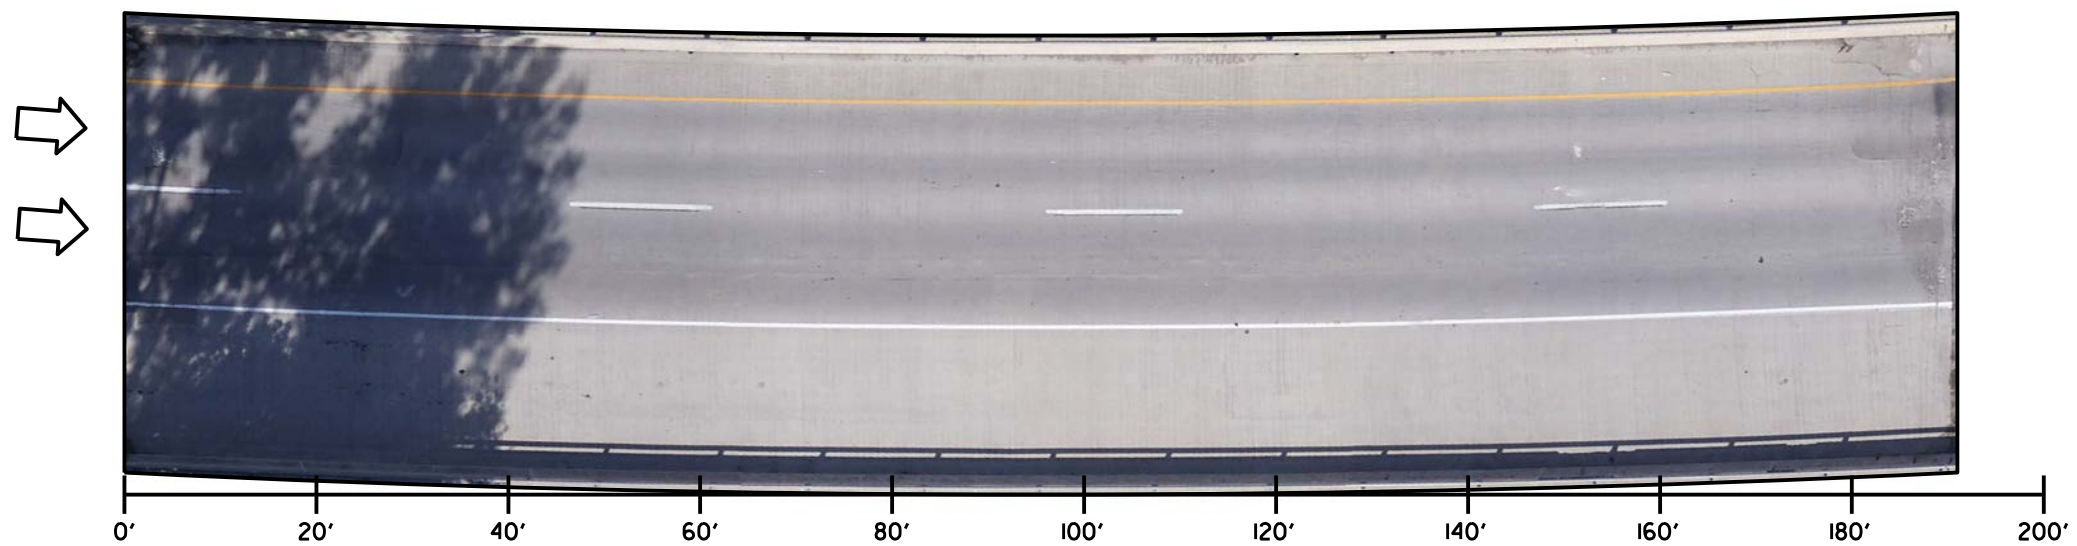
B670152  
AERIAL RGB OVERVIEW

SURFACE TYPE: CONCRETE OVERLAY  
INFRARED INSPECTION DATE: 9/29/22, 1:11 PM

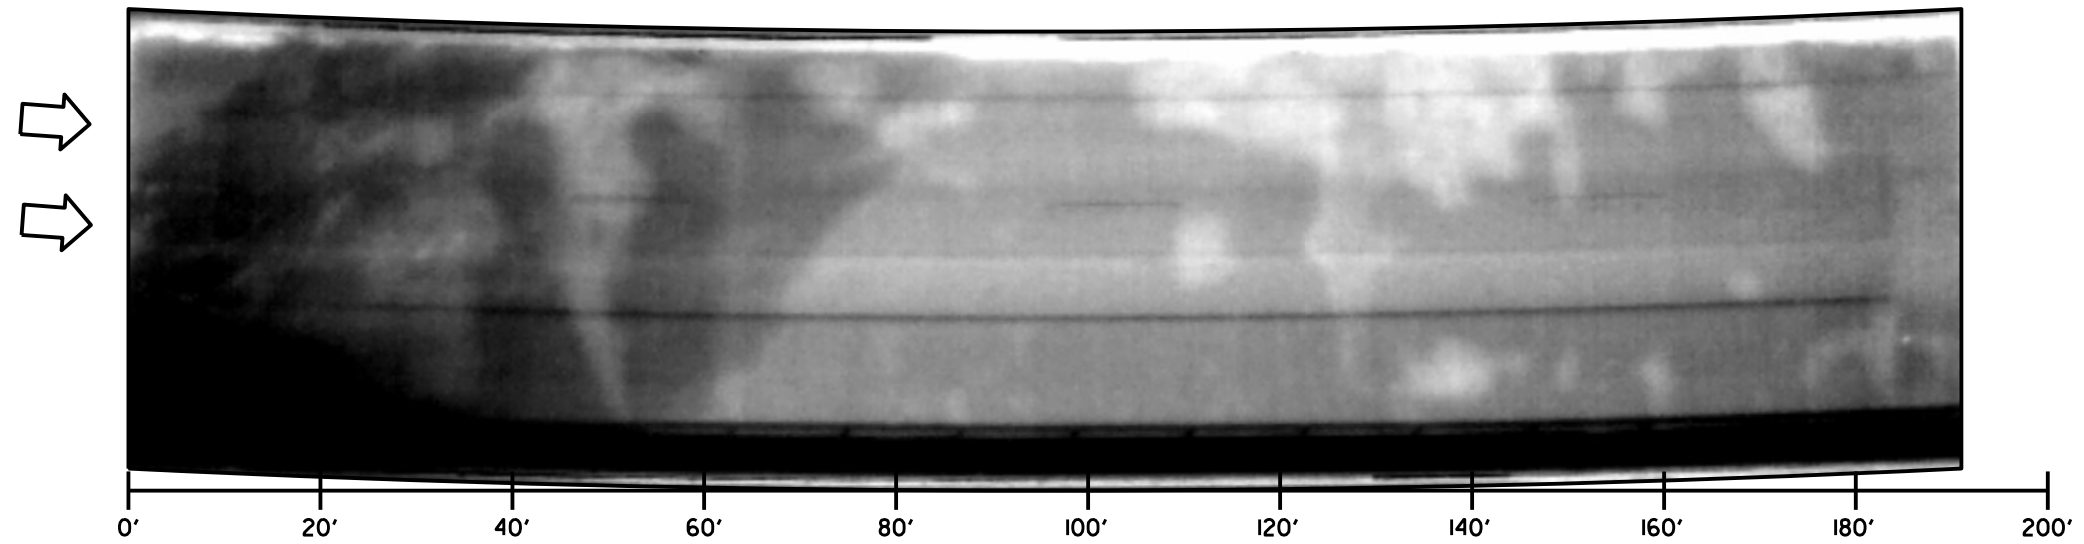
B670152

DRONE INFRARED THERMOGRAPHIC OVERVIEW

SURFACE TYPE: CONCRETE OVERLAY  
INFRARED INSPECTION DATE: 10/17/23, 2:50 PM

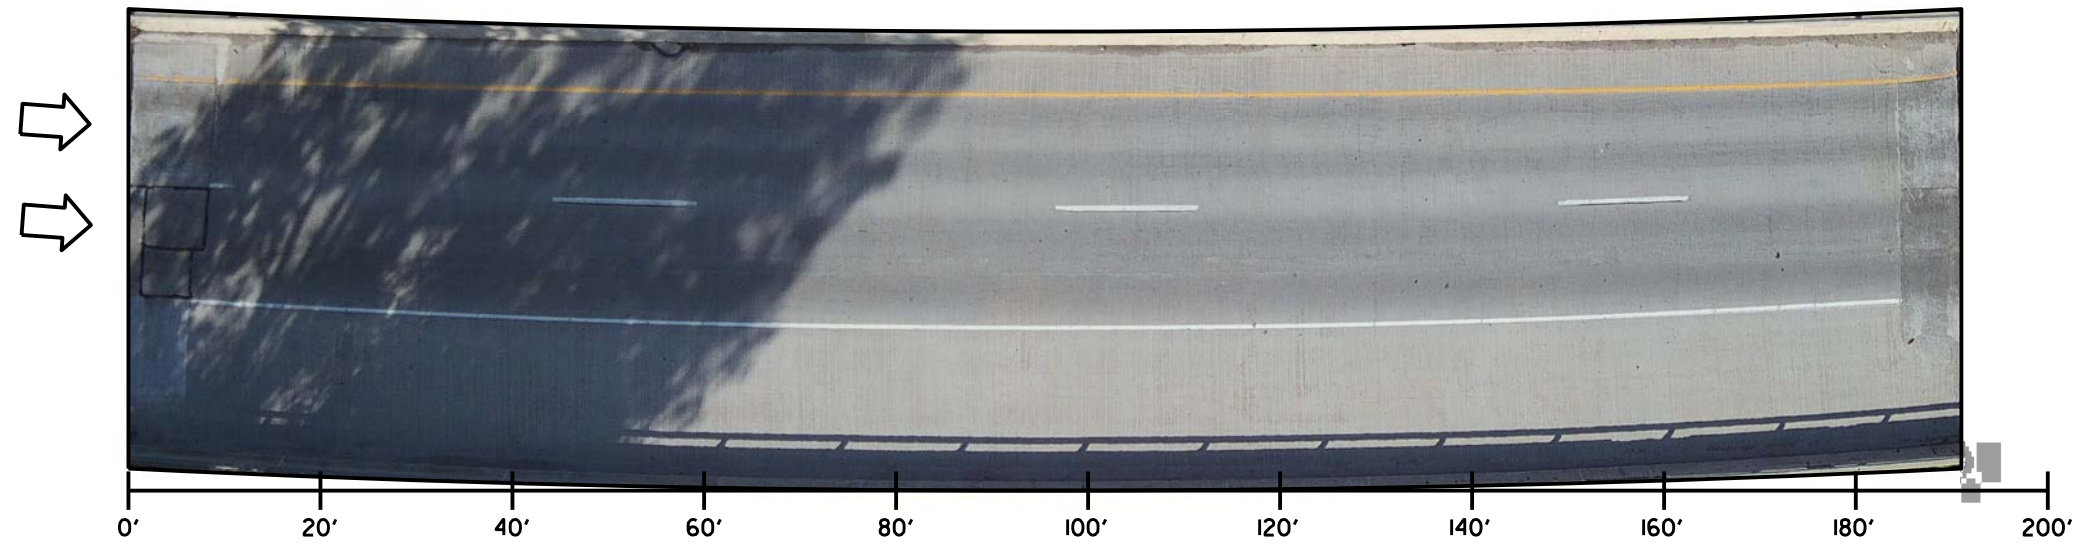
B670152  
DRONE RGB OVERVIEW

SURFACE TYPE: CONCRETE OVERLAY  
INFRARED INSPECTION DATE: 10/17/23, 2:50 PM

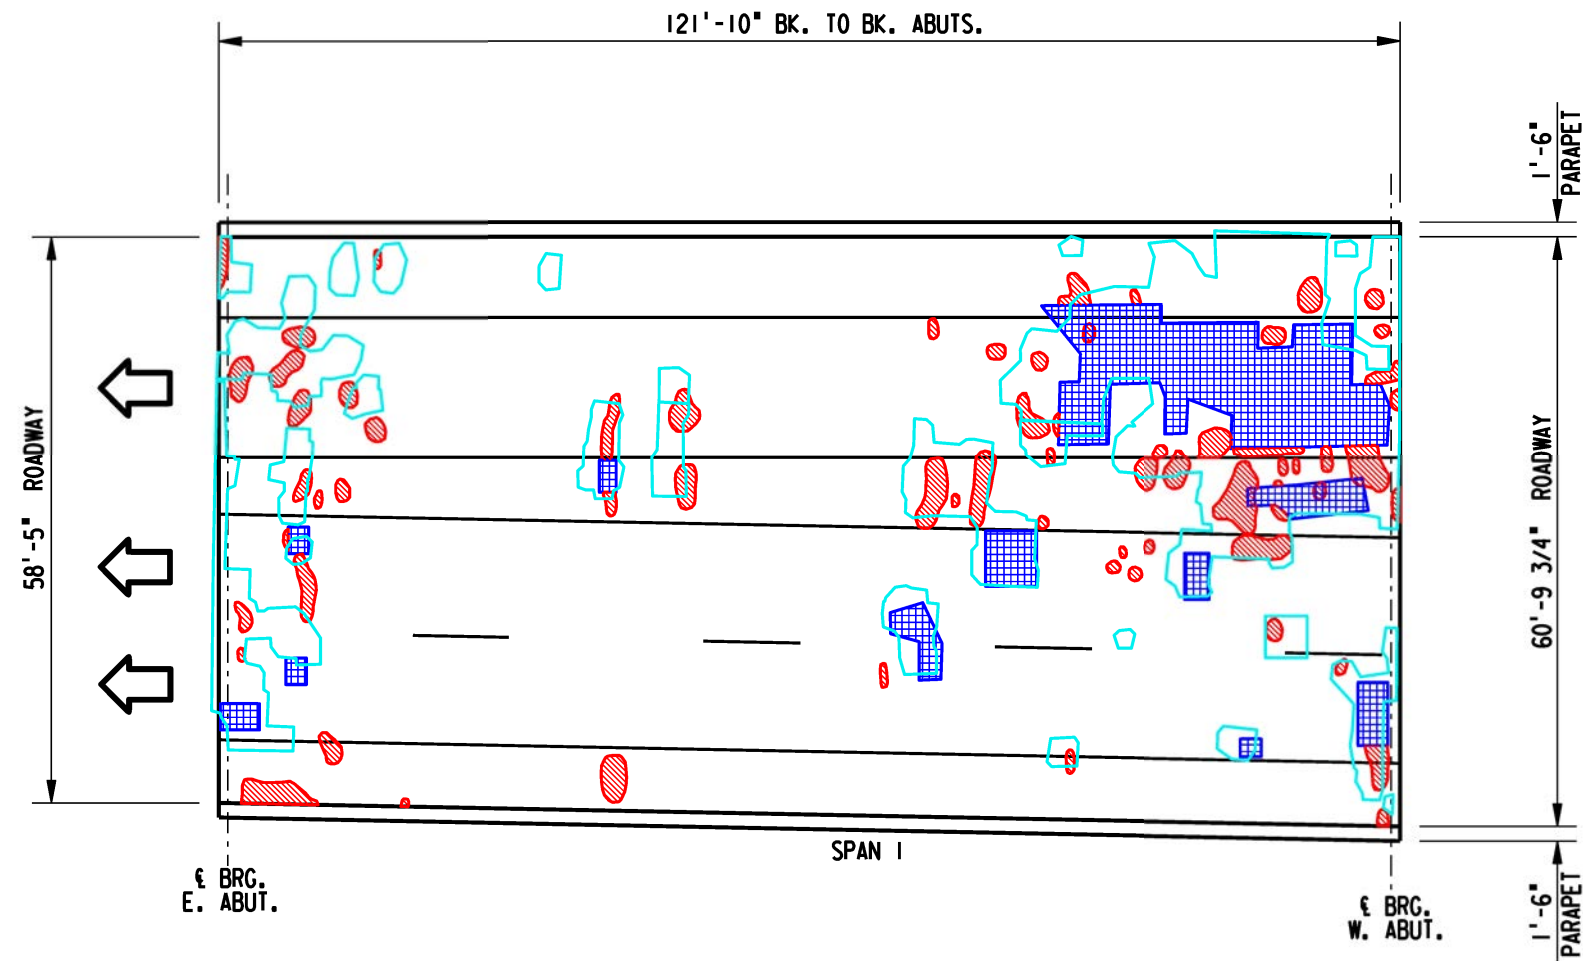
PLAN  
B-5-221

DEFECT-REHAB COMPARISON		STRUCTURE NO. B-5-221	
ITEM	UNIT	QUANT.	%
TOTAL AREA	ft <sup>2</sup>	7259	
TOTAL DEFECTS*	ft <sup>2</sup>	805	11.1
TOTAL TYPE-1 REHAB	ft <sup>2</sup>	1586	21.8
DEFECTS/REHAB OVERLAP	ft <sup>2</sup>	661	9.1
IR FALSE POSITIVES	ft <sup>2</sup>	144	2.0
REHAB NOT DETECTED BY IR	ft <sup>2</sup>	925	12.7

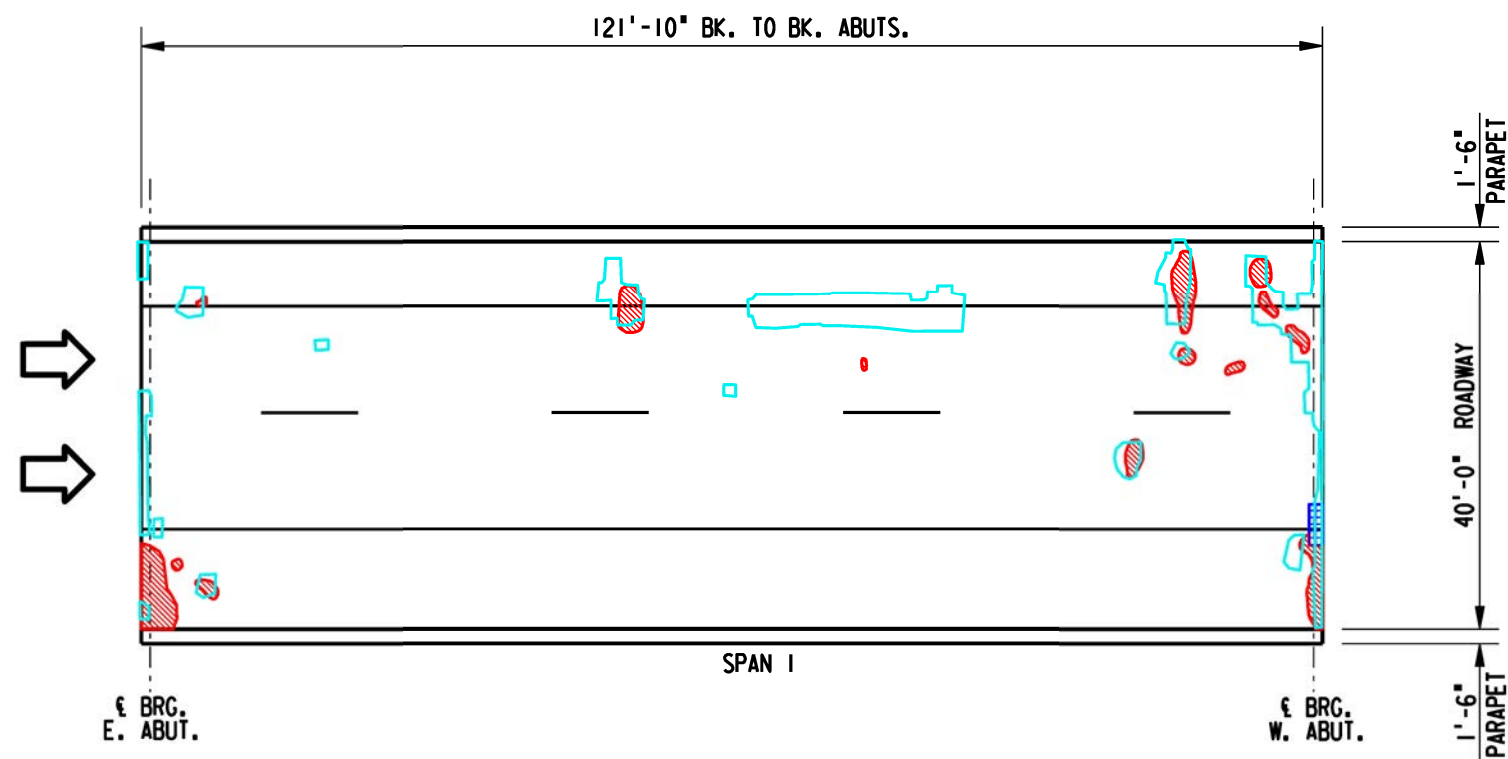
PLAN  
B-5-222

DEFECT-REHAB COMPARISON		STRUCTURE NO. B-5-222	
ITEM	UNIT	QUANT.	%
TOTAL AREA	ft <sup>2</sup>	4872	
TOTAL DEFECTS*	ft <sup>2</sup>	92	1.9
TOTAL TYPE-1 REHAB	ft <sup>2</sup>	239	4.9
DEFECTS/REHAB OVERLAP	ft <sup>2</sup>	47	1.0
IR FALSE POSITIVES	ft <sup>2</sup>	45	0.9
REHAB NOT DETECTED BY IR	ft <sup>2</sup>	192	3.9

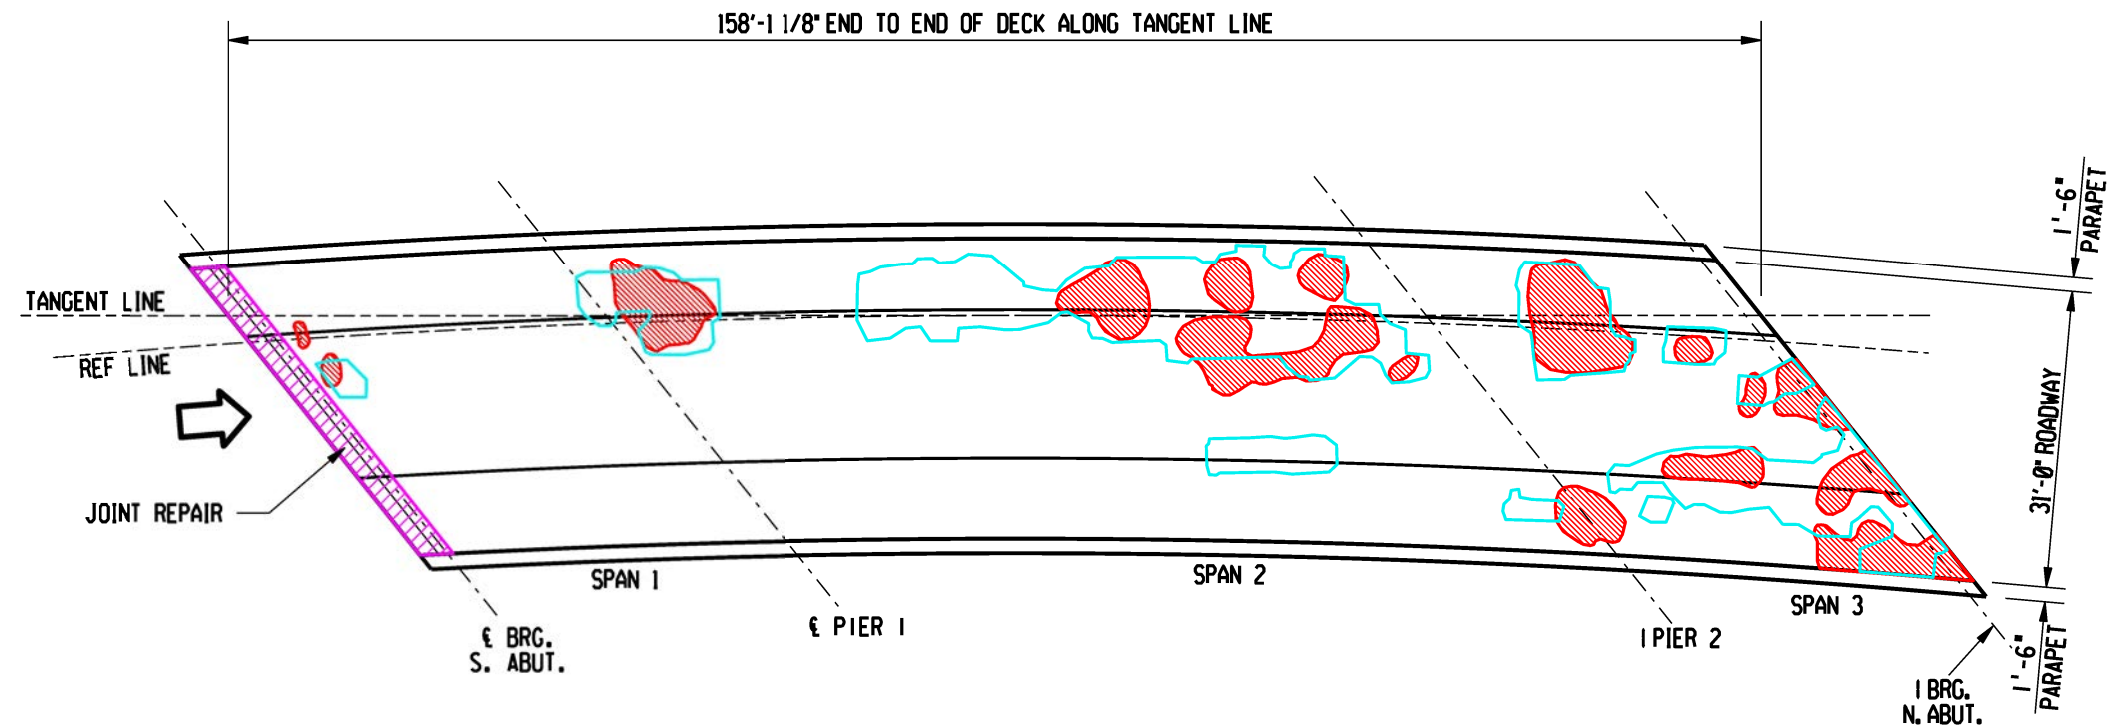
PLAN  
B-5-223

DEFECT-REHAB COMPARISON		STRUCTURE NO. B-5-223	
ITEM	UNIT	QUANT.	%
TOTAL AREA	ft <sup>2</sup>	4904	
TOTAL DEFECTS*	ft <sup>2</sup>	541	11.0
TOTAL TYPE-1 REHAB	ft <sup>2</sup>	1005	20.5
DEFECTS/REHAB OVERLAP	ft <sup>2</sup>	423	8.6
IR FALSE POSITIVES	ft <sup>2</sup>	118	2.4
REHAB NOT DETECTED BY IR	ft <sup>2</sup>	582	11.9

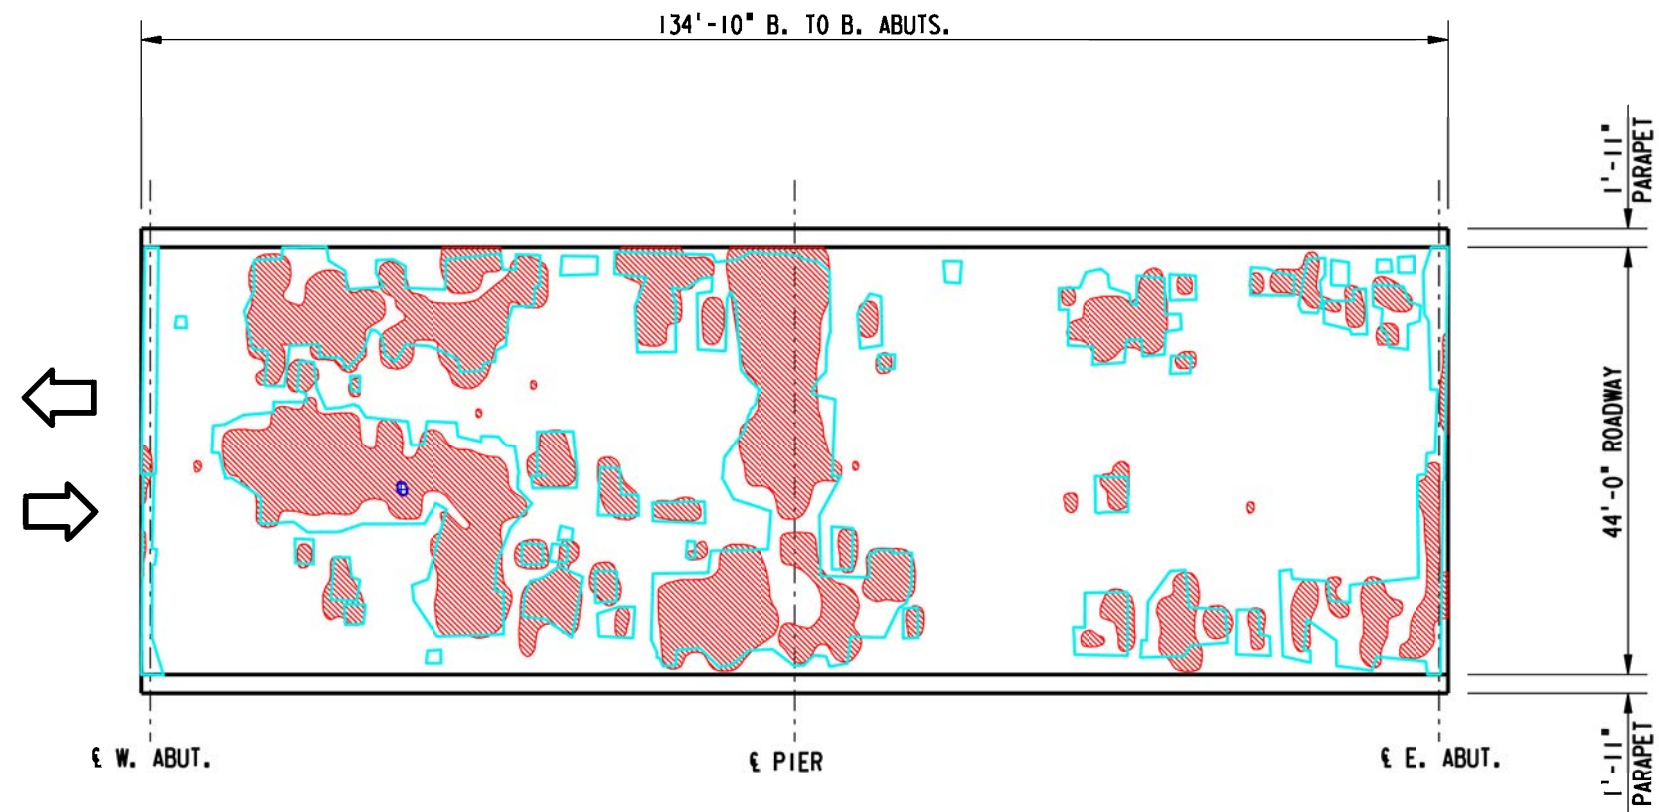
PLAN  
B-20-23

DEFECT-REHAB COMPARISON		STRUCTURE NO. B-20-23	
ITEM	UNIT	QUANT.	%
TOTAL AREA	ft <sup>2</sup>	5883	
TOTAL DEFECTS	ft <sup>2</sup>	1517	25.8
TOTAL TYPE-1 REHAB	ft <sup>2</sup>	1949	33.1
DEFECTS/REHAB OVERLAP	ft <sup>2</sup>	1335	22.7
IR FALSE POSITIVES	ft <sup>2</sup>	182	3.1
REHAB NOT DETECTED BY IR	ft <sup>2</sup>	614	10.4

FIELD OBSERVATIONS SUMMARY		S.N. B-20-23		LEGEND	
ITEM	UNIT	QUANT.	%		
TOTAL AREA	ft <sup>2</sup>	5883		DELAMINATION	
SHADE/DEBRIS	ft <sup>2</sup>	0		SPALL	
DELAMINATION	ft <sup>2</sup>	1516	25.8	DEBOND/SCALING	
SPALL	ft <sup>2</sup>	0	0	ASPHALT PATCH	
DEBOND	ft <sup>2</sup>	0	0	CONCRETE PATCH	
ASPHALT PATCH	ft <sup>2</sup>	1	<0.1	SHADE/DEBRIS	
CONCRETE PATCH	ft <sup>2</sup>	0	0	REHAB	
TYPE-1 REHAB AREA	ft <sup>2</sup>	1949	33.1

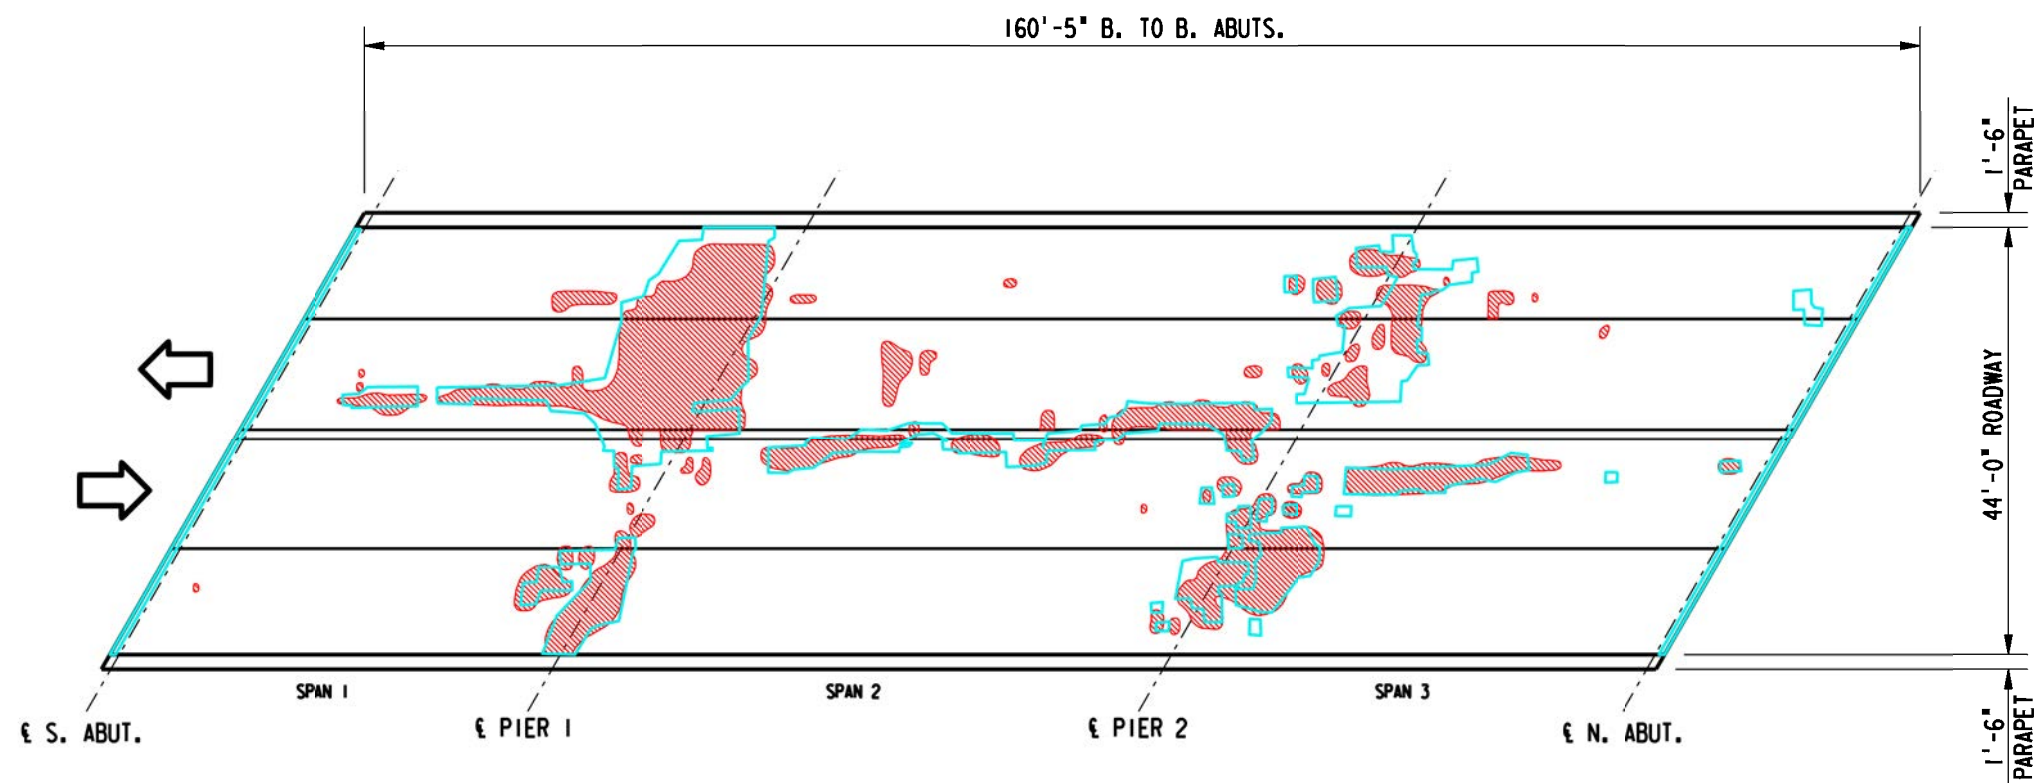
PLAN  
B-31-18

DEFECT-REHAB COMPARISON		STRUCTURE NO. B-31-18	
ITEM	UNIT	QUANT.	%
TOTAL AREA	ft <sup>2</sup>	7000	
TOTAL DEFECTS	ft <sup>2</sup>	782	11.2
TOTAL TYPE-1 REHAB	ft <sup>2</sup>	882	12.6
DEFECTS/REHAB OVERLAP	ft <sup>2</sup>	608	8.7
IR FALSE POSITIVES	ft <sup>2</sup>	173	2.5
REHAB NOT DETECTED BY IR	ft <sup>2</sup>	274	3.9

FIELD OBSERVATIONS SUMMARY		S.N. B-31-18		LEGEND	
ITEM	UNIT	QUANT.	%		
TOTAL AREA	ft <sup>2</sup>	7000		DELAMINATION	
SHADE/DEBRIS	ft <sup>2</sup>	0		SPALL	
DELAMINATION	ft <sup>2</sup>	785	11.2	DEBOND/SCALING	
SPALL	ft <sup>2</sup>	0	0	ASPHALT PATCH	
DEBOND	ft <sup>2</sup>	0	0	CONCRETE PATCH	
ASPHALT PATCH	ft <sup>2</sup>	0	0	SHADE/DEBRIS	
CONCRETE PATCH	ft <sup>2</sup>	0	0	REHAB	
TYPE-1 REHAB AREA	ft <sup>2</sup>	882	12.6

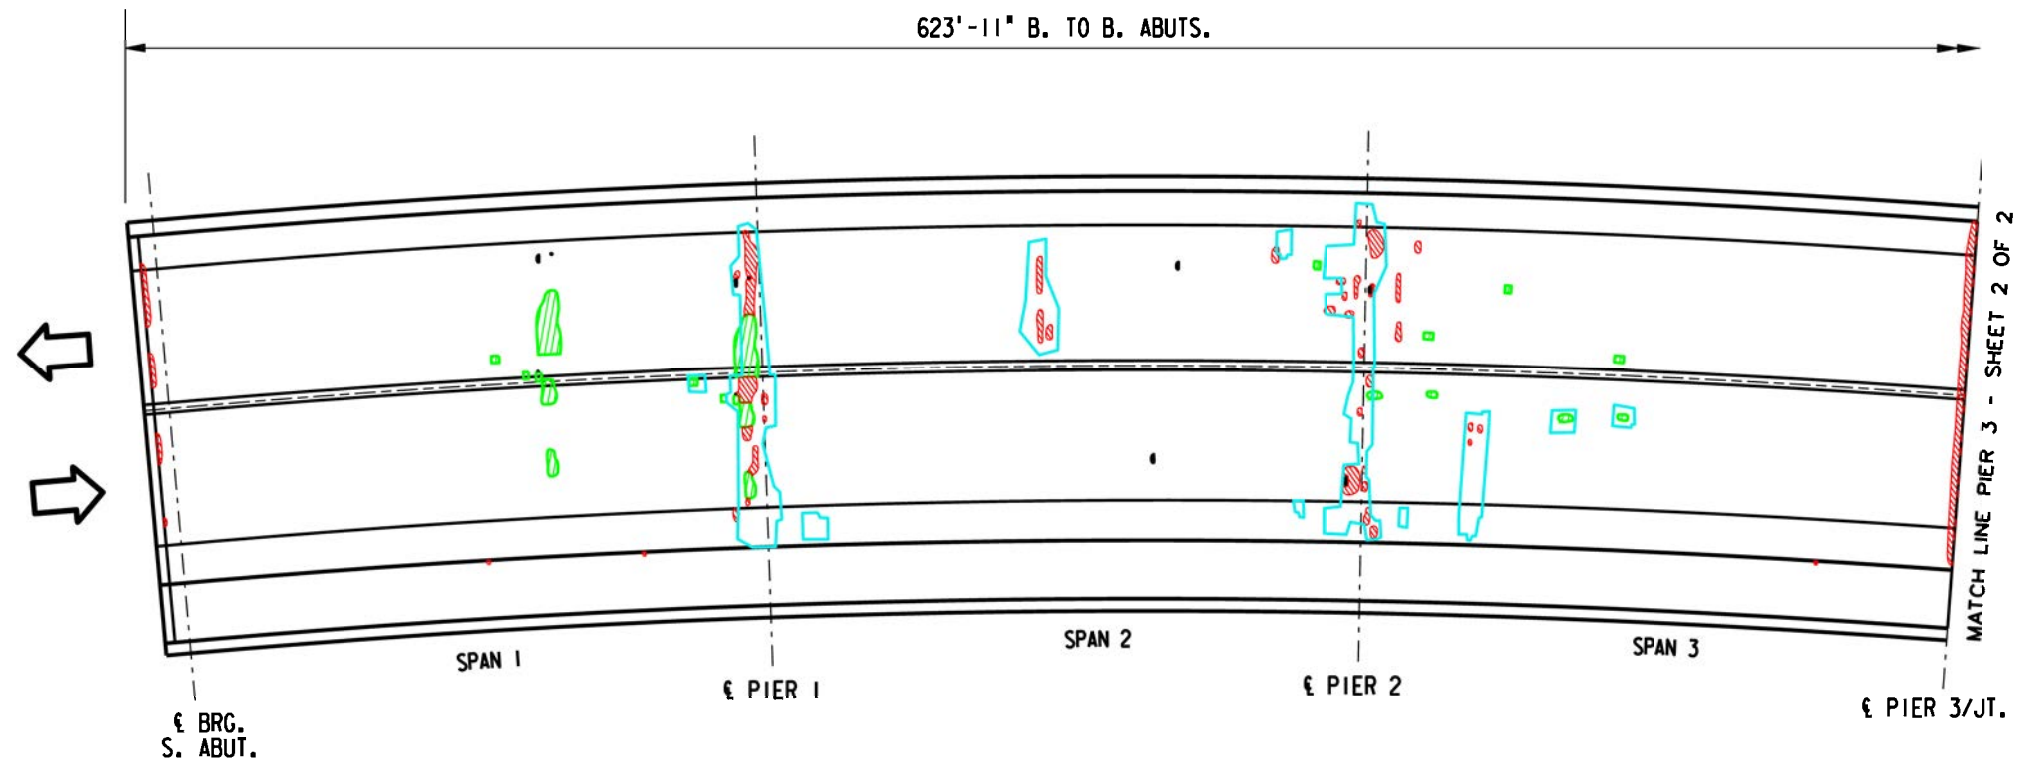
PLAN  
B-31-23

DEFECT-REHAB COMPARISON		STRUCTURE NO. B-31-23	
ITEM	UNIT	QUANT.	%
TOTAL AREA	ft <sup>2</sup>	22417	
TOTAL DEFECTS	ft <sup>2</sup>	301	1.3
TOTAL TYPE-1 REHAB	ft <sup>2</sup>	768	3.4
DEFECTS/REHAB OVERLAP	ft <sup>2</sup>	155	0.7
IR FALSE POSITIVES	ft <sup>2</sup>	146	0.7
REHAB NOT DETECTED BY IR	ft <sup>2</sup>	613	2.7

FIELD OBSERVATIONS SUMMARY		ROADWAY		LEGEND	
ITEM	UNIT	QUANT.	%		
TOTAL AREA	ft <sup>2</sup>	22417		DELAMINATION	
SHADE/DEBRIS	ft <sup>2</sup>	0		SPALL	
DELAMINATION	ft <sup>2</sup>	240	1.1	DEBOND/SCALING	
SPALL	ft <sup>2</sup>	3	<0.1	ASPHALT PATCH	
DEBOND	ft <sup>2</sup>	N/A	N/A	CONCRETE PATCH	
ASPHALT PATCH	ft <sup>2</sup>	0	0	SHADE/DEBRIS	
CONCRETE PATCH	ft <sup>2</sup>	58	0.3	REHAB	
TYPE-1 REHAB AREA	ft <sup>2</sup>	768	3.4
