Investigation of MSE Wall Corrosion in Wisconsin

> Prepared by: Geocomp, Inc. Acton, MA

WisDOT ID no. 0092-24-02

June 2025

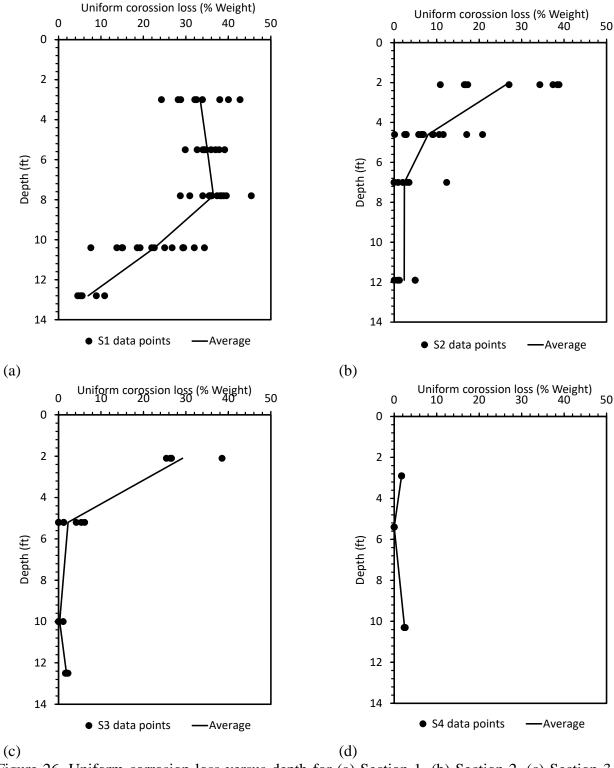
Figure 26. Uniform corrosion loss versus depth for (a) Section 1, (b) Section 2, (c) Section 3, and (d) Section 4.

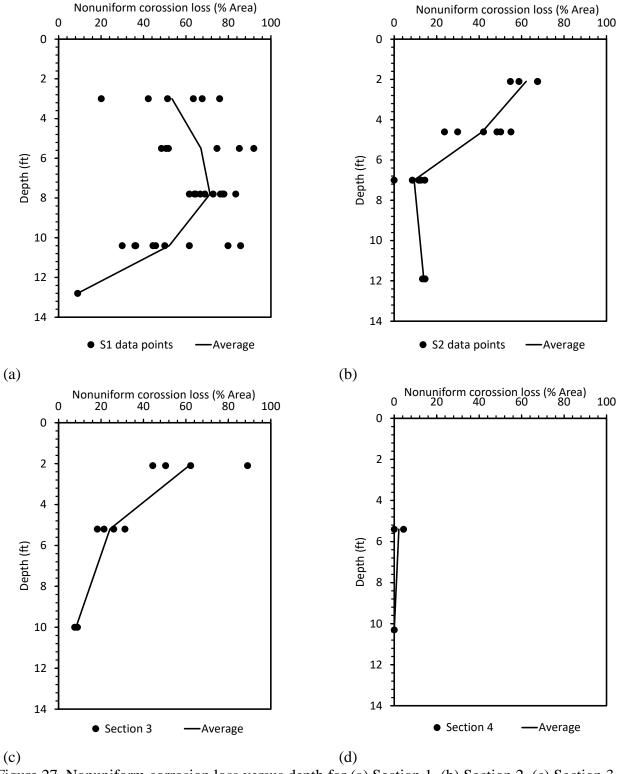
Figure 27. Nonuniform corrosion loss versus depth for (a) Section 1, (b) Section 2, (c) Section 3, and (d) Section 4.

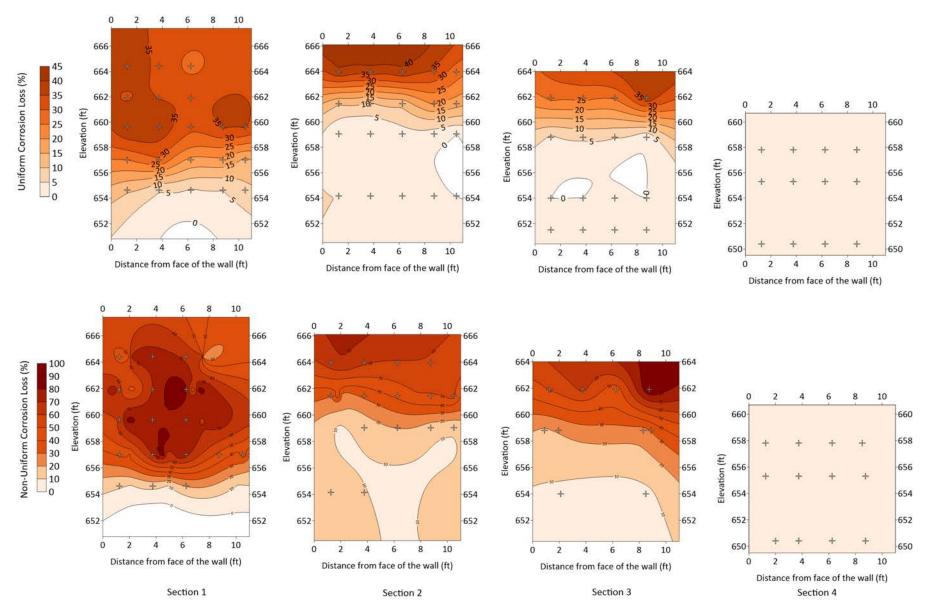
Figure 28. Uniform and nonuniform corrosion loss along the strips for excavation Sections 1 through 4. The "+" sign on the figure represents the sample locations.

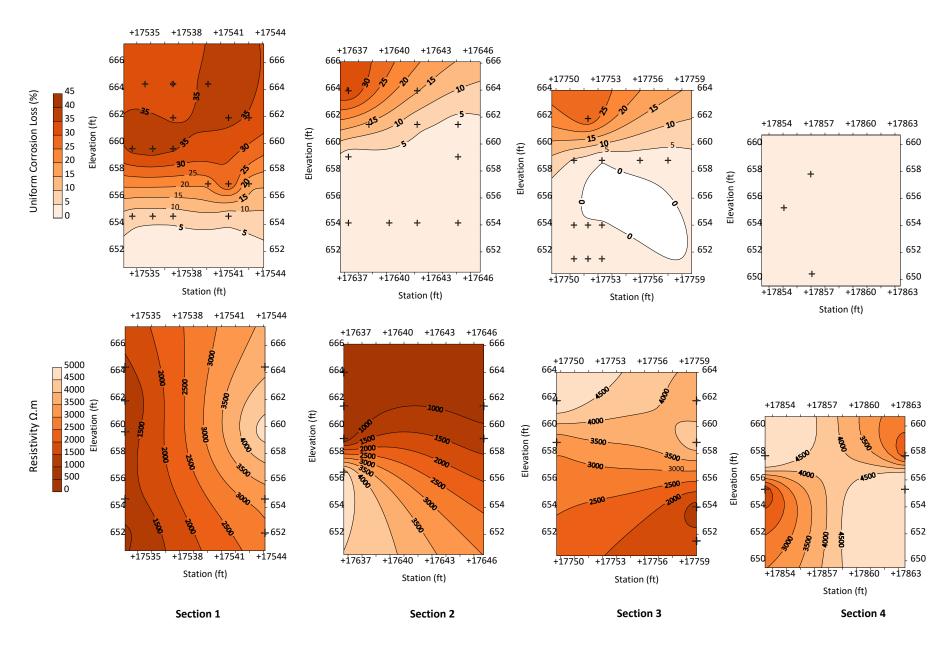
Figure 34. Uniform corrosion loss and minimum resistivity contour plots for excavation sections 1 through 4. The "+" sign on the figure represents the sample locations.

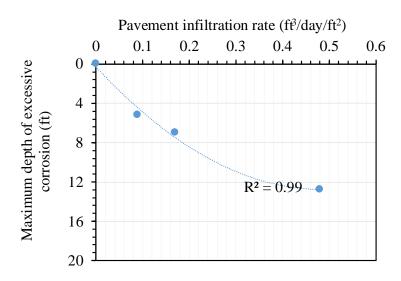
Figure 36. Crack infiltration rate versus the maximum depth of excessive corrosion loss.

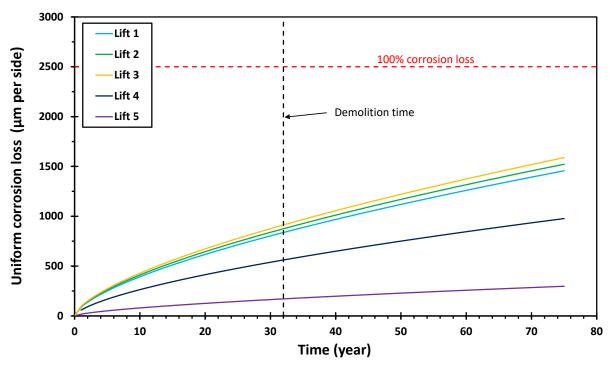
Figure 39. Uniform corrosion loss of reinforcing straps in lifts 1 through 5 of excavation Section 1 over service life of the study MSE wall.

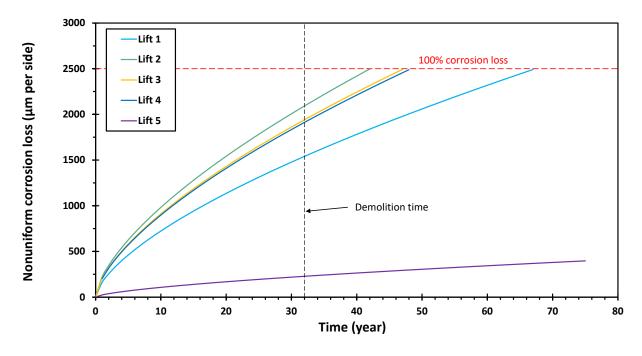
Figure 40. Nonuniform corrosion loss of reinforcing straps in lifts 1 through 5 of excavation Section 1 over service life of the study MSE wall.

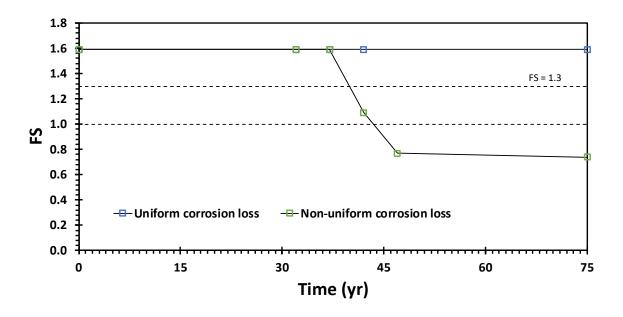
Figure 47 and Table 32 show the factors of safety against overall slope stability for non-uniform corrosion loss models. The slope stability analyses show that the critical slip surface, which initially extends under and beyond the reinforcement strips except for lift 6, shifts toward the MSE wall and intersects with reinforcing straps as the top four strips lose their tensile strength. At 42 years after construction, the critical slip surface transitions into an internal slip surface, intersecting four reinforcing strips and passing through the intersection of the MSE wall facing panels (Figure 46). The factor of safety at this time reduces from 1.59 to 1.09. The FS further decreases to 0.74 when the MSE wall is 47 years post construction. Results indicate the failure of the MSE wall at excavation Section 1 would be likely within 10 to 15 years after its demolition (i.e., 42 to 47 years post construction), if it was still in service (Figure 47).

Figure 46. Critical slip surface after 42 years considering non-uniform corrosion loss.
