WISCONSIN HIGHWAY RESEARCH PROGRAM

1. Report No. 0092-15-02	2. Government Accession No	3. Recipient's Catalog No	
4. Title and Subtitle Evaluation of Performance of Innovative Bridges in Wisconsin		5. Report Date July 2016	6. Performing Organization Code

EVALUATION OF PERFORMANCE OF INNOVATIVE BRIDGES IN WISCONSIN

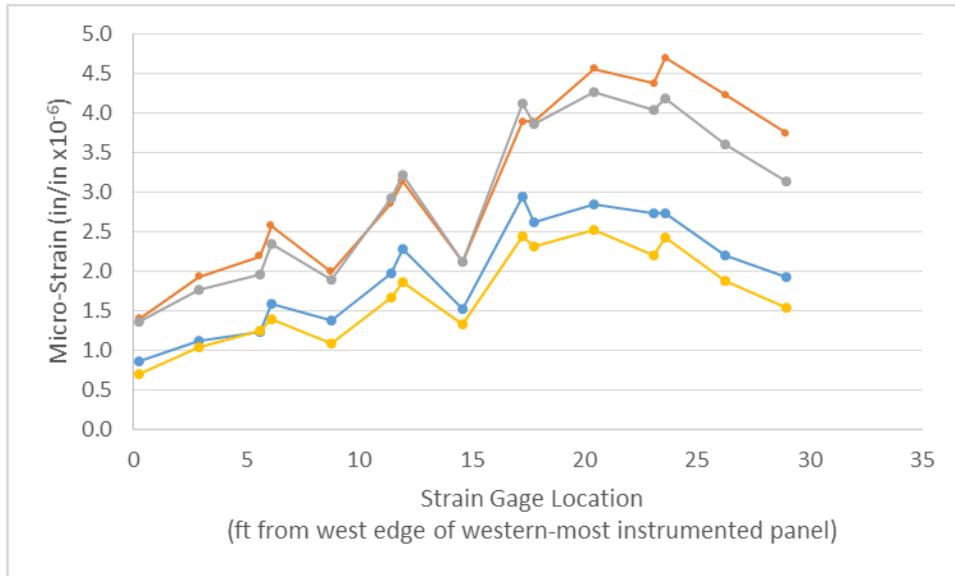
Figure 33. US 41 over Ashwaubenon Creek strain distribution under load

The vehicle events that resulted in the four highest recorded strain values were extracted from the data. A plot, shown in Figure 33, was then created using the strain value of each gage at the point in time when the maximum strain was recorded.

The lines in the plot show the transverse distribution of the four loads. The plot shows the strain gage locations relative to the west edge of the western-most instrumented panel. Each of the cases shown have similar distribution patterns and were likely the result of a heavily loaded vehicle traveling in the eastern-most travel lane. The load distribution does not strictly follow a gradually increasing nor decreasing trend. Nonetheless, the overall trend indicates that the load is being shared amongst multiple panels load sharing among the adjacent panels. In addition to the global distribution of live loads, Figure 33 shows that strains on both sides of the joint were basically identical. This, coupled with the differential deflection data discussed next, indicates that the entire bridge is basically acting as one monolithic unit.

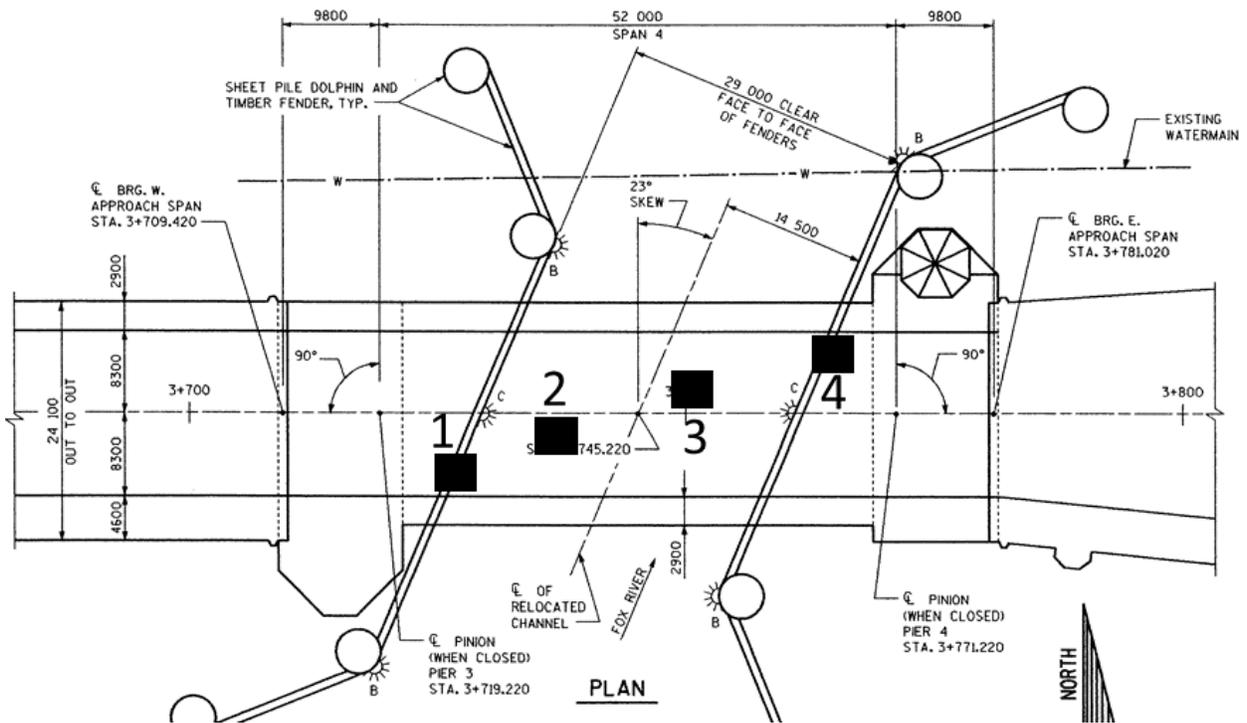
Figure 42. US 141-Main Street over the Fox River crack survey locations

In order to better quantify the amount of deck surface cracking, a detailed crack survey was completed in four areas, each approximately 100 ft². The areas were randomly selected along the length of the bridge, although an area was purposely selected in each of the travel lanes. The approximate locations of the areas selected are indicated and labeled in Figure 42; photographs and crack maps of each area are given in Figure 43 through Figure 46.

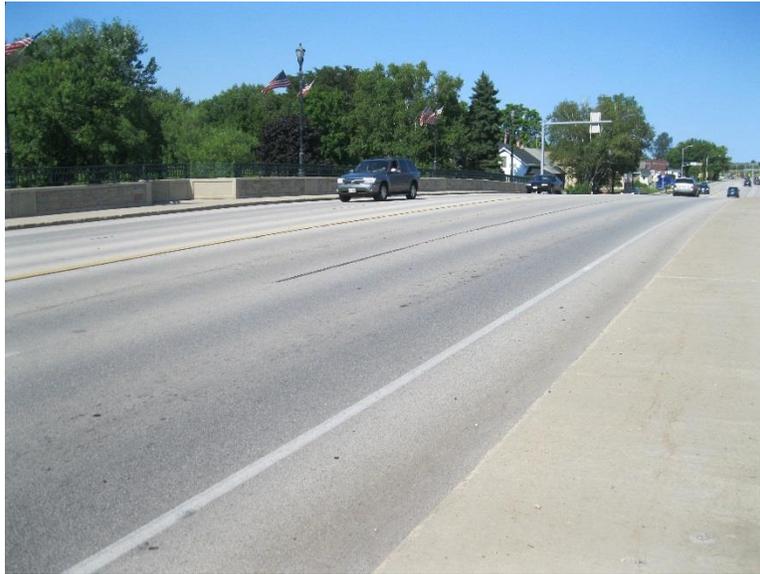
The top surface of the bridge, shown in Figure 125, has been overlaid with asphalt and thus the condition of the concrete surface could not be verified. The overlay was placed in 2006 primarily to seal the deck and secondarily to improve the ride.

Figure 125.STH 33 over the Milwaukee River asphalt overlay

Even so, the asphalt appeared in very good condition and given the condition of the underside of the deck, it is assumed the top surface is also in very good condition.
