# WisDOT Structure Inspection - Field Manual Updates

This module details important information on Field Manual Updates.

STRUCTURE INSPECTION FIELD MANUAL

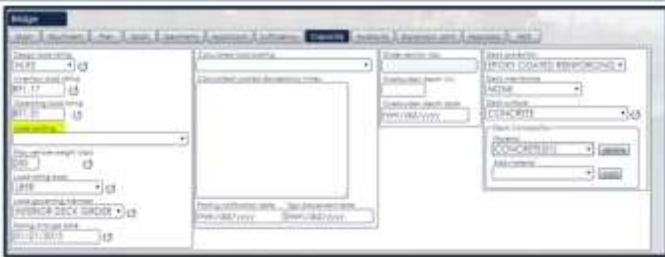
Page 107

**Assessment 9034**

On page 107 The Assessment Signs-Weight Limit Posting 9034 is not used if the bridge is not load posted. In the past some inspectors have coded 9034 when there is no sign present because of the CS 4 language that states sign is absent. This should only be utilized when a load posting is listed under the capacity tab in HSI. [Bring in bottom image when reading this last sentence]

Signs - Weight Limit Posting (9034)	EA	Defines all weight limit posting signs (both near bridge and advanced warning). <b>Do not use if bridge is not load posted.</b>	Sign is present and is in good condition (there may be superficial damage or deterioration).	Sign is present - sign may have some damage or deterioration (slightly bent or fading), but remains readable.	Sign is present, but is deteriorated to the point that replacement or repair should be considered in next inspection cycle.	Sign is absent, or incorrect, or existing sign is damaged or deteriorated to the extent that repair or replacement is required as soon as possible.
-------------------------------------	----	---	--	---	---	---
