## 2019 WisDOT Structure Inspection - Superstructures

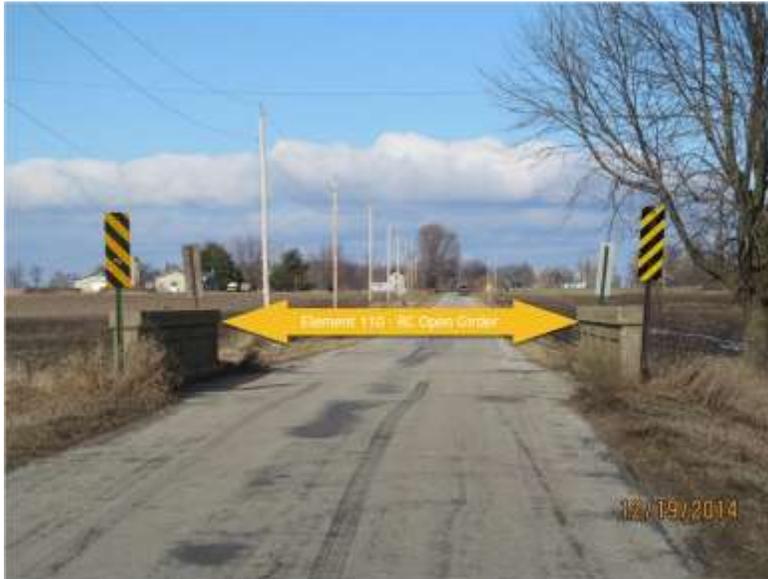
### 1.3 Untitled Slide

*“During the 1920’s and 1930’s, many reinforced concrete deck girder bridges were built throughout the United States. As of 2018, 264 of these structures remain in the Wisconsin bridge inventory.*

*These structures consist of concrete girders both below the deck. The exterior members have the primary function as a girder and a secondary function as a bridge parapets.*

*Because of the dual functions these members serve, they can in theory be inspected under both Girder and Railing elements.*

*However, WisDOT policy is to code these members using Element 110 – Reinforced Concrete Open Girder.”*

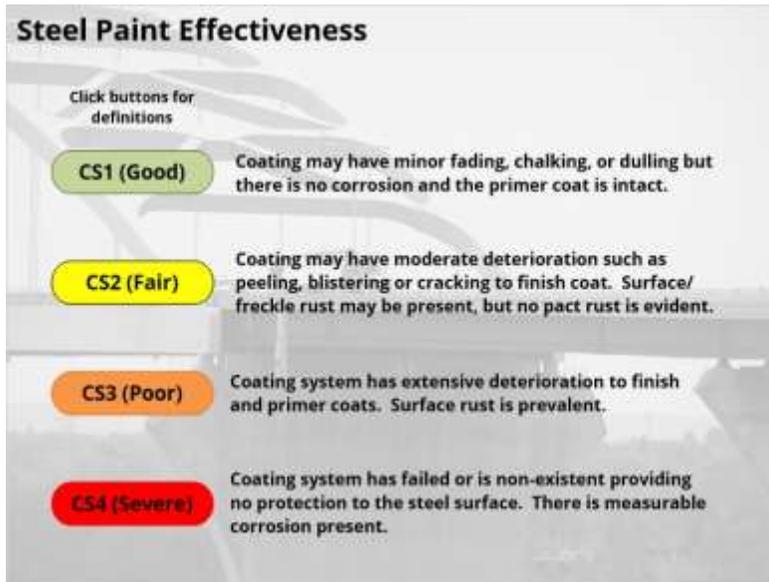
## 1.5 Untitled Slide

*“The effectiveness language used for the inspection of painted surfaces was updated in the 2018 field manual. Basically paint effectiveness can fall into one of four condition states.*

*Good condition, or CS1, defines paint that is fully effective.*

*Fair condition, or CS2, is considered substantially effective with only minor defects present.*

*Poor condition, or CS3, is considered limited effectiveness. The coatings system has extensive deterioration but is still providing some benefits.*

*Severe condition, or CS4, defines paint systems that have failed or are non-existent.”*

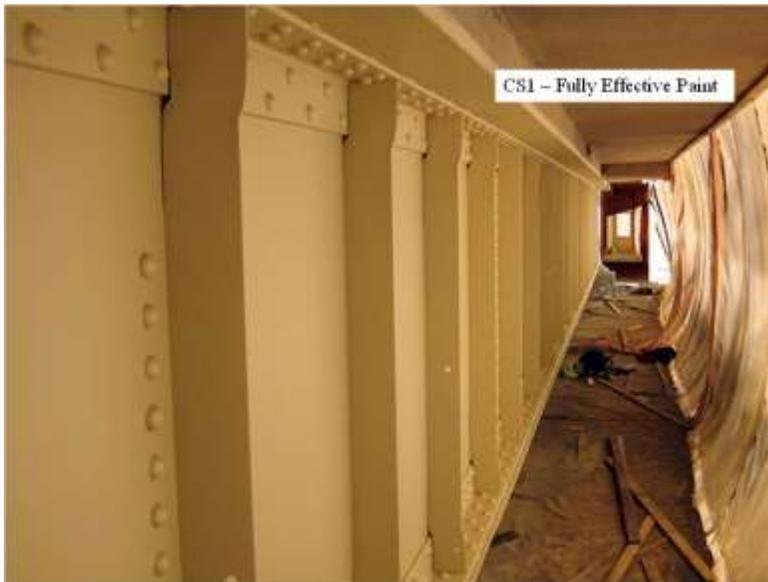
## 1.6 Untitled Slide

*Paint that is in good condition is depicted in this photo. Note that the paint shows no signs of fading nor peeling, and both the finish and primer coats are in excellent condition.*

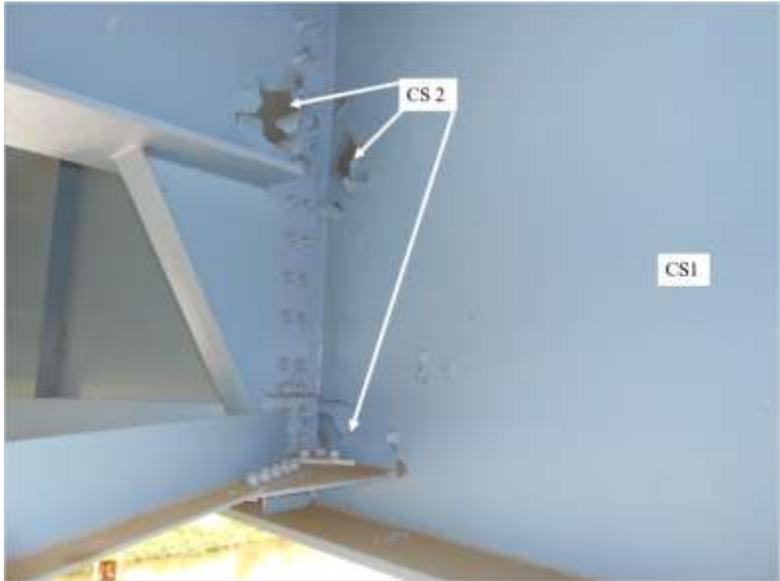
### 1.7 Untitled Slide

*In this example, the paint system is generally in good condition, but has spots where the finish coat is starting to peel away from the still fully-intact primer coat. These isolated areas would be coded in fair condition (CS2) while most of the paint system would still be in Good condition (or CS1).*

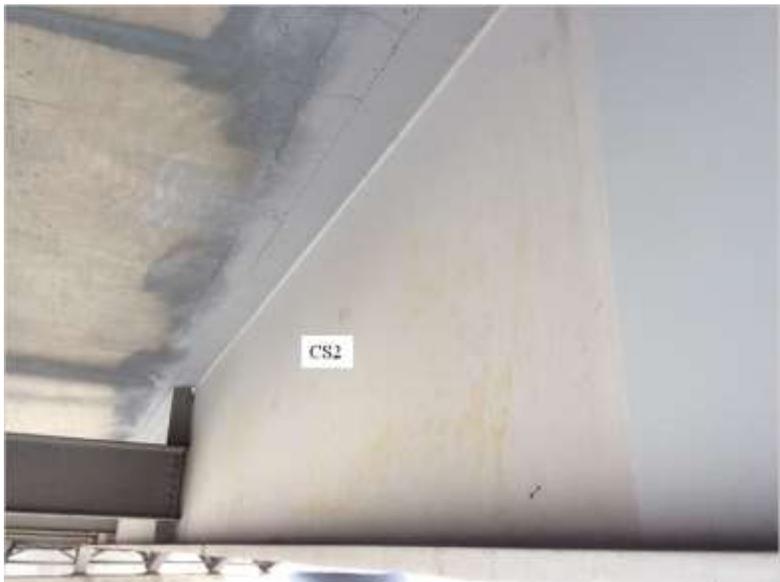
### 1.8 Untitled Slide

*This is another example of the fair condition state (or CS2). As can be seen in the photo, most of the web of this girder has blush rust (or sometimes called freckle rust), but for the most part the paint system is performing its intended function.*

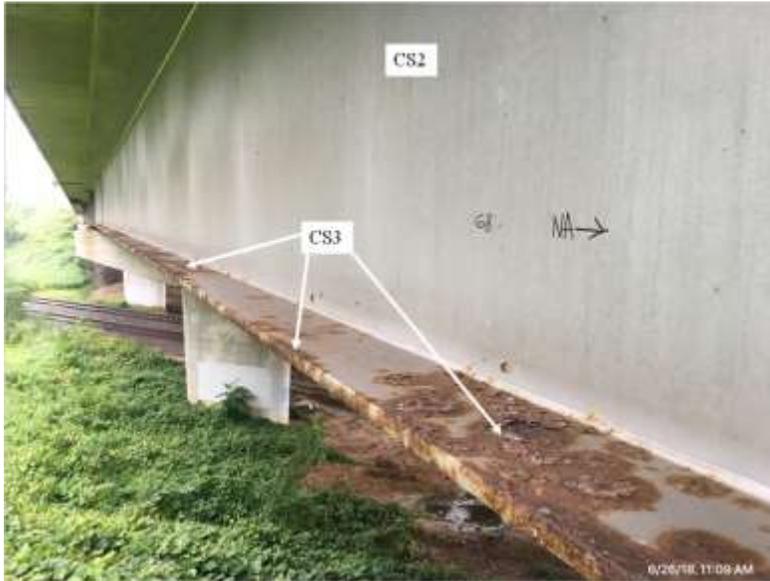
### 1.9 Untitled Slide

A common location for paint deterioration is on the bottom flange. This is due to several factors including the flat flange surface capturing salts, moisture and debris. In addition, on sharp corners such as the edge of flanges, there is potential for the paint to be thinner due to difficulties in application.

As can be seen in the photo, the web is mostly in condition state 2 due to minor deterioration of the finish coat. The flange is in condition state 3 due to extensive deterioration of the finish and primer coats and the moderate amount of areas of surface rust forming.

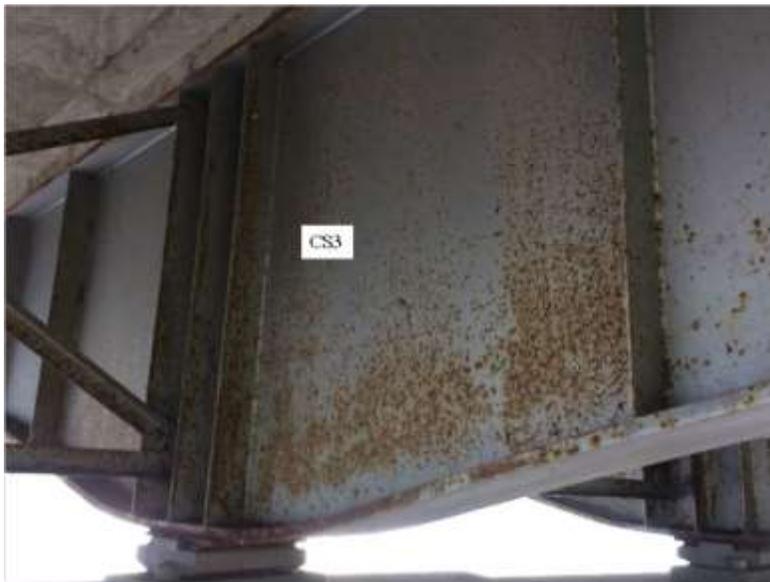
### 1.10 Untitled Slide

This is another example of condition state 3 due to the prevalence of surface rust throughout the girder.

A general rule of thumb to determine when paint goes from CS2 to CS3 is as follows: If the inspector can wipe or scrape rust off the area with a hand or dull putty knife, then the paint is considered to be in at least CS3.

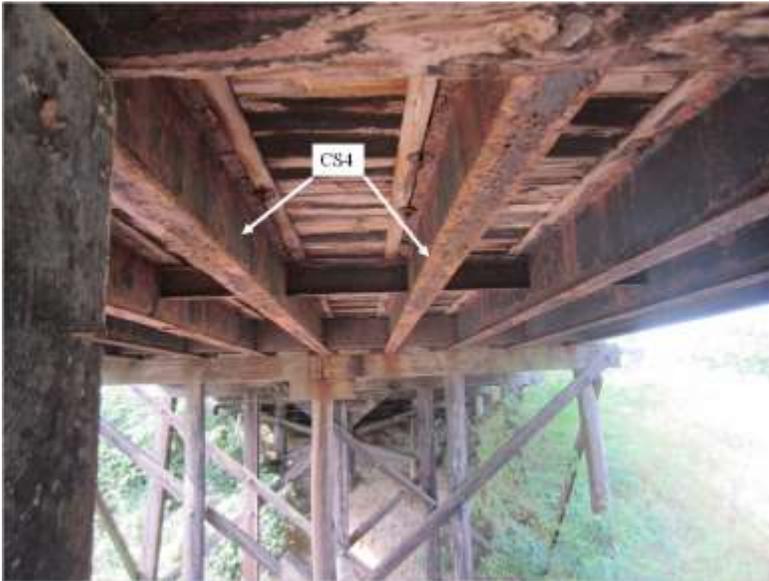
## 1.11 Untitled Slide

*This example shows a failed paint system, or condition state 4.*

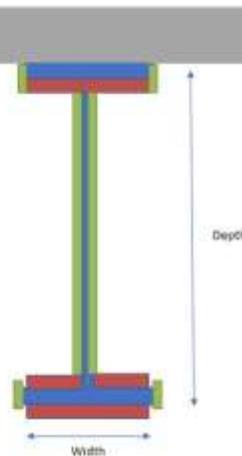
### Paint Quality Estimating Tips

- Girder Paint Surface
  - Width x 3 = flange paint area
  - Depth x 2 = web paint area
- Don't forget secondary members (diaphragms, cross bracing, etc.)
- Example
  - For a 10' deep girder, with 1.5' flange width
    - $A_f = 1.5' \times 3 = 4.5$  square feet
    - $A_w = 10' \times 2 = 20$  square feet
    - $4.5 + 20 = 24.5$  square feet

*A tip on how to quickly estimate the square footage of paint on a girder is as follows.*

*For the flanges, take the width of the bottom flange and multiply it by 3. The 3 represents the three distinct surfaces of the flange that are covered with paint. Note that the top side of the top flange is not included because it is buried in the concrete deck.*

*For the web paint, simply take the depth of the girder and multiply that by 2 to get the paint on both sides of the web*

*Add those numbers together and you have a rough square footage of a one foot section of the girder. Don't forget the secondary members as well; the paint area on those members can add up fast.*

*For example, a 10' deep girder with 1.5' wide flanges would have 4.5 square foot of paint area for the flanges and 20 square foot of paint area for the web, for a total of 24.5 square feet of paint surface per linear foot of girder.*

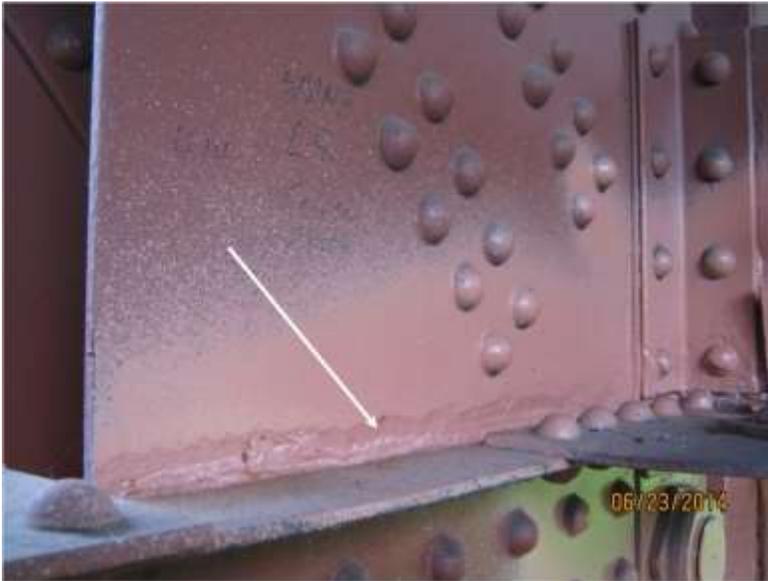
### 1.13 Untitled Slide

*Another important tip to remember is that an element with measurable section loss where the defect is in condition state 3 or 4 for corrosion will still be in that same condition state after it has been repainted. Only the paint effectiveness element will be reverted back to a good condition state. The paint only covers up the section loss; it does not fix it.*

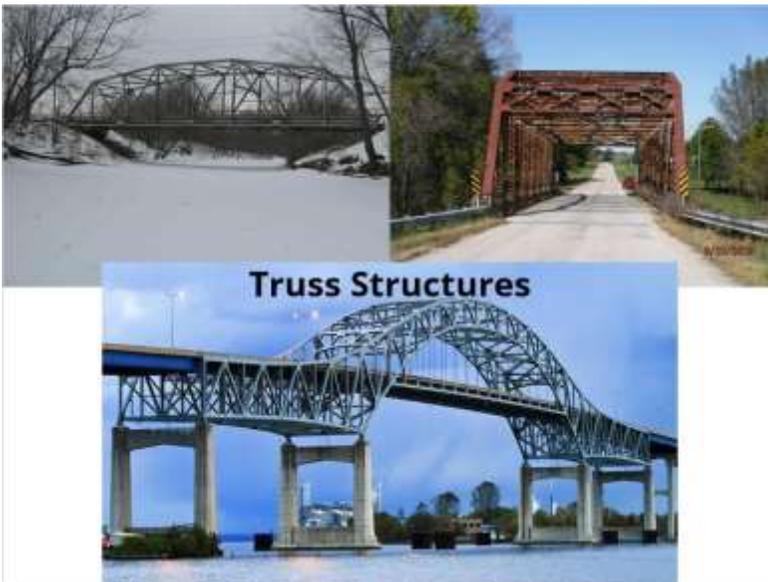
### 1.16 Untitled Slide

Steel truss bridges were commonly built in the early to mid 1900's due to the ability for these structures to span long distances. As advances in technology allowed for steel girders and later prestressed girders allowed for longer and longer spans, the truss structure became mostly obsolete.

As of 2018, only 64 trusses remain in Wisconsin that carry highway traffic.

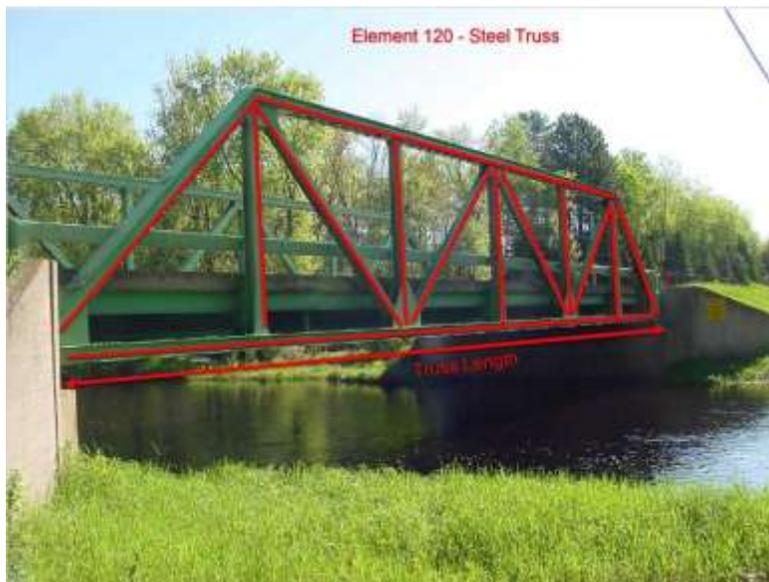
## 1.18 Untitled Slide

Element 120 encompasses all tension and compression members in the plane of the truss as well as secondary gusset plates in the plane of the truss, and the condition is recorded in units of lineal feet.

In general, members should be inspected for corrosion and loss of cross-sectional area, which is the most common steel defect encountered with these structures. They should also be examined for cracking, pack rust, distortion, missing or loose fasteners and other common defects. A more detailed checklist for inspection of these members can be found in Part 2 Chapter 4 of the Wisconsin Structures Inspection Manual.

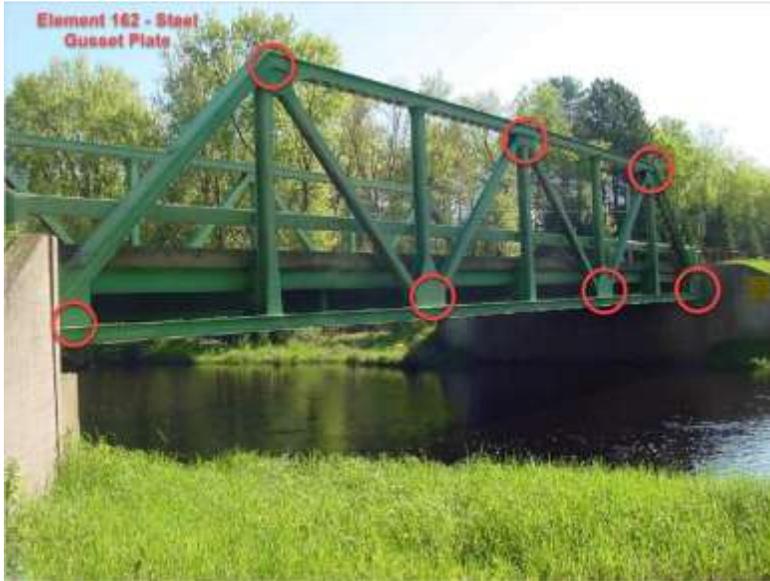
### 1.19 Untitled Slide

Gusset plates are typically used to connect truss members together, most commonly with bolts or rivets. They are constructed of one or more steel plates and are documented in Each units on the inspection form.

Though all connection locations are thoroughly inspected, only gusset plates connecting primary truss members are recorded in Element 162.

For this bridge, the quantity for Element 162 would be 14, consisting of 7 primary gusset plate locations on each of the two trusses.

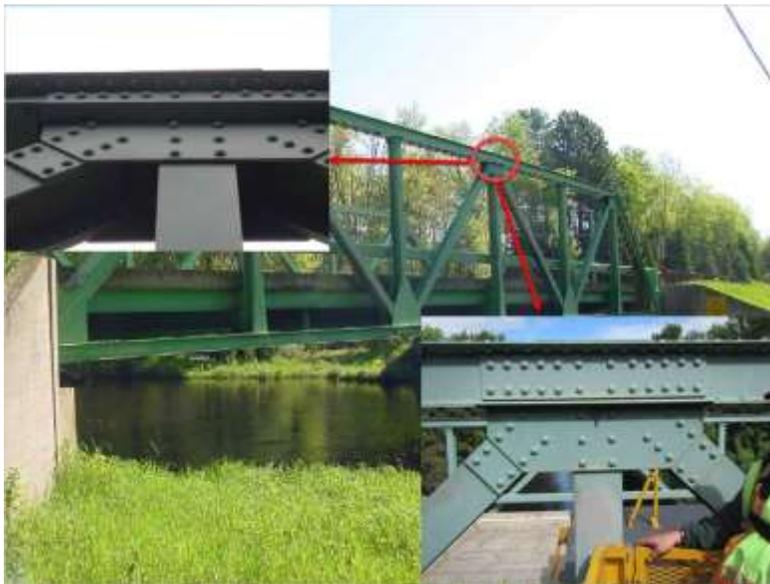
### 1.20 Untitled Slide

Typically a panel point connection consists of two plates, one on the roadside of the truss and one on the exterior of the truss. This assembly is counted as a quantity of one on the inspection report.

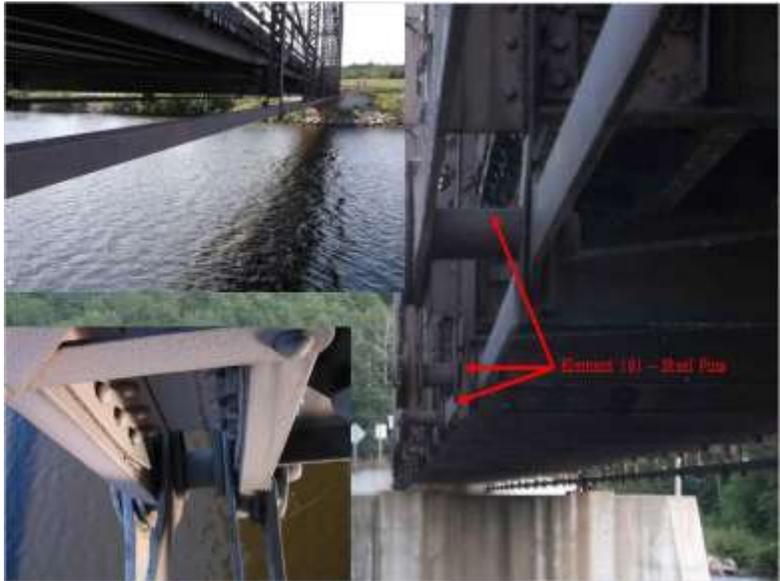
### 1.21 Untitled Slide

One other connection type consists of steel pins connecting eyebar members. For these situations, the gusset plate element is generally not valid. The inspector should code these using Element 161 for Steel Pins.

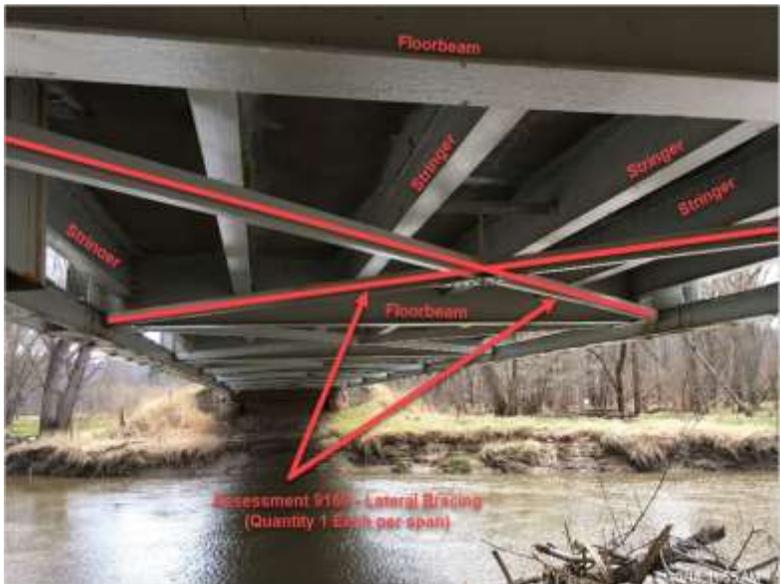
### 1.22 Untitled Slide

Below the truss deck, the primary superstructure components include: Element 152 Steel floor beams and Element 113 – Steel Stringers which are both recorded in lineal feet.

Also included is the Assessment for lower lateral bracing, where the quantity is recorded as 1 each per span.

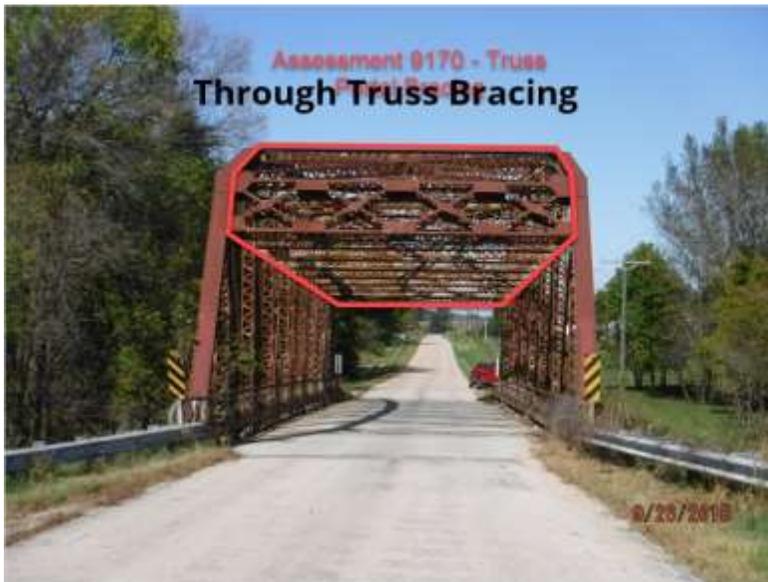
### 1.23 Untitled Slide

For overhead trusses that have bracing members above the roadway, use assessment 9170.

This assessment includes all portal, lateral and sway bracing above the roadway and the quantity is one Each per span.

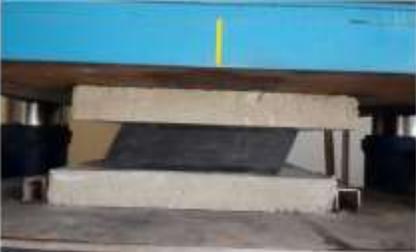
#### Elastomeric Bearings (310)

- Click** Checking for excessive bulging on the sides of the pad. Bulging in excess of about 15 percent of the pad's thickness is a cause for concern.
- Click** Looking for splits or tears in the pad.
- Click** Measure the amount of longitudinal expansion/contraction in expansion bearings. Longitudinal displacement should have an upper limit of about 25 percent of the bearing pad height.
- Click** Checking for any uplift along the bottom edges

Expansion elastomeric bearings made of neoprene rubber and generally are thick rectangular pads that accommodate longitudinal and rotational superstructure movements.

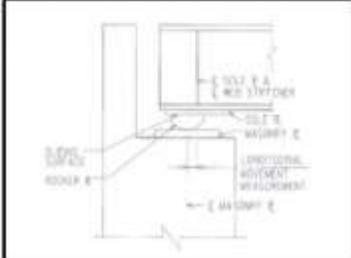
**Movable (311) and Fixed (313) Bearings**

- Look for deteriorated or spalled concrete underneath of the masonry plate
- Check for anchor bolts/nuts which have risen up above the masonry plate, or sound strange when hit with a hammer
- Watch for masonry plates that are walking out from underneath the sliding plate bearings
- Note excessive corrosion and/or pack rust between sliding plates or between the masonry plate and rocker or roller
- Check for any broken keeper bars, retainer angles or pintles
- Record excessive movements of expansion bearing from the masonry plate to the sole plate and record the temperature
- Note excessive wear in the sole plate

The diagram illustrates a cross-section of a movable bearing assembly. It shows a masonry plate (3) supported by a sole plate (1). A rocker (2) is positioned between the sole plate and the masonry plate. A roller (4) is shown in contact with the sole plate. Labels include: SOLE PLATE (1), MASONRY PLATE (3), ROCKER (2), ROLLER (4), and ANCHOR BOLTS (5). Arrows indicate the direction of movement: HORIZONTAL MOVEMENT (RIGHT) and HORIZONTAL MOVEMENT (LEFT).

There are several types of movable steel bearings that are used to support bridge superstructures. These include rollers, rockers, and sliding plates. Movable bearings are designed to accommodate superstructure expansion, contraction, and rotation.

Corrosion is often a problem with movable bearings because they are always used at expansion joints. When these joints leak, water, deicing chemicals, and road debris are allowed to fall directly onto the bearing assemblies.

Check for wear and/or pitting on rubbing surfaces such as the underside of the sole plate, the bottom of the rocker, etc.

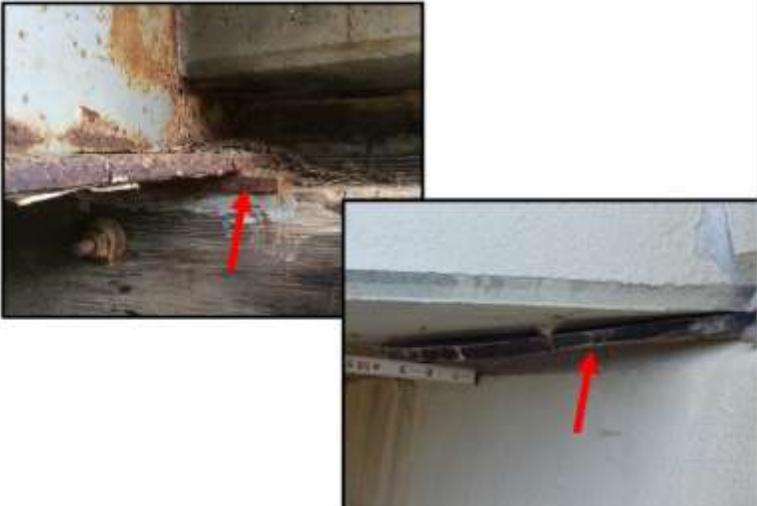
**Thin Plates or Elastomeric Pads**

The top photograph shows a close-up of a girder element resting on a thin, dark, rectangular pad. A red arrow points to the pad. The bottom photograph shows a similar setup from a different angle, with a red arrow pointing to the pad. The pads appear to be made of a soft material, possibly elastomer or a thin steel plate.

Inspectors should be aware there are configurations where the girder rests on a single steel plate or elastomeric pad. These are not to be considered bearings and any defects shall be noted with the girder element.
