# BUREAU OF **STRUCTURES**

## **Fatigue-Prone Detail Inspection Manual**

**March 2025**

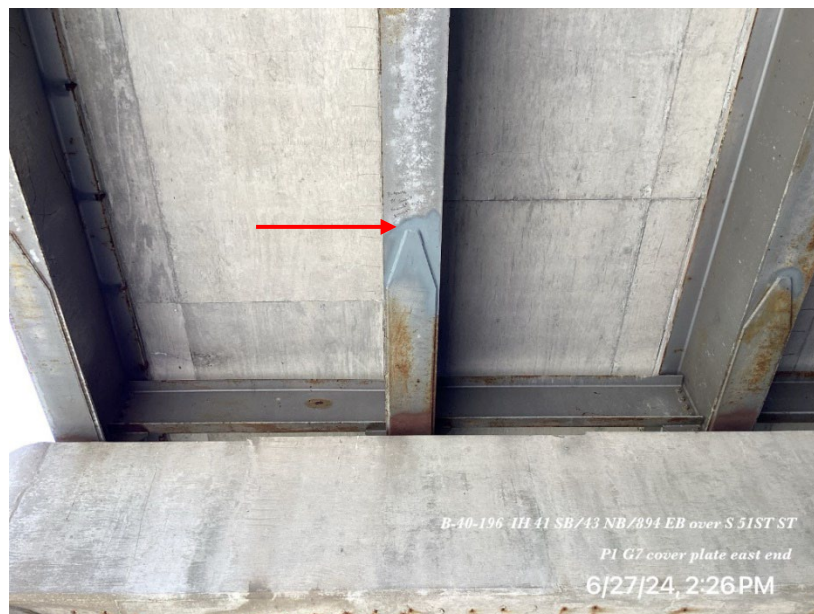
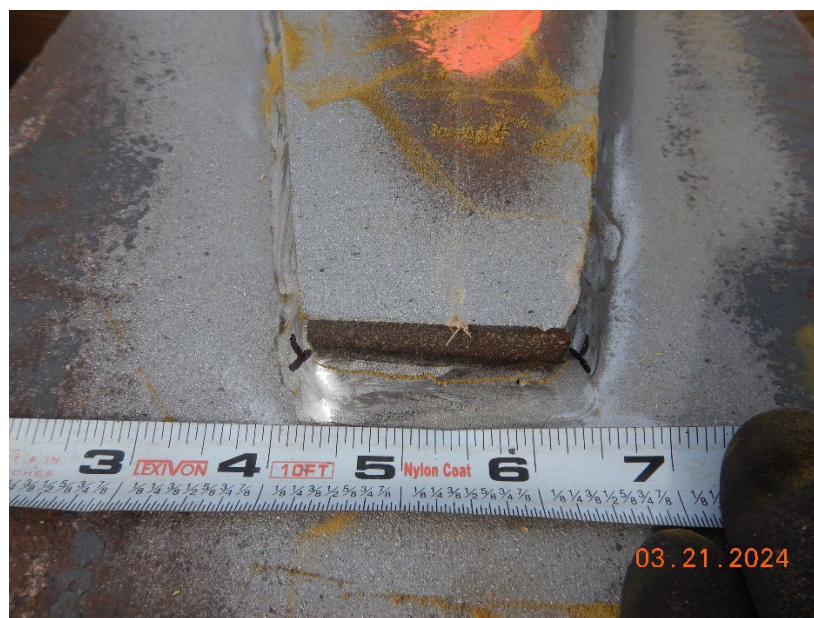
Nature of Crack: Often forms at the toe of the weld at the tip of the coverplate.

Repair Method: Grind out crack. If 1/16" or less in depth, no further action needed. Consider weld peening. If greater than 1/16" used bolted splice or similar.

Photo Location: B-40-196

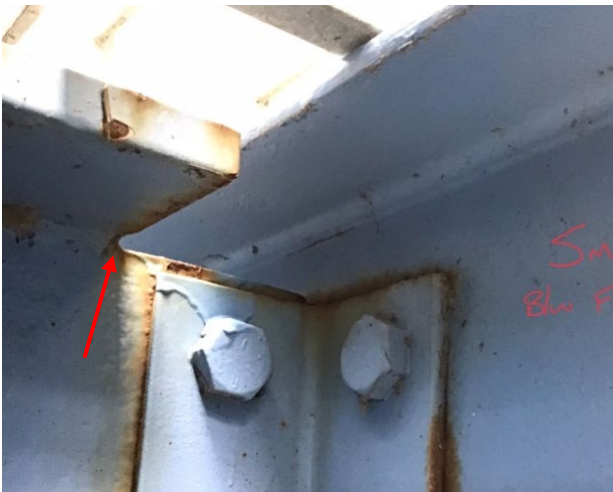
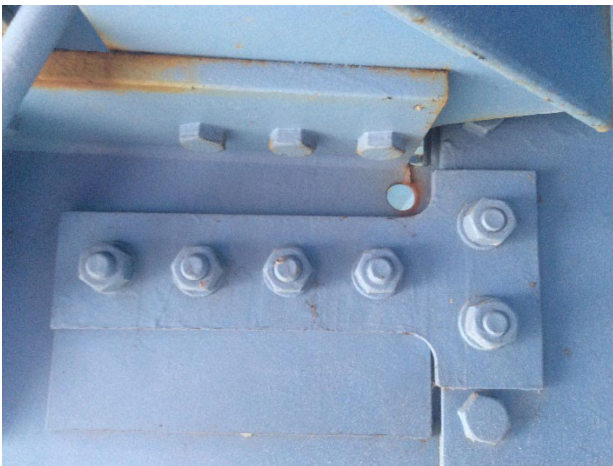
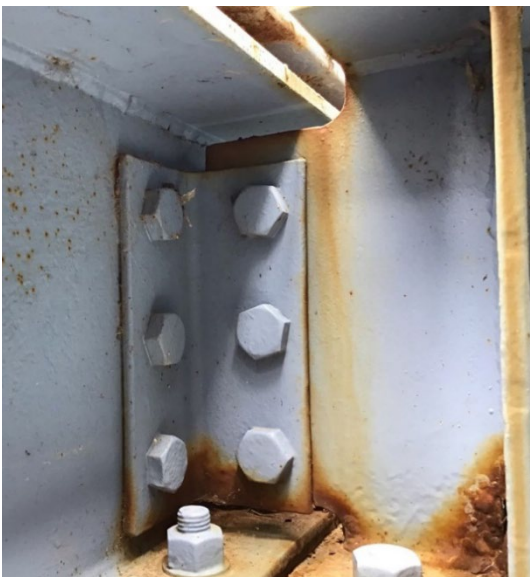
## **2. Reentrant Corners at Cope**

Detail Category: C-E'

Note: If a 1" min. cope is provided, the detail is a Category C, as seen in the 3<sup>rd</sup> photo. Small radii (1<sup>st</sup> photo) or flame cut copes are unclassified but can be less than an E' detail.

Nature of Crack: Emanates out of the cope as shown in the 2<sup>nd</sup> photo.

Repair Method: If the space allows, the initial approach should be to provide a 2" stop hole or provide a 1" cope radius.

Photo Location: B-15-4  
(Bayview Bridge)

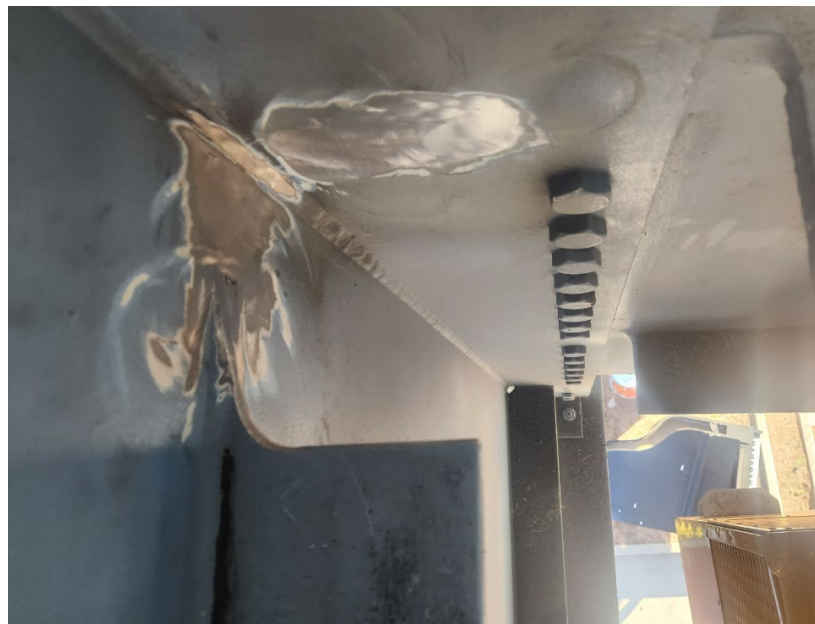
### **3. (continued) Intersecting Welds at Longitudinal Stiffener Plates**

Note: Again, three conditions are needed to be considered a CIF detail. In this example a crack developed between the longitudinal stiffener and the vertical stiffener. This interrupted the flow of stress through the longitudinal stiffener which then had to pass through the web (stress riser). This detail made itself a CIF detail when it cracked, but sometimes the longitudinal stiffener is intentionally not welded to the vertical and there is an abrupt end. The  $\frac{1}{4}$ " gap is an important consideration when this is the case. If it is  $\frac{1}{4}$ " or greater than the risk is low, less than that however is more at risk of CIF, as was the case here.

Repair Method: cut longitudinal stiffener back and provide smooth radius as shown in the 2<sup>nd</sup> photo.

Photo Location: B-40-400 (Hoan)

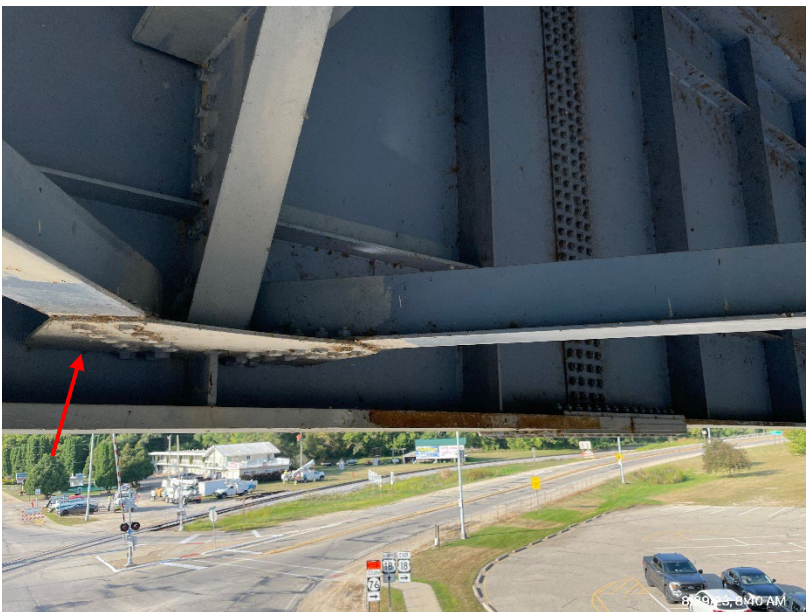
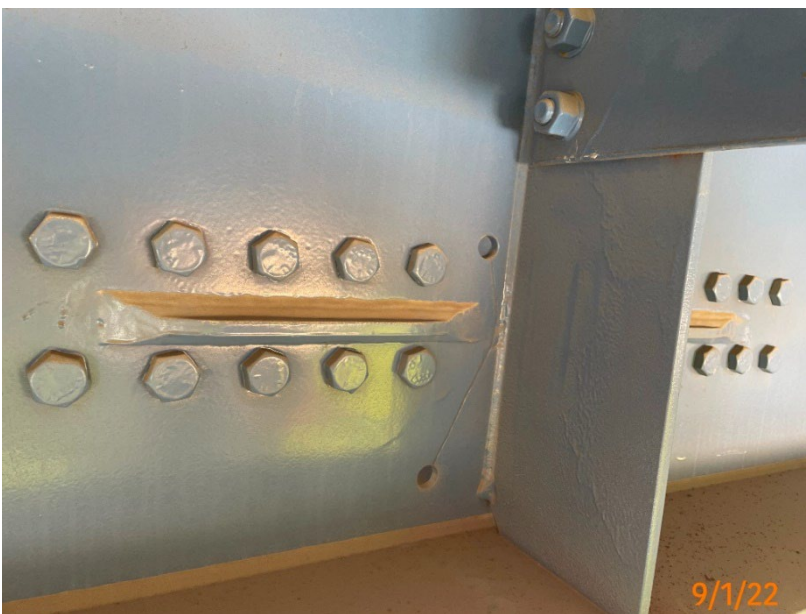
### 4. Shelf Plate (To Web)

Note: Shelf plates are present when there is lateral bracing. They have similar fatigue resistance to longitudinal stiffeners. The detail category is a function of the length of plate, but generally this will be an E or E' detail. Cracks can form in compression zones but will self-arrest. Note that Constraint Induced Fracture can be a concern as well (See next page)

Repair Method: Can drill a minimum 2" diameter hole into the shelf plate providing a radius at the weld tip. Alternatively web isolation holes can be drilled to "catch" a crack (shown in the 2<sup>nd</sup> photo – with shelf plates removed).

Photo Location: 1<sup>st</sup> photo: B-12-27 (Prairie du Chien) / 2<sup>nd</sup> photo: B-40-285 (Valley Bridge)

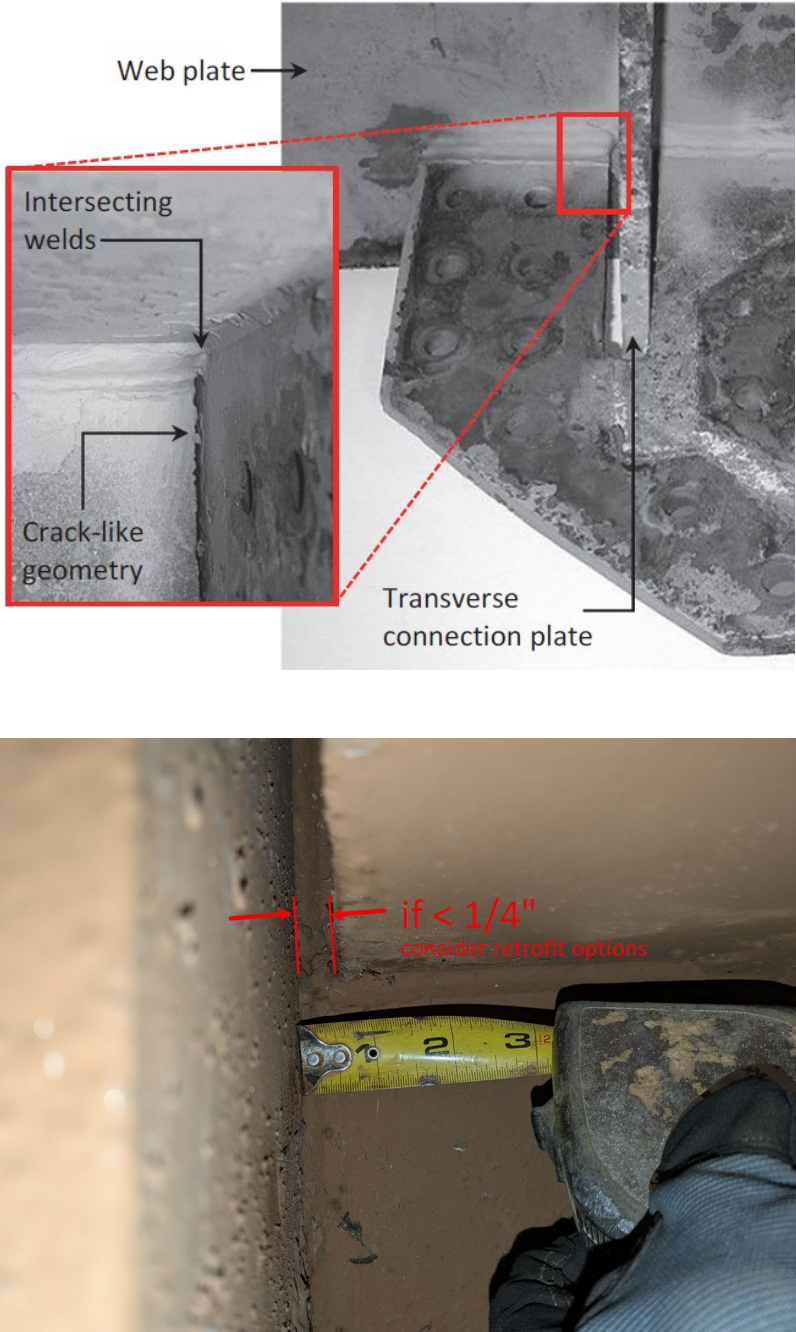
4. (continued) Constraint Induced Fracture Concerns	
Detail Category: n/a

Prevalence: Uncommon	
<p>Note: This detail is often referred to as the “Hoan” detail due to its role in the Hoan fracture in 2000. It is categorized as a Constraint-Induced Fracture or CIF detail. Three aspects are needed to make a CIF detail – 1) welded, 2) presence of crack-like geometry (stress concentration/riser), and 3) Highly constrained material (intersecting welds, or <math>&lt; \frac{1}{4}</math>” gap). Many of these details had been retrofitted after the Hoan, but some may still exist.</p> <p>Nature of Crack: Little to no warning is given with this detail. The presence of such detail does not mean the structure is unsafe, in fact many CIF details have performed satisfactorily over the life of many structures. However, knowledge of its presence can be used as part of a risk assessment of the structure and whether a retrofit strategy should be employed.</p> <p>Repair Method: Several well documented retrofits are available.</p> <p>Photo Location: B-40-400 (Hoan) *these were retrofitted following the 2000 event*</p>

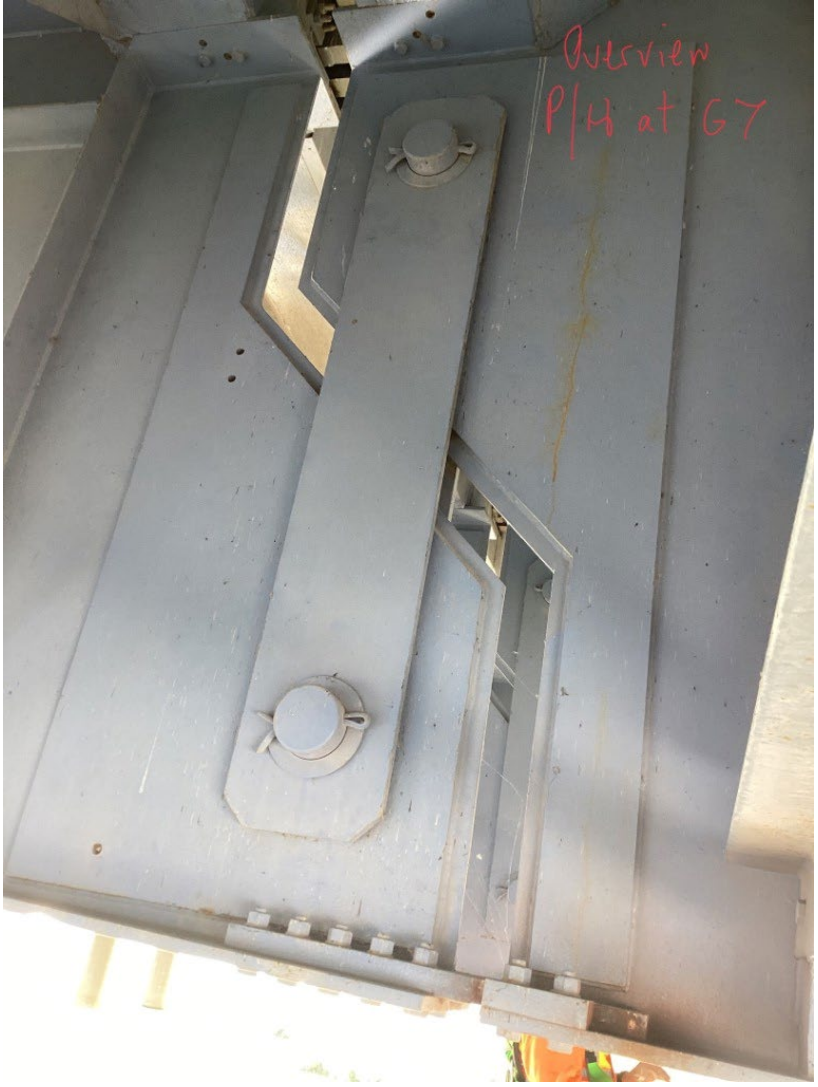
6. Pin and Hanger	
Detail Category: E

Prevalence: Common	
<p>Note: A common detail used in steel bridge construction until the early 1980's. Lack of redundancy is the primary concern with this detail as highlighted by the 1983 Mianus River Bridge collapse. 2-girder (NSTM) bridges that have this detail are most at risk.</p> <p>Nature of Crack: cracks are an unlikely cause of pin and hanger failure. More often, corrosion and/or seizing up of the pin are to blame for failure.</p> <p>Repair Method: Replacement</p> <p>Photo Location: B-5-158 (Leo Frigo)</p>

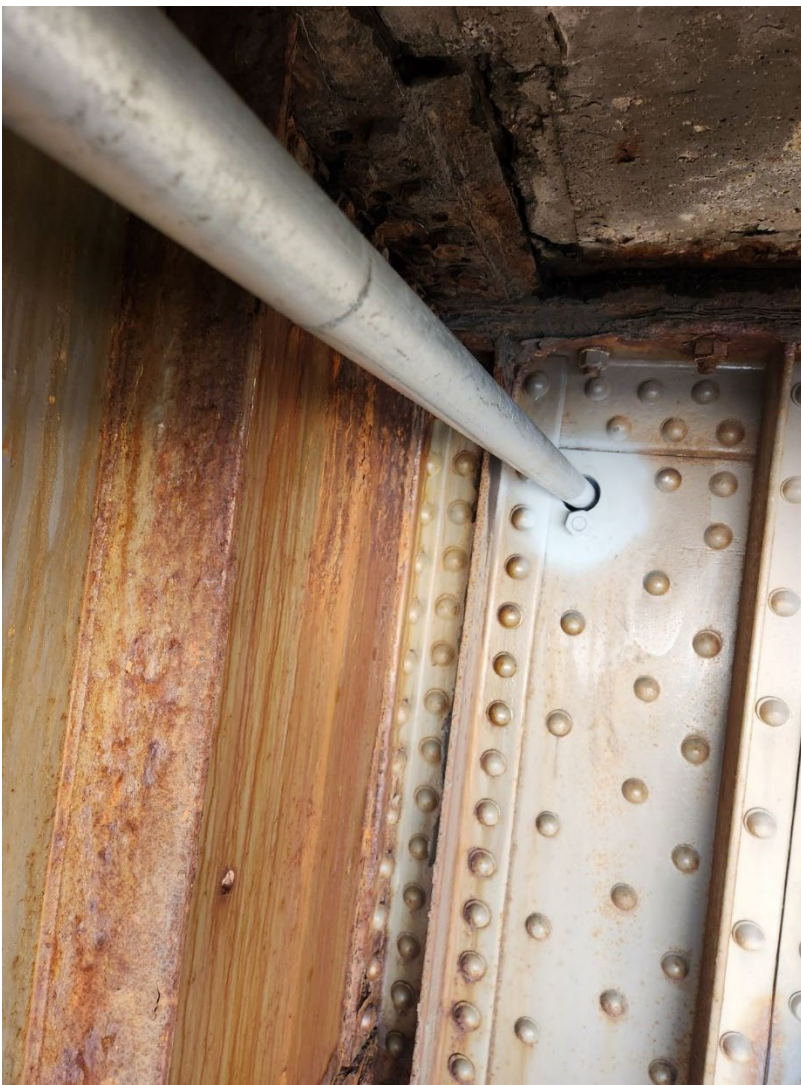
### 7. Open Holes

Note: Open holes are a Category D detail per AASHTO. However, research supports that holes that have a minimum radius of 1" and have a smooth surface will perform as a Category C.

Nature of Crack: emanating out of hole

Repair Method: enlarge hole and/or improve surface smoothness.

Photo Location: B-40-550

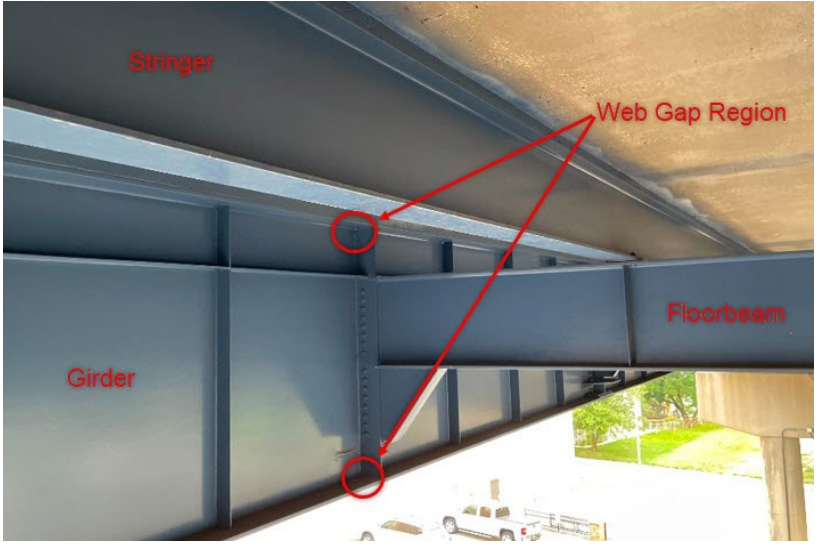
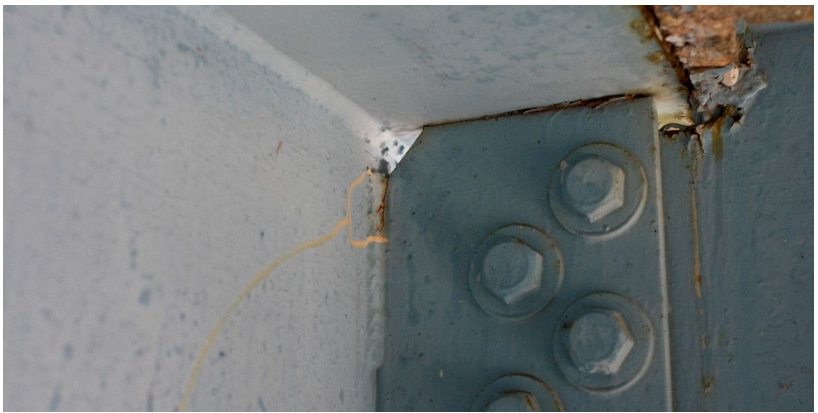
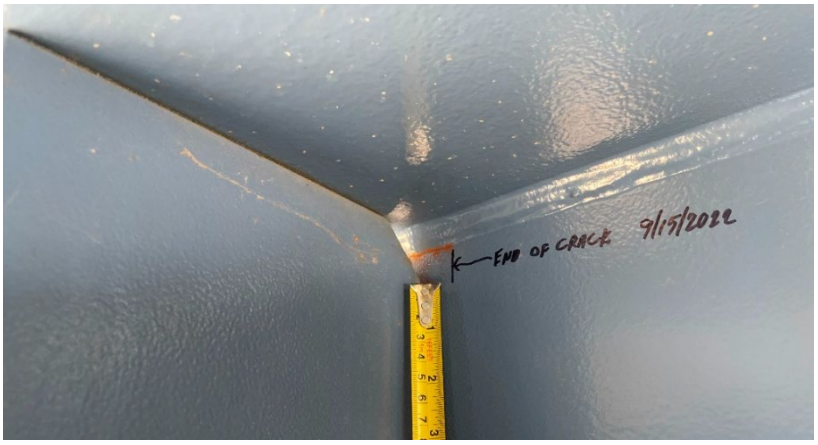
8. Connection Plate Web Gap	
Detail Category: n/a

Prevalence: Common	
<p>Note: This is type of fatigue cracking is distortion induced. It is common with floorbeams or other primary transverse members that frame into the longitudinal members. It can occur with cross frames but that is rare.</p> <p>Nature of Crack: The crack typically forms in one of two ways (sometimes both are present). The first is a longitudinal crack that forms along the flange-to-web weld toe. The second is in the shape of a frown, starting at the tip of the vertical weld and running down both sides of the connection plate.</p> <p>Repair Method: Various</p> <p>Photo Location: B-40-285 (Valley Bridge)</p>

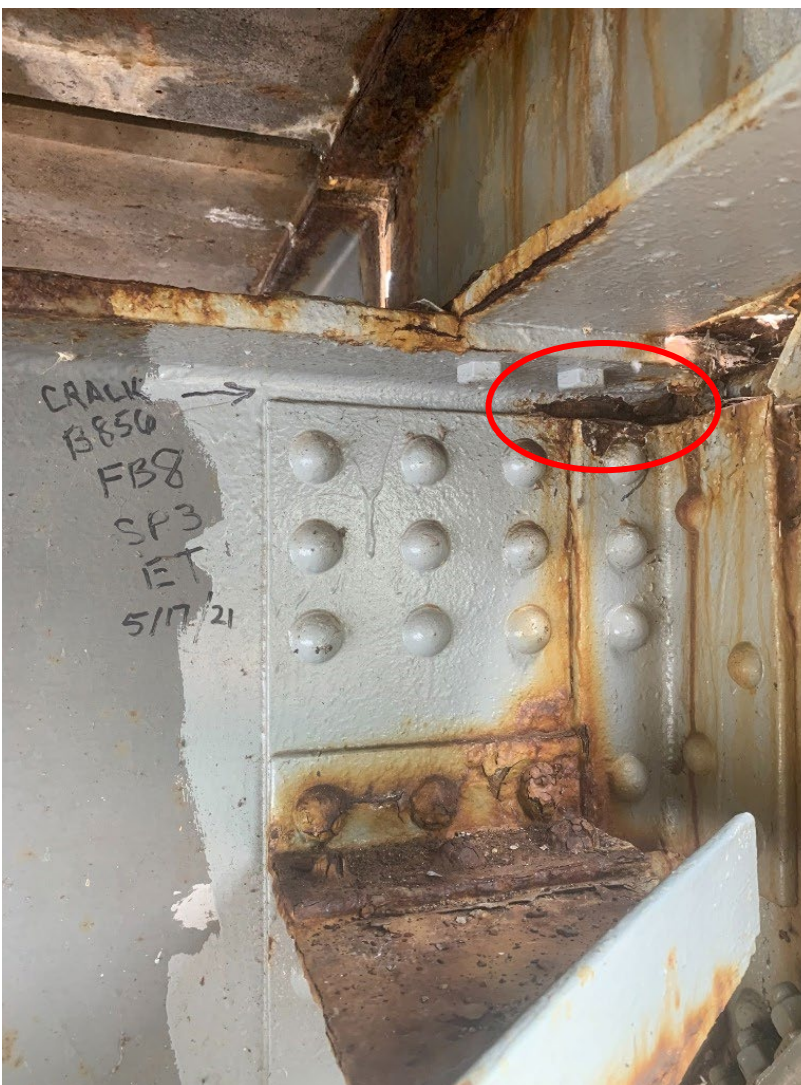
### 9. Floorbeam Web Gap

Note: Predominantly this occurs in floorbeams attached to trusses or tied-arches, typically those nearest the supports. Differential longitudinal displacements between the deck and truss/tie cause the top flange of the floorbeam to move out-of-plane relative to the web which is fixed to the primary member.

Nature of Crack: The crack is horizontal near the top flange-to-web interface. It begins at the connection to the primary member and works its way inward.

Repair Method: Drill a large diameter hole at the tip of the crack. Cracks may reinitiate on the other side of the hole depending on the configuration. In that case, cutting the floorbeam flange back to increase flexibility may be a viable option.

Photo Location: B-52-856  
(Lone Rock Truss)

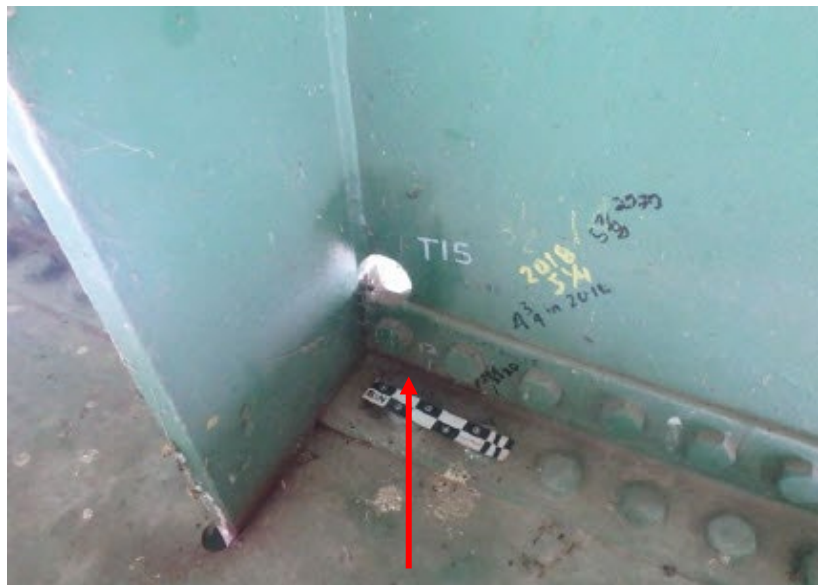
### 10. Riveted and Bolted Connections Using Angles

Note: The use of angles to connect members together is very common. These connections are normally designed as “simple” connections, when in reality they do provide a certain amount of rotational stiffness. For certain configurations this can impart significant secondary forces and prying action to the angle.

Nature of Crack: cracks initiate along the angle fillet or near the edge of the fastener.

Repair Method: Varies – generally softening the connection or removing secondary members if not needed.

Photo Location: B-22-61  
(USH 151 over Mississippi River)

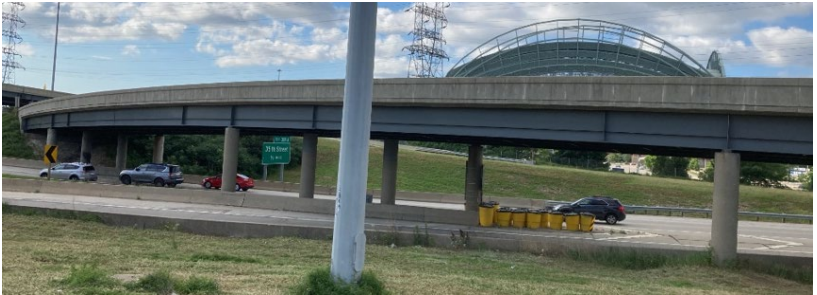
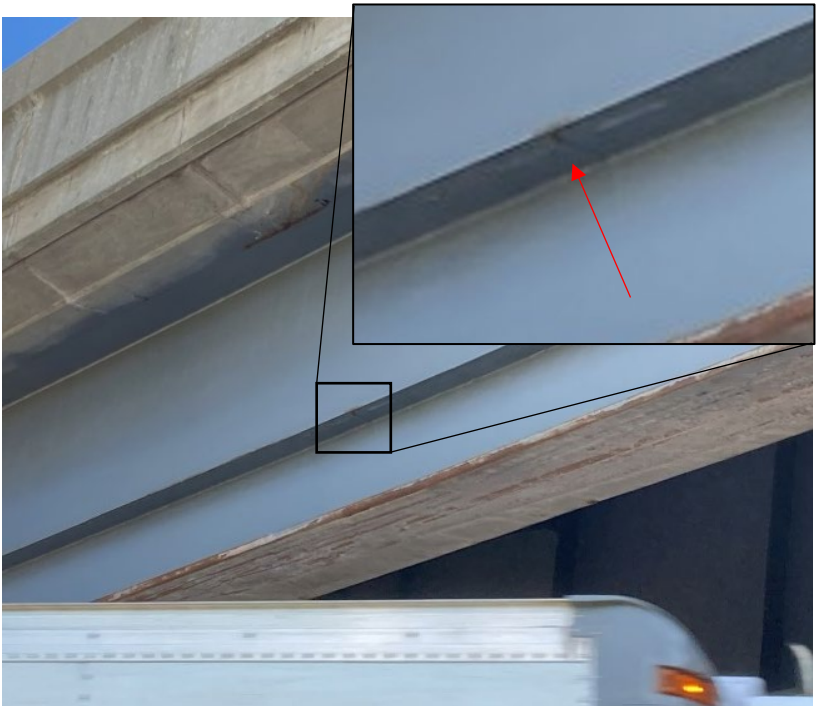
### **12. Transverse Butt Welds**

Note: Full penetration welds, or butt welds, have been widely used since the 1940s. However, the quality of these welds from the 1940s and 1950s tended to be poorly executed with little or no inspection. Problem areas are web insert plates for haunched girders, flange and web splices, groove-welded cover plates, and continuous groove-welded longitudinal stiffeners. Note that Constraint Induced Fracture can be a concern (See detail #3).

Nature of Crack: cracks begin at the weld toe and grow perpendicular to the direction of primary stress.

Photo Location: B-40-39  
(Stadium Interchange)

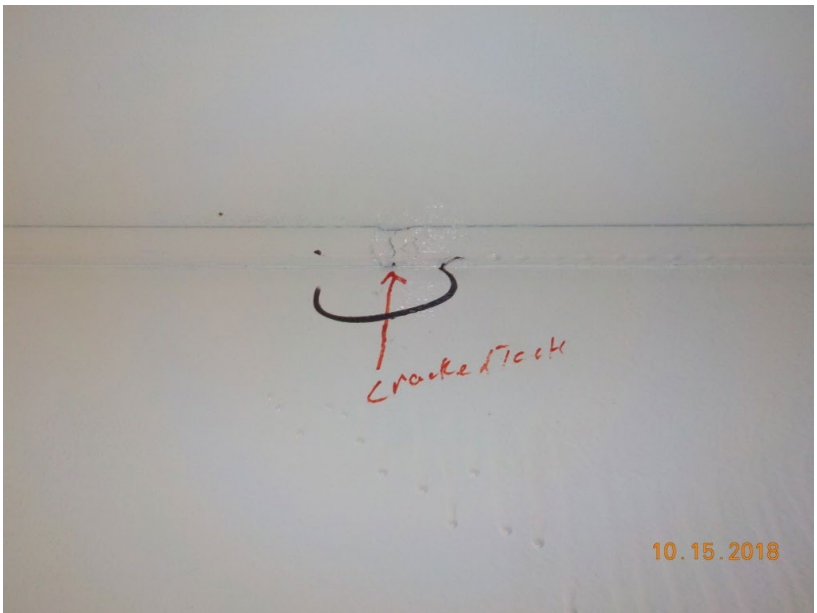
13. Discontinuous Backing Bars	
Detail Category: n/a

Prevalence: Uncommon	
<p>Note: Particularly with older structures, long runs of backing bar were made of multiple bars that were not always welded together, or it was of poor weld quality, as seen in the 1<sup>st</sup> photo. Because they fuse to the welded joint, they become a structural member. The abrupt ends introduce a crack-like condition.</p> <p>Nature of Crack: crack will form along the discontinuity potentially extending into the base metal. Discontinuities in tension zones or stress reversals are of most concern.</p> <p>Repair Method: Provide a transition similar to what is shown in the 2<sup>nd</sup> photo.</p> <p>Photo Location: B-40-400 (Hoan)</p>

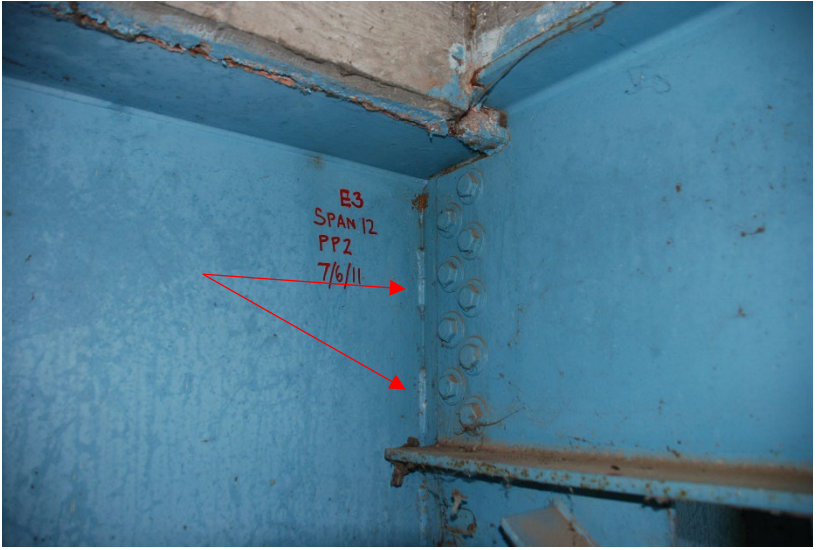
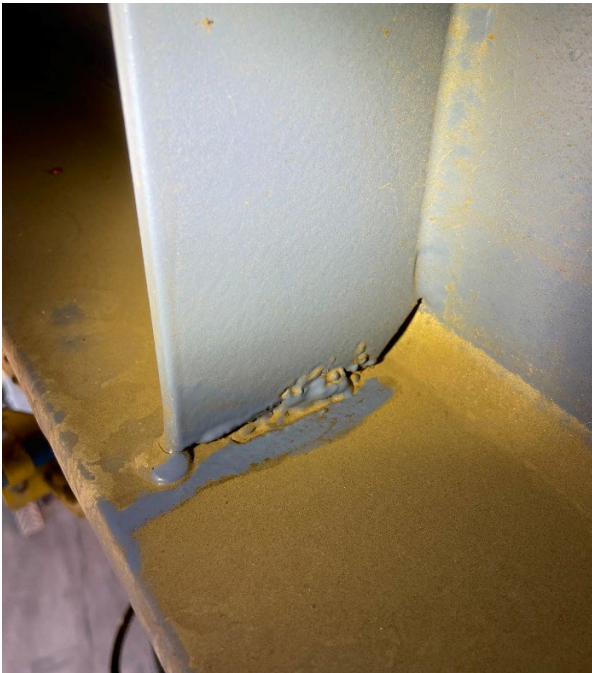
14. Intermittent/Tack Welds or Other Poor-Quality Welds	
Detail Category: n/a

Prevalence: Uncommon	
<p>Note: Generally, cracks in tack welds are uncommon and when they do, they are usually benign, but in rare cases they can crack into the base metal which becomes a concern.</p> <p>Poor-welds, as shown in the 2<sup>nd</sup> photo, can introduce stress risers which can result in fatigue cracking.</p> <p>Nature of Crack: Various</p> <p>Repair Method: Various – depending on the nature of the weld</p> <p>Photo Location: 1<sup>st</sup> photo: B-11-22 (Wisconsin River Bridges) / 2<sup>nd</sup> photo: B-40-285 (Valley Bridge)</p>
