# WisDOT Structure Inspection Manual    Part 4 – Ancillary Structures

## Chapter 4 – Retaining Walls

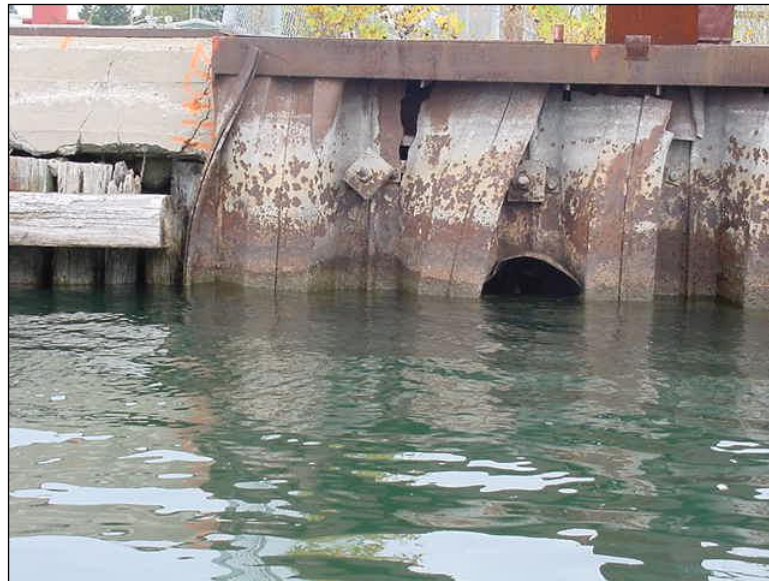
Impact damage is typically confined to an area directly adjacent to the point of contact and is characterized by distortion or crushing of the construction material at the point of contact with cracking, splitting, or splintering radiating from this point. Refer to Figure for a view of an impacted dockwall.

Figure 4.4.2-1: Impact Damage to a Steel Sheet Pile Dockwall.

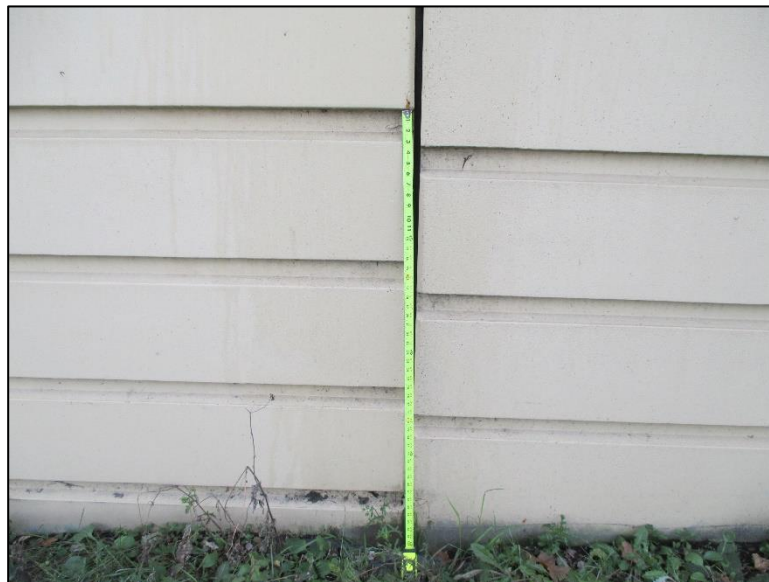
Figure 4.4.2-8: View of Differential Settlement between Precast Concrete Panels. Note Misalignment in Rustication.

opening of joints or cause wall cracking or transverse tipping. Refer to Figure 4.4.2-7, Figure 4.4.2-8 and Figure 4.4.2-9 for a diagram and view of differential settlement under a retaining wall.

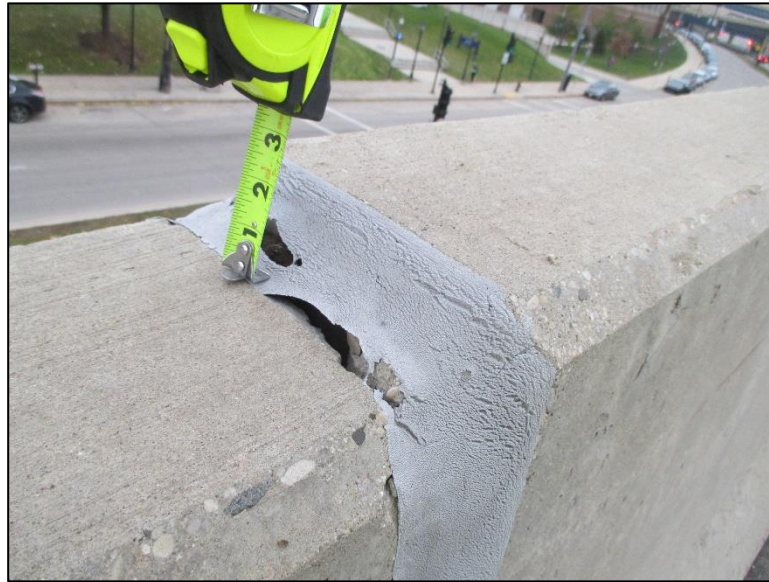
Figure 4.4.2-9: Settlement as Seen from Bridge Rail at Top of Wall.  
Note, Settlement was Reflected in Adjacent HMA Pavement.

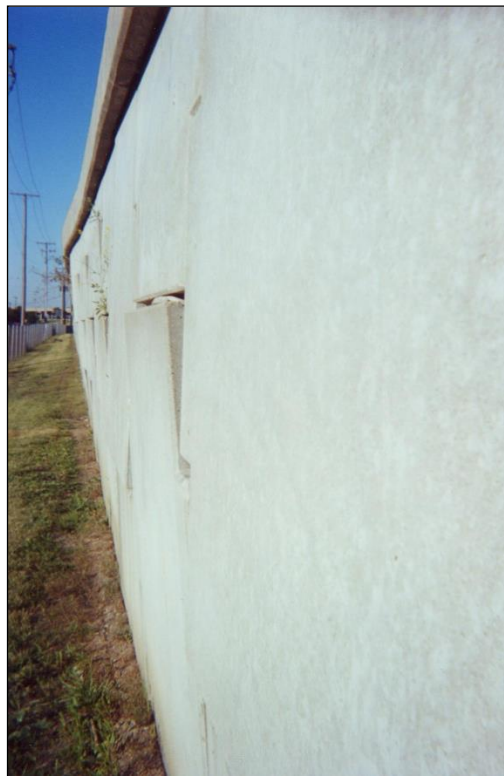
Figure 4.4.2-11: Lateral Movement of an Individual Panel of a MSE Wall.

The most common causes of lateral movement are slope failures (deep shear failures); seepage; changes in soil characteristics (e.g., frost action and ice); and consolidation of the original soil. Deep shear failures occur along a cylindrical surface when there is a weak layer of soil under the wall at a depth of approximately 1.5 times the width of the base of the wall. Refer to Figure 4.4.2-10 for a diagram depicting lateral movement of a wall due to deep shear failure. Refer to Figure 4.4.2-11 for a view of a mechanically stabilized earth (MSE) wall with extensive lateral movement.

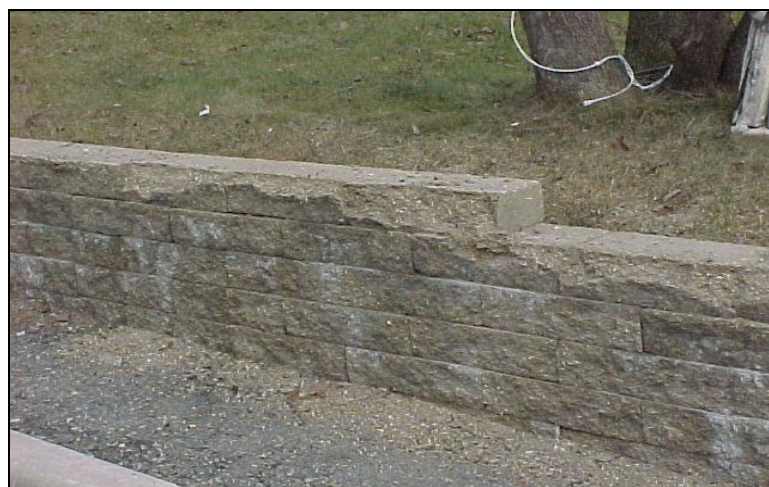
- **Efflorescence:** Efflorescence, informally referred to as leaching, is a white deposit on the concrete surface caused by the crystallization of soluble salts (calcium chloride, calcium hydroxide) contained within the cement paste. Water traveling through the concrete dissolves these salts and usually deposits them along cracks where the water exits. Efflorescence indicates that water and dissolved chemicals are able to pass through and contaminate the concrete. This is primarily an aesthetic problem, but can serve as evidence of increased block porosity and weakness in extreme cases. Refer to Figure 4.4.2-16 for a view of efflorescence.

Figure 4.4.2-16: White Precipitate Formed due to Efflorescence.

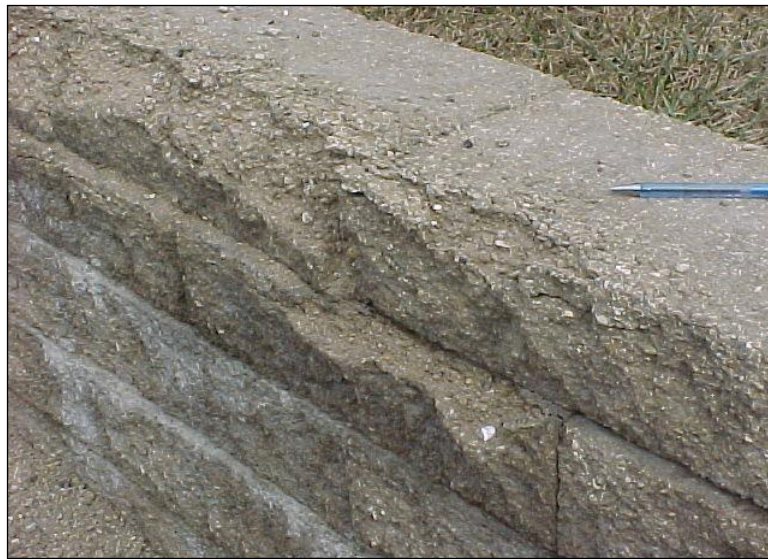
- **Fraying/Spalling (Block Edges):** Fraying or spalling is the presence of minor chipping along block edges and corners. Occasionally fraying or spalling will be the result of improper handling and placement during construction. Other causes include thermal expansion, or the placement of blocks on uneven surfaces. The presence of a large number of spalls in the same place on each block may indicate a problem in manufacturing. Refer to Figure 4.4.2-17 for a view of spalling and fraying along the block edges.

Figure 4.4.2-17: Spalling and Fraying on the Top Edge of the Block.

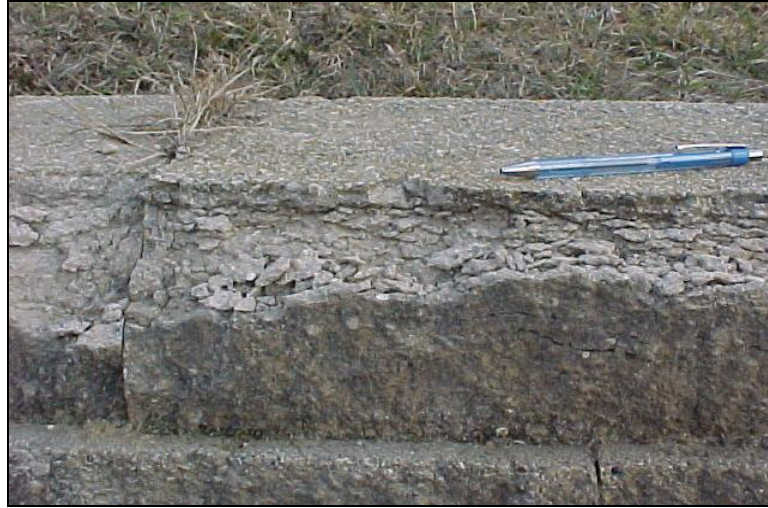
- **Freeze-Thaw Damage:** This is the progressive internal deterioration of saturated block material in the presence of freezing and thawing temperatures. The expansion of water during freezing periods can produce significant internal damage. Resulting defects will appear as areas of crumbling or general deterioration. This type of damage is most often found in areas that are frequently saturated and exposed to freezing conditions. Note if this type of damage is occurring on a vertical or horizontal surface. Refer to Figure 4.4.2-18 for a view of typical freeze-thaw damage.

Figure 4.4.2-18: Freeze-Thaw Damage at a Corner.

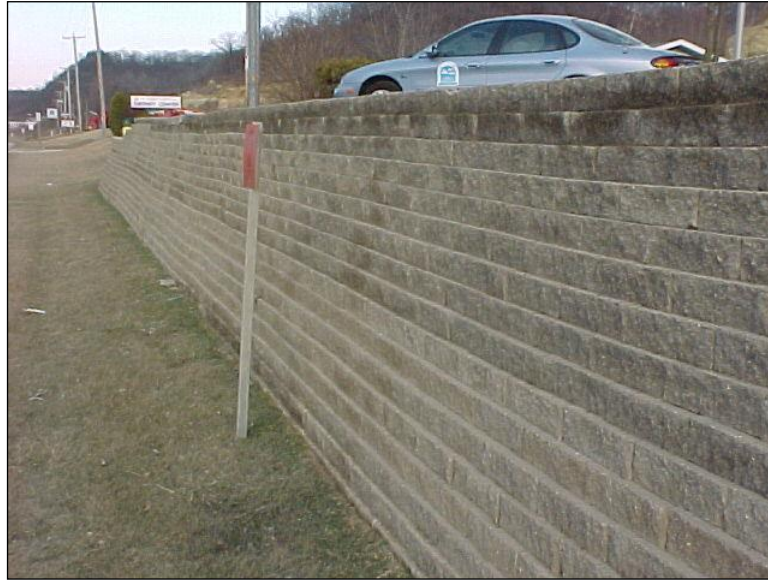
- **Staining:** This is the discoloration of block units caused by exposure to elements such as surface runoff containing dark clays or organic material, deicing chemicals, mold growth, moss, and other sources. Refer to Figure 4.4.2-19 for a view of staining.

Figure 4.4.2-19: Typical Staining Evidenced by the Brown Discoloration of the Blocks.

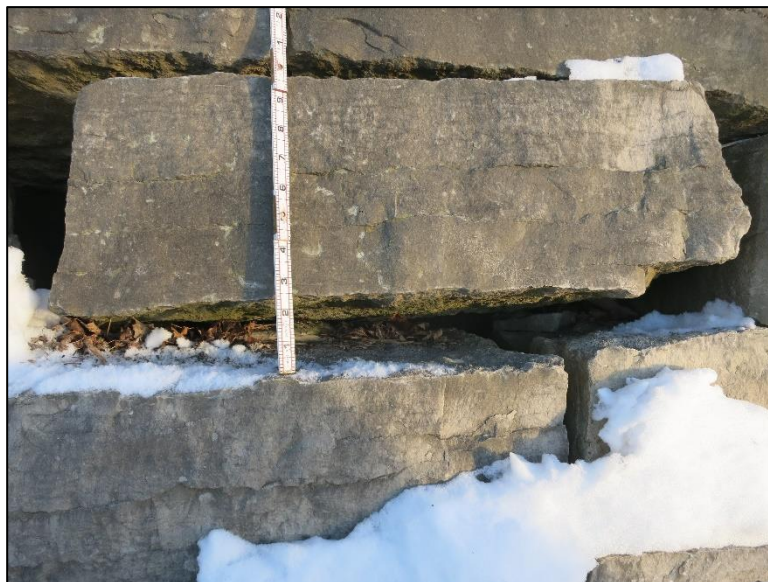
Figure 4.4.2-20: Excessive Gap Forming At Base of Stone Block.

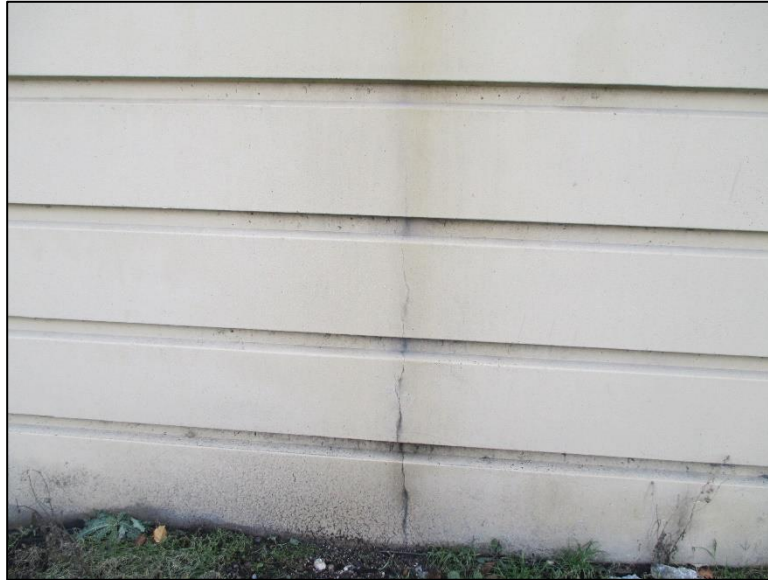
- **Cracking:** Random cracks in the structure. The direct cause of the crack development is uncertain and may be attributed to movement, shrinkage or temperature. Examples might include diagonal, straight, or horizontal crack propagation. Refer to Figure 4.4.2-21 for a view of typical vertical cracking found in precast concrete panels.

Figure 4.4.2-21: Vertical Crack Through Precast Concrete Panel.

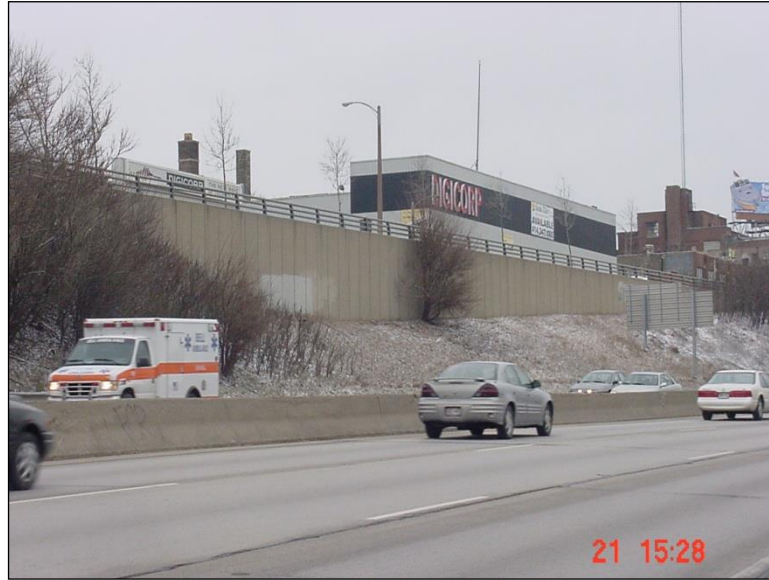
Figure 4.4.4-2: Cast-in-Place Concrete Cantilever Wall.

The exposed concrete stem may be plain, textured and/or colored. The height on these types of walls is typically less than 28 feet. Walls higher than 28 feet typically require counterforts or tie-backs for additional strength and deflection control. Refer to Figure 4.4.4-1 and Figure 4.4.4-2: Cast-in-Place Concrete Cantilever Wall. for a typical cast-in-place concrete gravity cantilever wall.

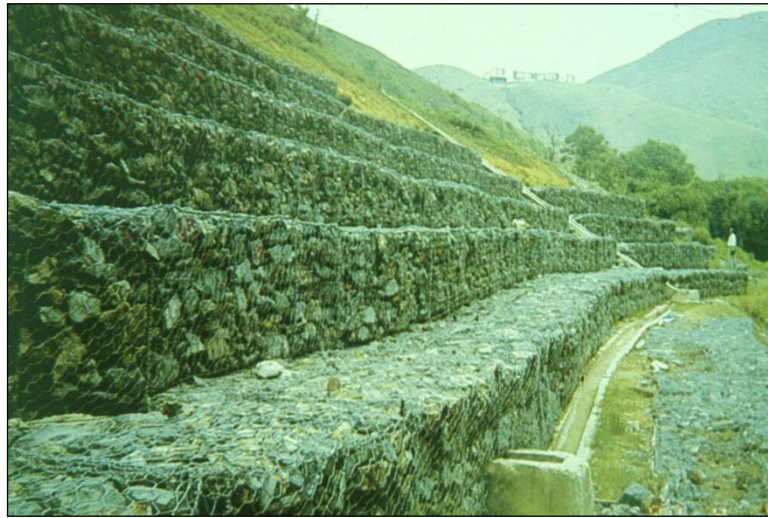
Figure 4.4.4-4: Tiered Gabion Gravity Crib Wall.

There are a variety of different types of gabion gravity crib walls on the market. They can be easily constructed without the use of skilled labor or specialized equipment, and they are often built rapidly. Unfortunately, it is difficult to make height adjustments to the wall once in place. Refer to Figure 4.4.4-3 and Figure 4.4.4-4 for views of gabion gravity crib walls.

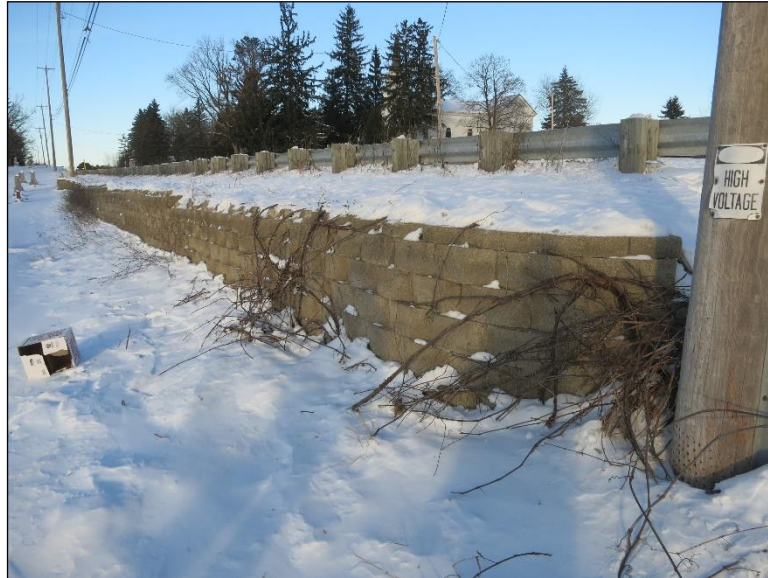
Figure 4.4.4-5: Segmented Modular Block Gravity Wall.

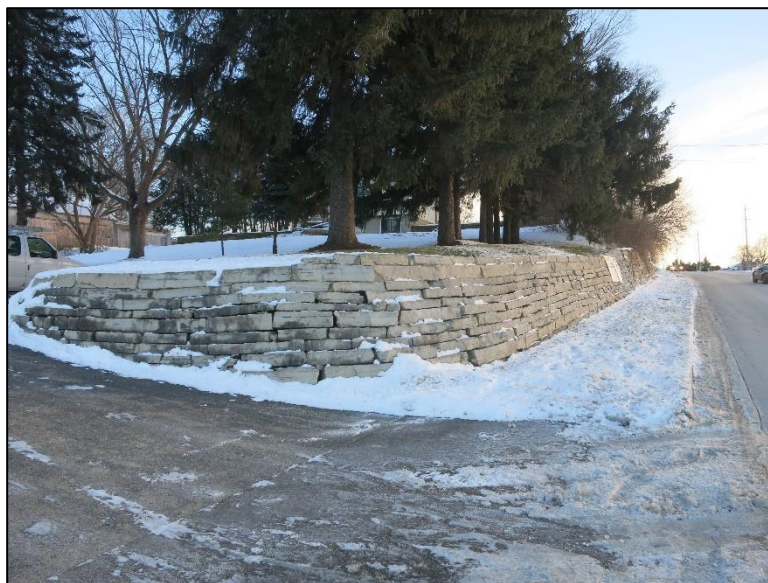
Figure 4.4.4-6: Lannon Stone (Limestone) Block Gravity Wall.

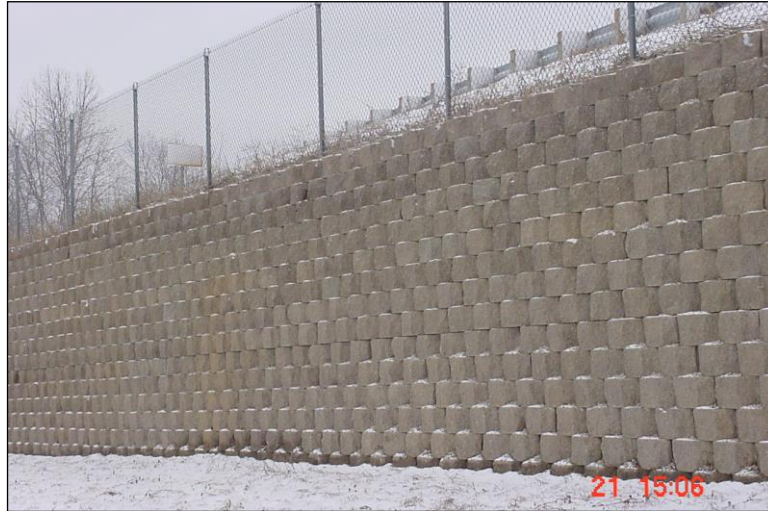
Figure 4.4.4-7: Segmented Modular Block MSE Wall.

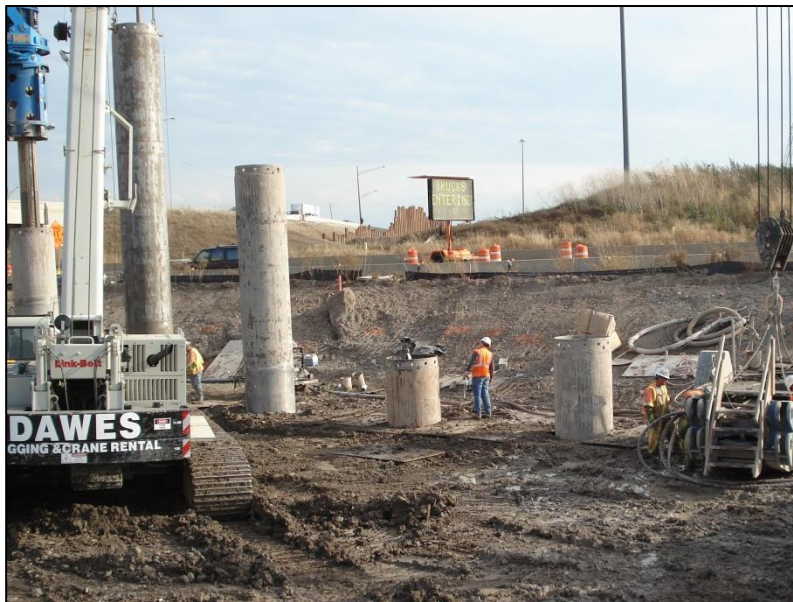
Figure 4.4.4-14: Secant Wall Construction.

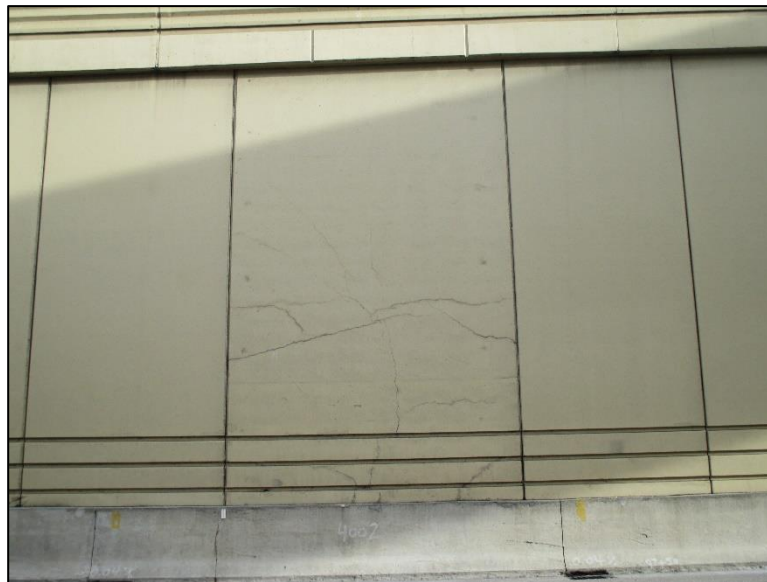
Figure 4.4.4-16: Excessive Cracking within Secant Wall Facade Concrete Panel.

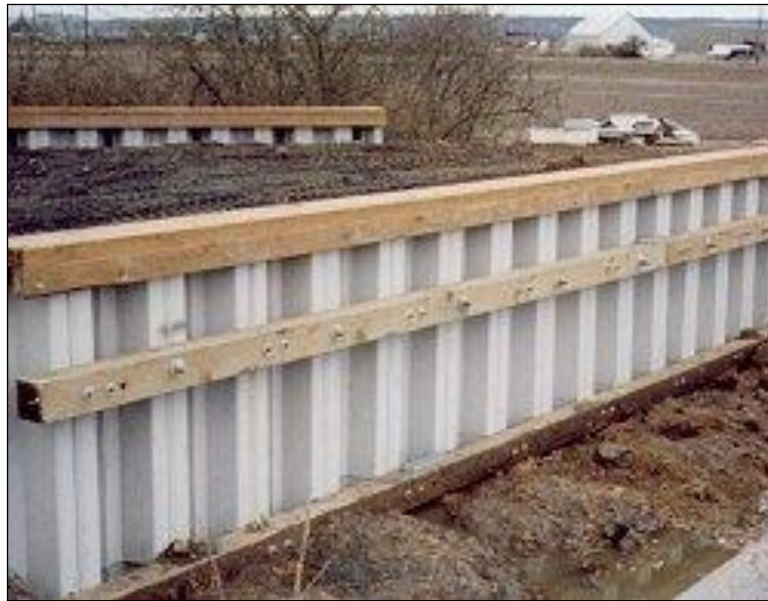
Figure 4.4.4-17: Vinyl Sheet Piling Retaining Wall.

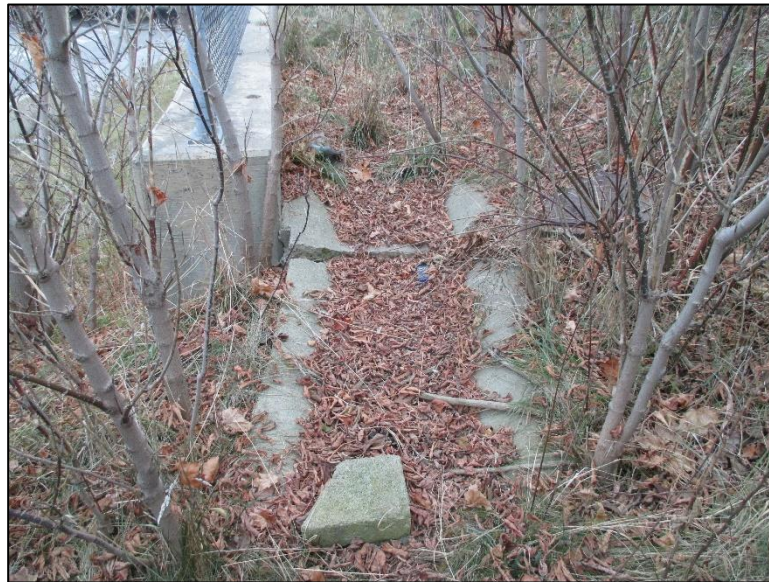
Figure 4.4.5-1: Concrete Flume at End of Wall. Condition State 2 (Fair) – No Erosion Evident, with wide crack.

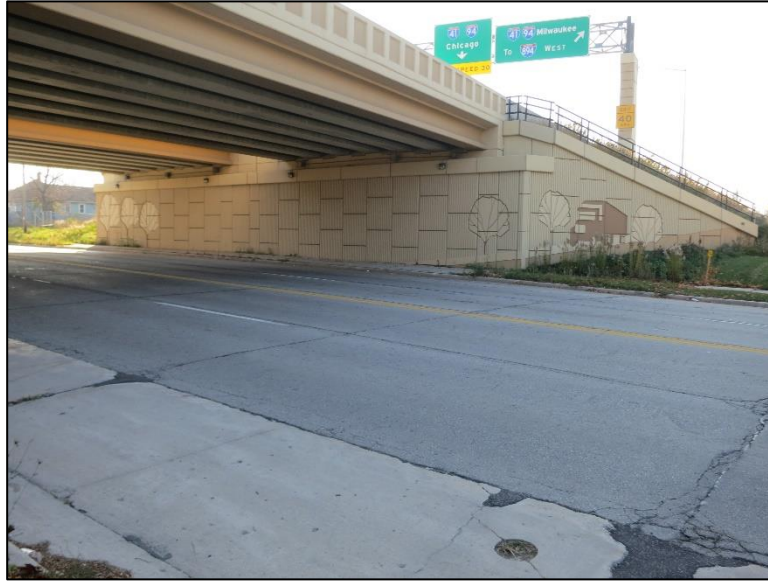
Figure 4.4.5-3: Aesthetic Treatment Form-Lined Precast Concrete Panels.

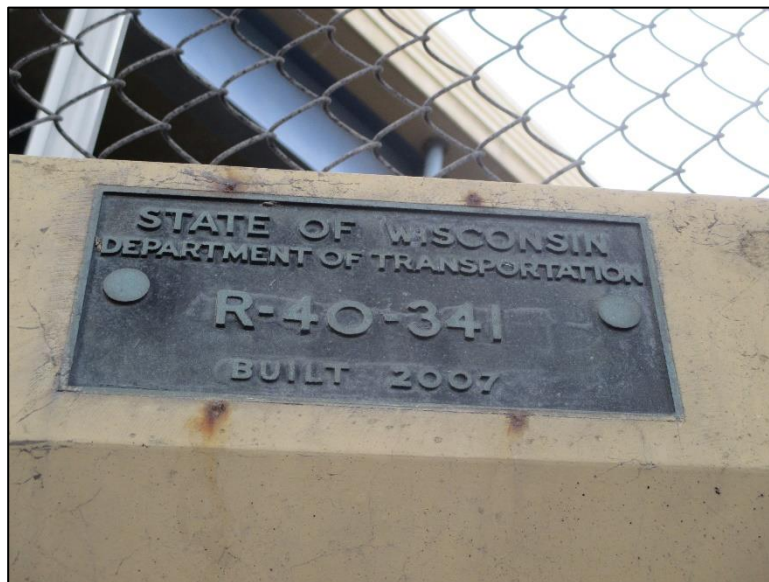
Figure 4.4.5-4: Retaining Wall Name ID Plaque.

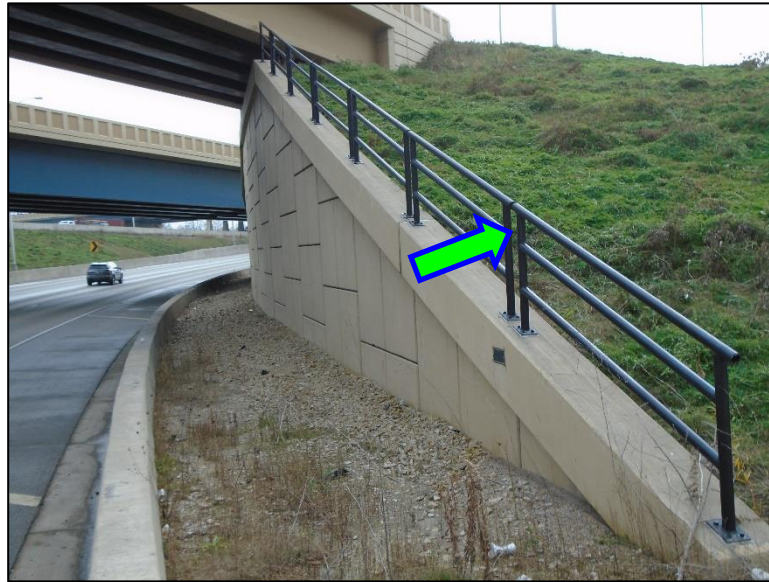
Figure 4.4.5-5: Decorative Rail atop a Horizontal Coping.

All extensions fastened to a bridge railing element or horizontal coping on a retaining earth structure and not considered comprised of chain-link fencing shall be quantified and evaluated under the Decorative Rail assessment.

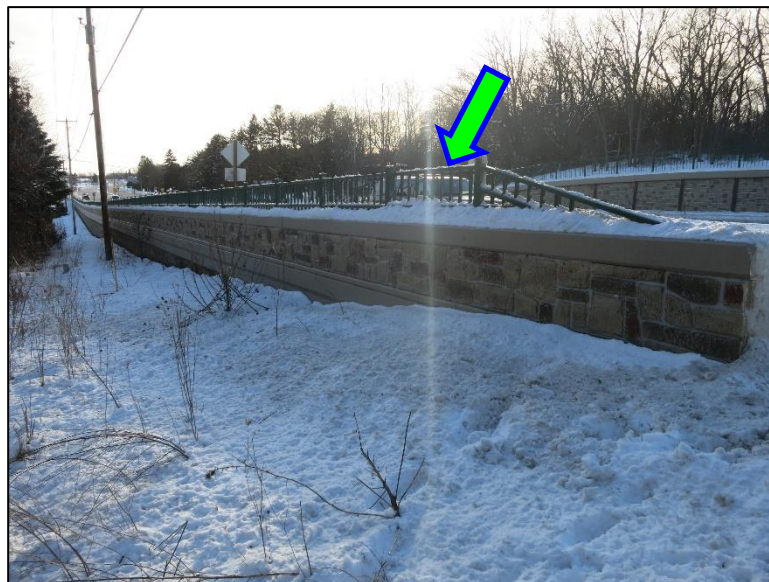
Figure 4.4.5-6: Decorative Rail atop a Bridge Rail Element.

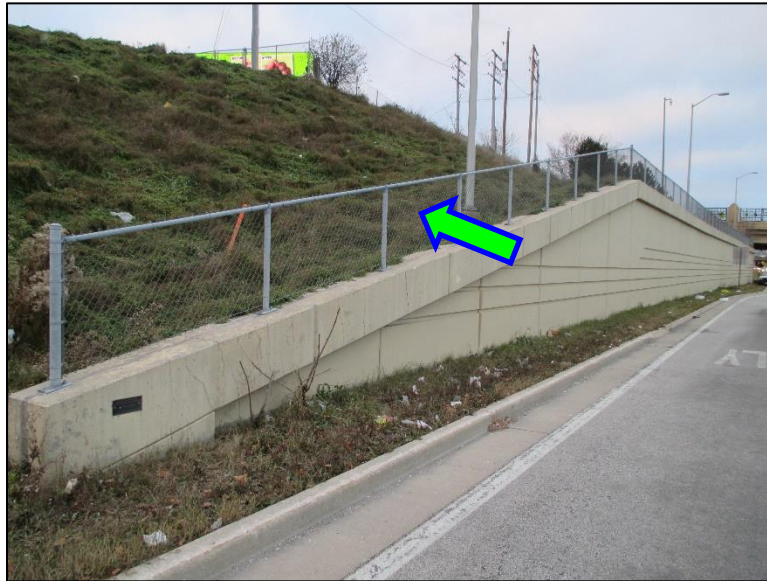
Figure 4.4.5-8: Protective Screening Fastened to a Horizontal Coping. Note the Screening is Not Adjacent to a Sidewalk.

In contrast to the Decorative Rail assessment, the Protective Screening assessment shall be utilized for any extension above a bridge railing element or coping that is comprised of chain-link fencing. This is regardless if the screening is the active barrier between the leading edge of a sidewalk or simply on top of the coping/railing.

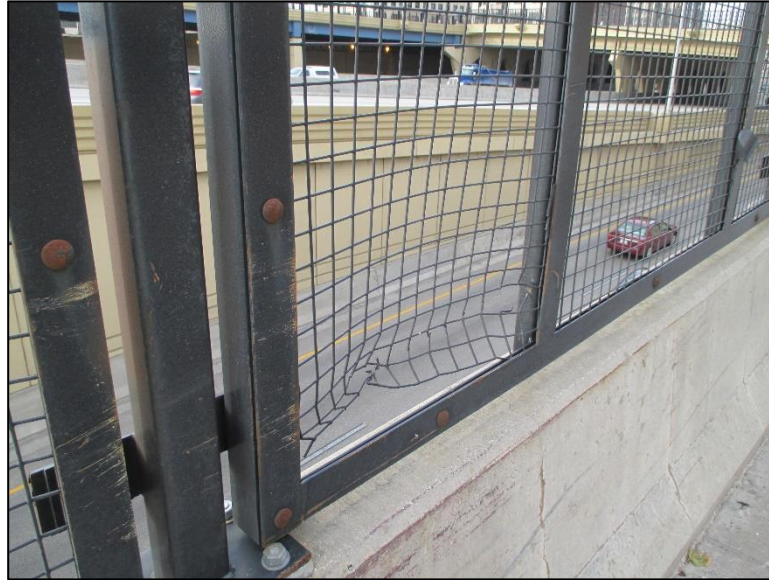
Figure 4.4.5-9: Assessment State 3 Protective Screening atop Bridge Rail. Note Chain-link Fence Deformation but Function Remains.

- **Condition State 3 (Poor):** Chain-link fence has moderate deterioration. Coating may have moderate failure – surface rust may be prevalent. Components may be slightly bent or misaligned – connections may be slightly loose. Fabric may have snags or holes (areas may be slightly stretched or deformed).

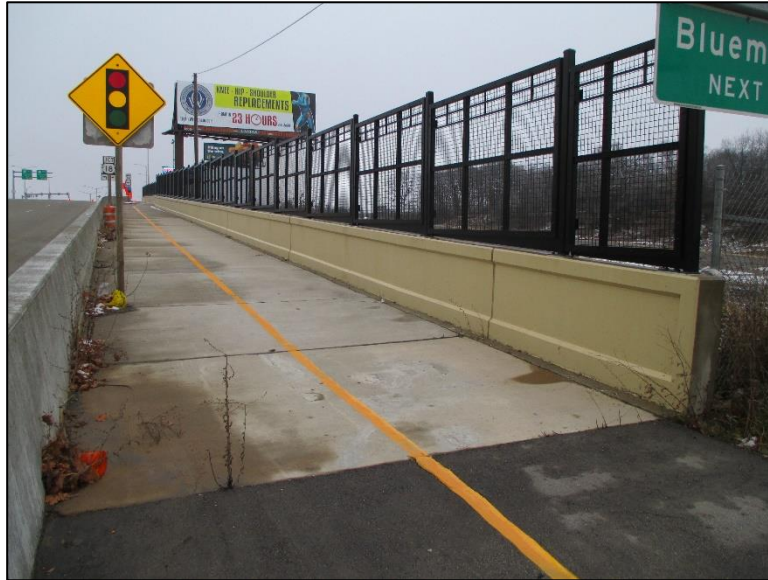
Figure 4.4.5-11: Concrete Sidewalk Along Top of Retaining Wall.

Typically, fill and cut section walls will have roadways, sidewalks, driveways or other facilities adjacent or carried by the wall. Regardless if these features are along the face or along the top of the wall, the inspector shall perform a visual inspection of the features paying particular attention to any settlement, joint separation or excessive cracking. These deficiencies may indicate wall movement or wall distress in the adjacent wall. The slope behind the wall should be stable and adequately supported by the wall. Any backfill losses, indication of water retention, or other defects may indicate performance issues with the wall and should be noted.

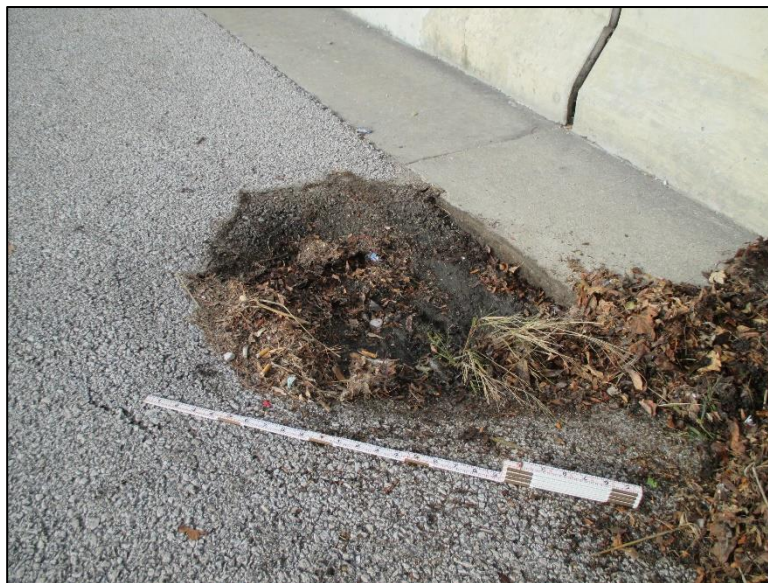
Figure 4.4.5-12: Pothole Due to Loss of Fill Within Shoulder Gutter Pan Along Top of Retaining Wall.
