4.5 NOISE BARRIERS

4.5.1 Introduction

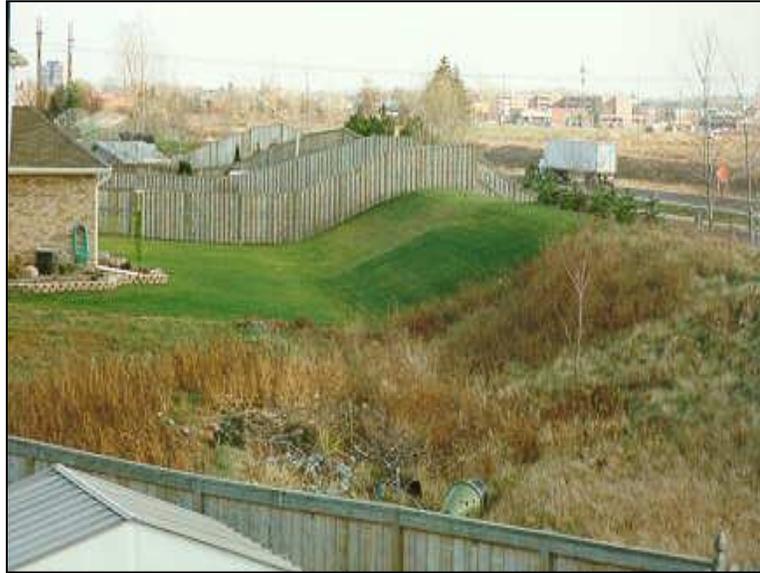
Figure 4.5.1-1: Noise Barrier Berm between Residential Buildings (Foreground) and a Roadway (Background).

naturally stable slope. Noise barrier berms typically require more width than noise barrier walls due to the required slope of the sides, which needs to be gradual enough to maintain stability. Noise protection is typically warranted in more urban settings. Consequently, the available footprint for a structure is limited due to the higher cost associated with it. This results in the construction of a Noise Barrier Wall rather than Noise Barrier Berm in nearly all instances in Wisconsin. WisDOT does not inventory or inspect Noise Barrier Berms. Refer to Figure 4.5.1-1 for a view of a noise barrier berm.

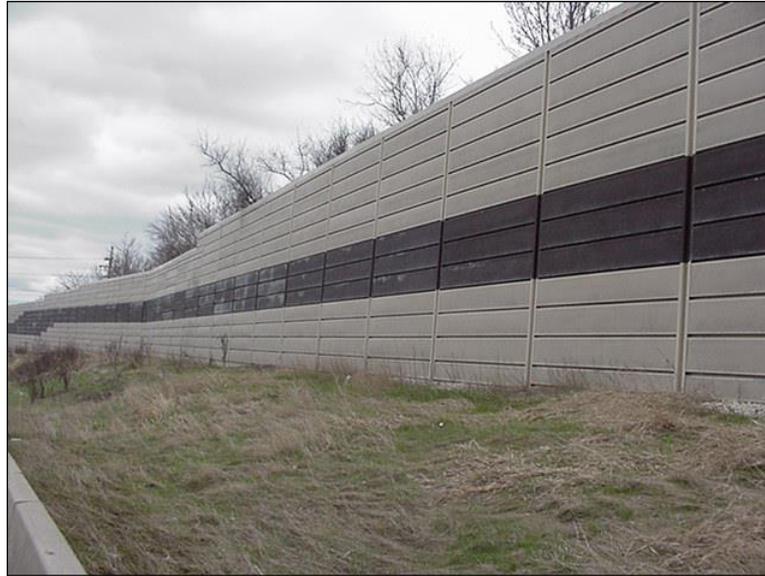
Figure 4.5.1-2: Ground Mounted Metal Panel Noise Barrier Wall.

A noise barrier wall is typically a designed-cantilever structure. The components are typically prefabricated off-site and assembled on-site. A variety of noise barrier wall designs exist including: post & panel; brick & masonry block; freestanding noise walls; direct burial panels; noise walls as earth retention structures; and cast-in-place concrete walls. Refer to Figure 4.5.1-2 for a view of a noise barrier wall.

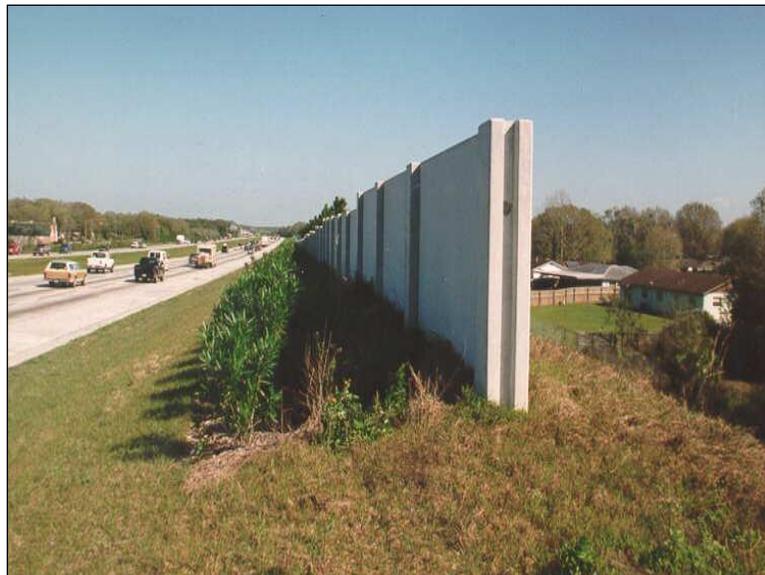
Figure 4.5.1-3: Combination Noise Barrier Berm and Wall.

Many systems use a combination of types to obtain the required height of the noise barrier. Noise walls are frequently erected on top of a noise berm. Refer to Figure 4.5.1-3 for a view of a berm and noise barrier combination structure.

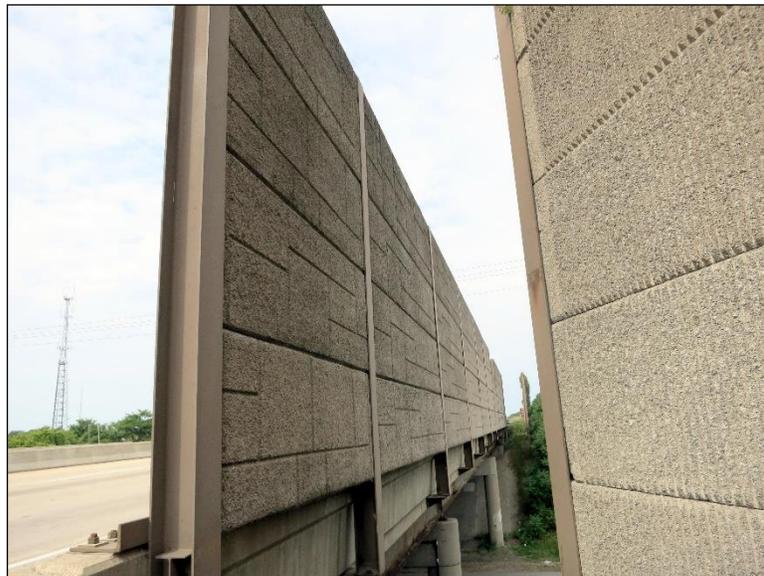
Figure 4.5.1-4: Precast Panel Noise Barrier Wall Mounted on a Bridge.

retaining walls. For bridge inspections, it is the inspector’s task to identify all non-‘N’ numbered noise barriers, and record them as Element 8610 Noise Barrier – Structure Mounted on the bridge inspection form. Refer to Section 4.5.3 of this manual for further information on Noise Barrier Elements. If the noise barrier has an ‘N’ number assigned to it, then the noise barrier will not be recorded on the supporting structure inspection form, but will be properly inventoried and inspected under its own report and inspection interval. The inspector shall, however, note within the ‘Structure Specific Notes’ of the supporting structure report the ‘N’ number structure, where its located and perform a cursory inspection of the noise barrier and note them within this section. If significant defects affecting the functionality of the barrier or the safety of the travelling public are discovered, the owner of the noise barrier shall be notified immediately. Non ‘N’ numbered noise barriers will not be assigned ‘N’ numbers in the future. Therefore, the inspector is required to include non ‘N’ numbered structure-mounted noise barriers within the supporting structure inspection report with the appropriate element and defects. Refer to Figure 4.5.1-4 through Figure 4.5.1-6 for views of structure-mounted noise barrier walls.

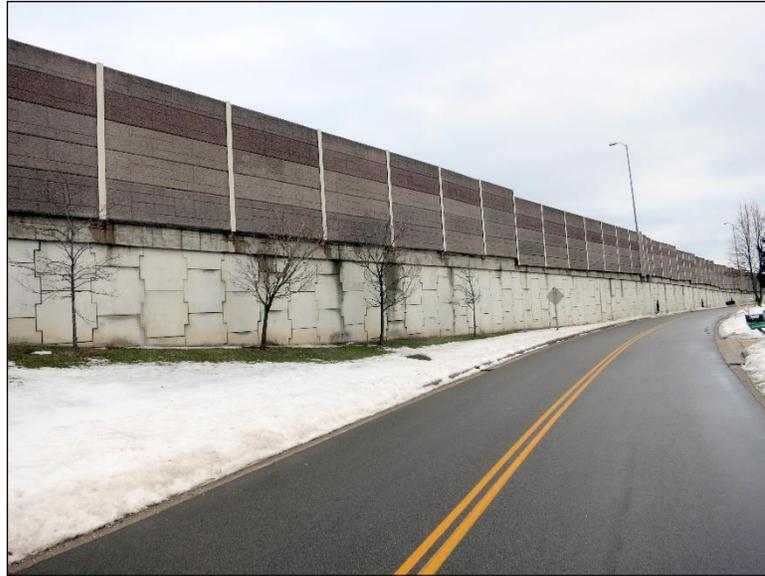
Figure 4.5.1-5: Precast Concrete Panel Noise Barrier Wall Mounted on a Retaining Wall.

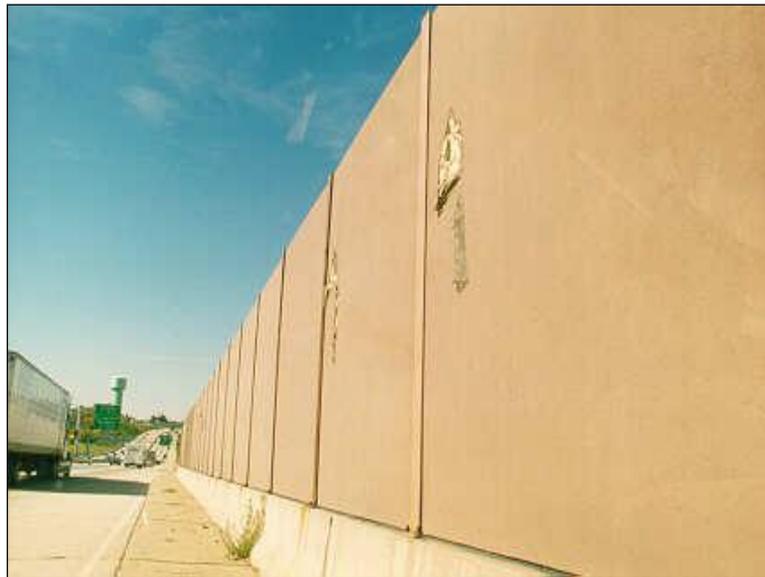
Figure 4.5.1-6: Precast Concrete Noise Barrier Wall Mounted on Concrete Vehicular Crash Barrier.

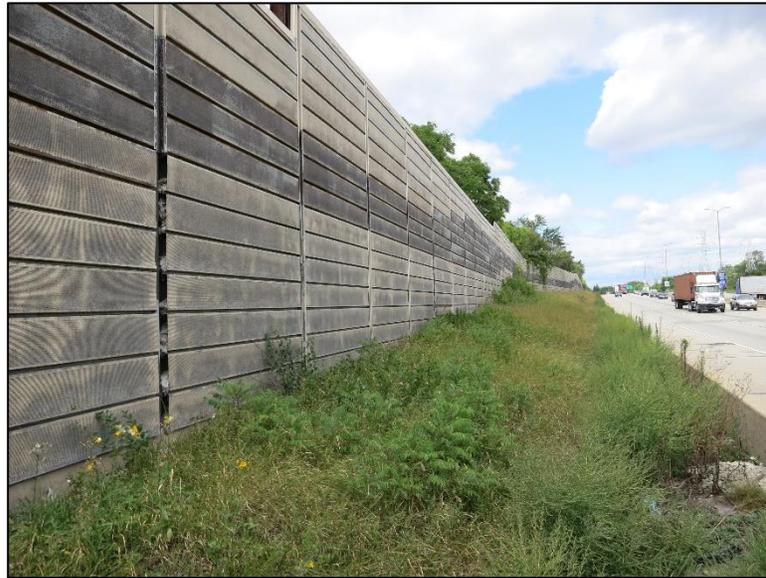
Noise walls that are not attached to other systems are considered ground mounted.

Figure 4.5.3-1: Ground Mounted Noise Wall.

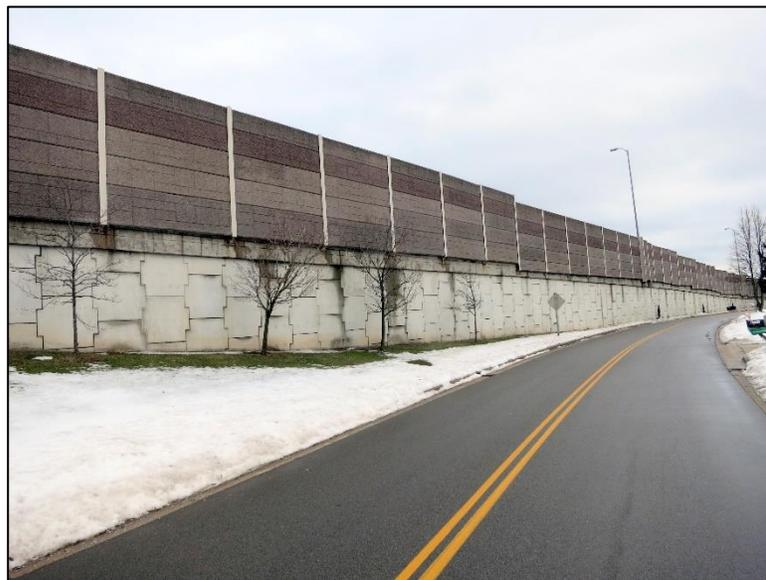
Noise walls that are attached to other systems are considered structure mounted. If the noise barrier is attached to the bridge and has an 'N' number assigned to it, then the noise barrier will not be recorded on the bridge inspection form. However, it is the inspector's due diligence to perform a cursory inspection of the noise barrier to ensure that the travelling public is not threatened by any notable deterioration of the noise barrier. Any areas of concern can be captured as maintenance items, but would not have the element associated with it.

Figure 4.5.3-2: Structure Mounted Noise Wall. Mounted to Retaining Wall Structure.

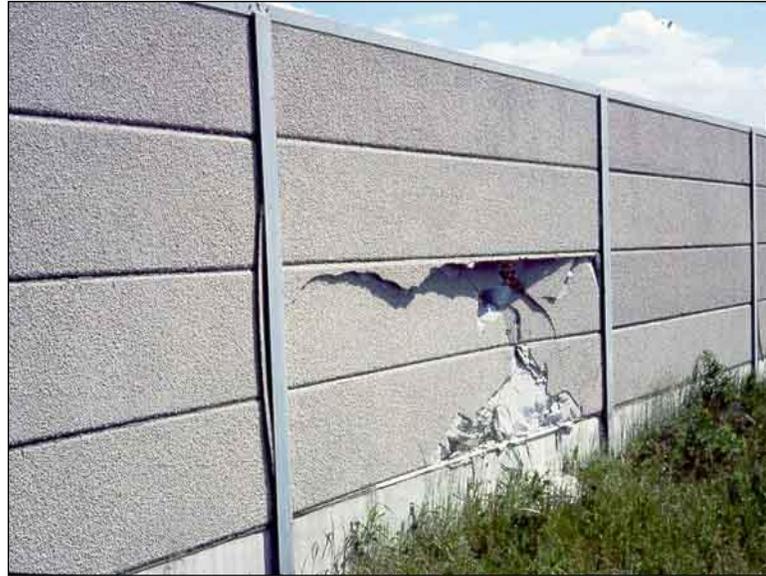
Figure 4.5.4-1: Impact Damage to a Noise Barrier Wall.

Impact damage is typically confined to an area directly adjacent to the point of contact and is characterized by distortion or crushing of the construction material at the point of contact with cracking, splitting, or splintering radiating from this point. Refer to Figure 4.5.4-1 through Figure 4.5.4-3 for views of impact damage.

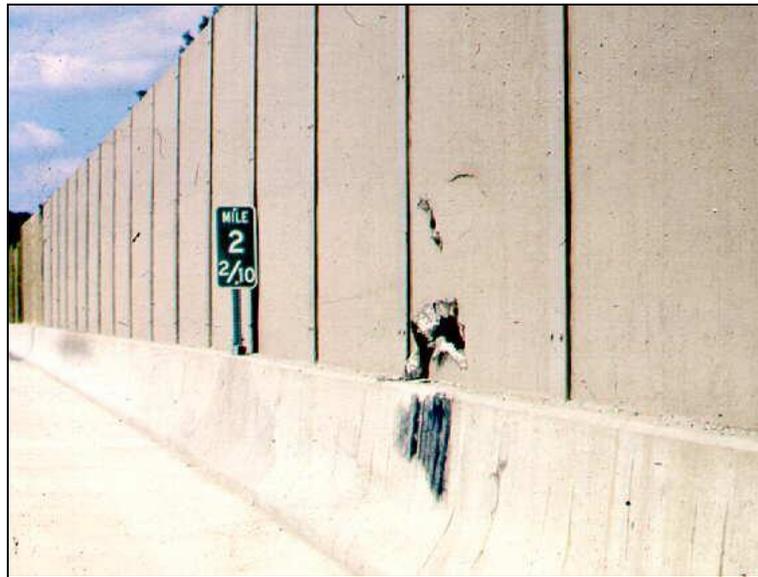
Figure 4.5.4-2: Impact Damage to a Noise Barrier Wall.

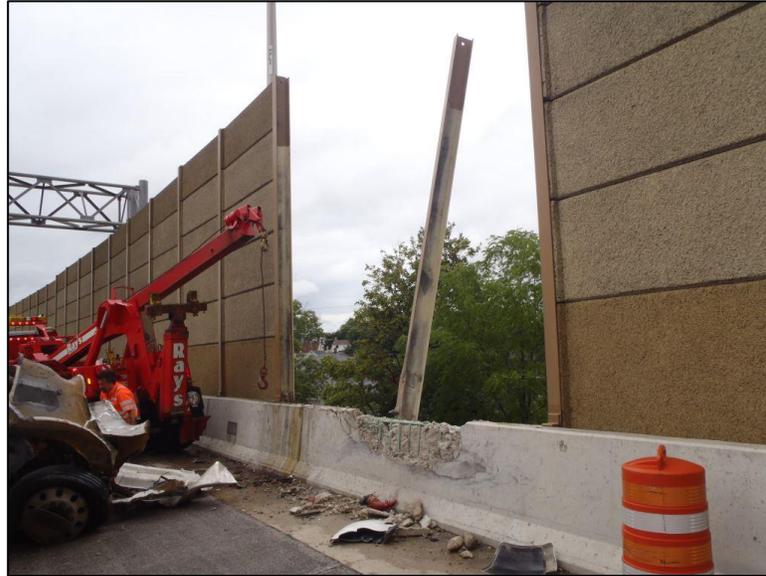
Figure 4.5.4-3: Impact Damage with Failed Post and Paneling of Structure Mounted Noise Wall.

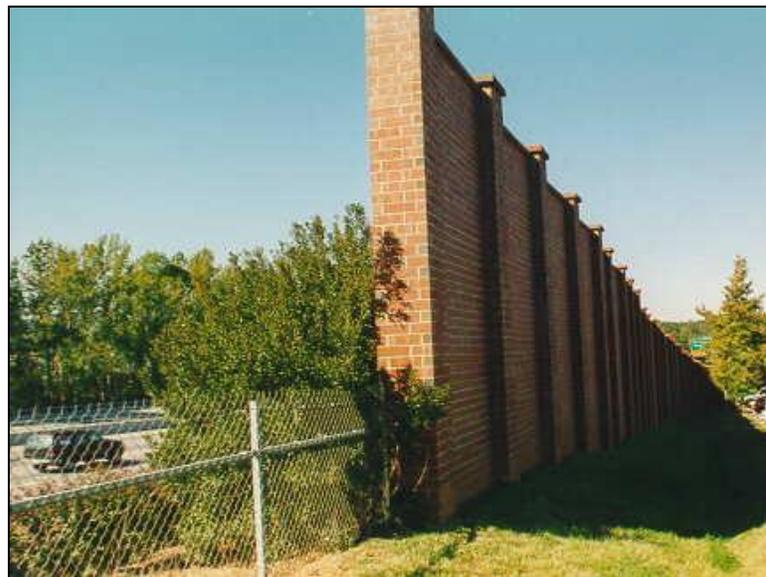
Figure 4.5.4-4: Typical Masonry Noise Barrier Wall.

The following is a discussion of different types of material defects that may be found when inspecting masonry units. Refer to Figure 4.5.4-4 for an overall view of a masonry noise barrier wall. Refer to Part 4, Section 4.3.1 for photographs of typical Masonry deterioration.

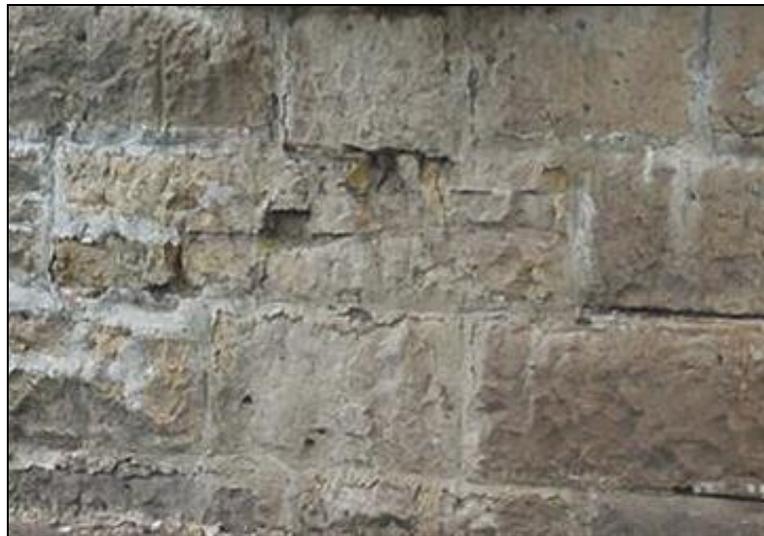
Figure 4.5.4-5: Heavy Scaling with Efflorescence on a Masonry Noise Barrier Wall.

- **Scaling:** This is a special type of freeze-thaw damage. It is generally characterized by significant exterior damage and crumbling, more so than typical freeze-thaw damage. Refer to Figure 4.5.4-5 for a view of heavy scaling on a masonry noise barrier wall.

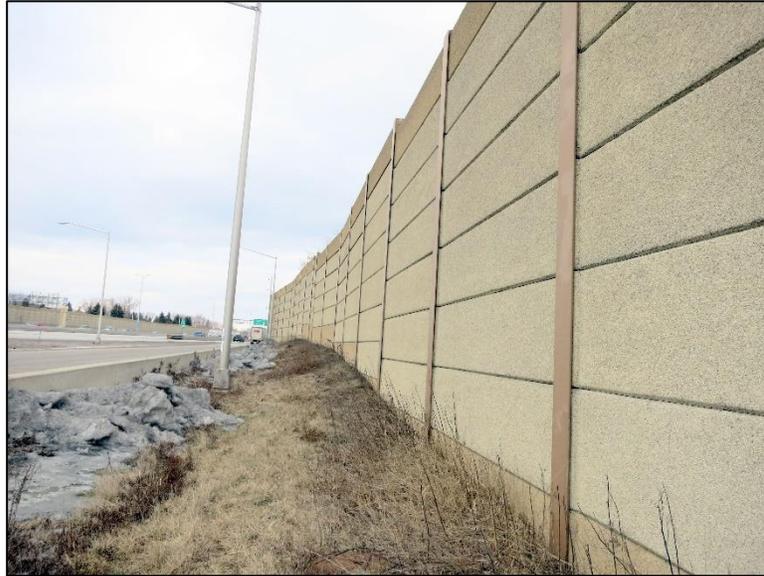
Figure 4.5.4-6: Overall View of a Concrete Noise Barrier Wall Comprised of Reinforced Concrete Core and Durisol (wood/cement fiber) Cladding.

The following is a discussion of different types of material defects that may be found when inspecting pre-fabricated concrete panels and cast-in-place concrete. Refer to Figure 4.5.4-6 for an overall view of a concrete noise barrier wall.

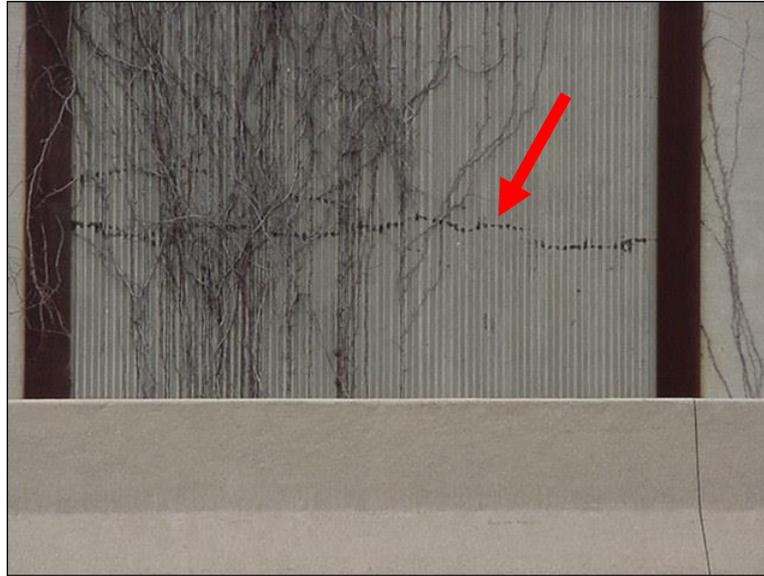
Figure 4.5.4-7: Concrete Panel Noise Barrier Wall with a Horizontal Crack at Mid-Panel.

- **Scaling:** This is a special type of freeze-thaw damage. It is generally characterized by significant exterior damage and crumbling.
- **Cracking:** Random cracks in the structure. Examples might include diagonal, straight, or horizontal crack propagation. Cracking may also occur longitudinally within the concrete core of the Durisol type panels which may not be visible except along the bottom face of the bottom panel of structure-mounted noise walls. Refer to Figure 4.5.4-7 for a view of a concrete panel with a horizontal crack. Refer to Figure 4.5.4-8 for a view of cracking along the underside of a bottom panel of a structure mounted noise wall.

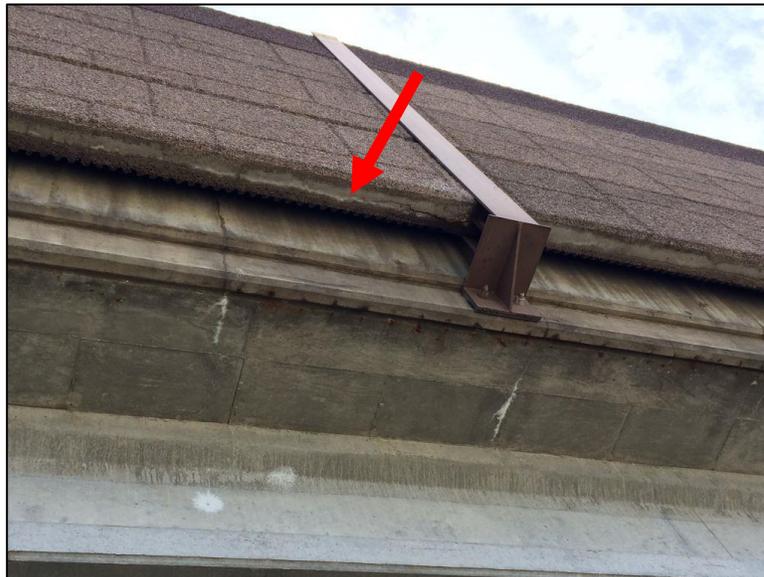
Figure 4.5.4-8: Cracking with Efflorescence Along Midline of Underside Panel.

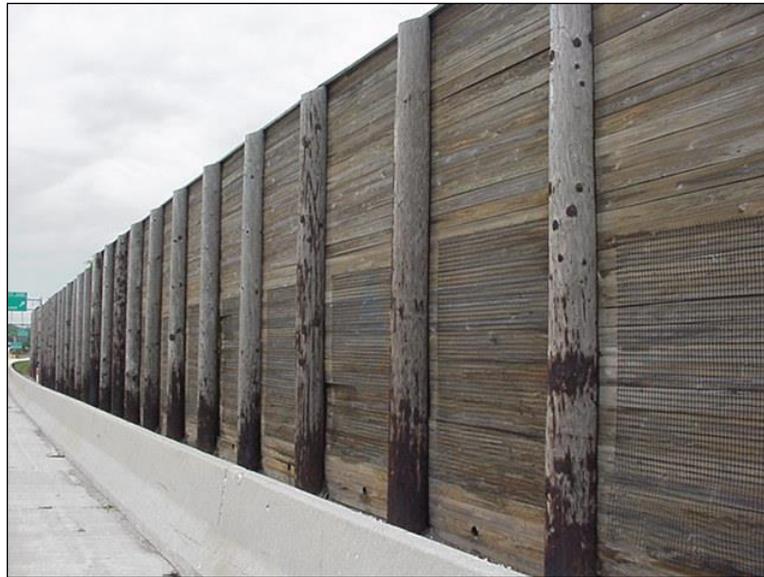
Figure 4.5.4-9: Timber Plank and Post Noise Barrier Wall.

The following is a discussion of different types of material defects that may be found when inspecting timber. Refer to Figure 4.5.4-9 for an overall view of a timber plank noise barrier wall and Figure 4.5.4-10 for a view of missing timber planks on a noise barrier wall.

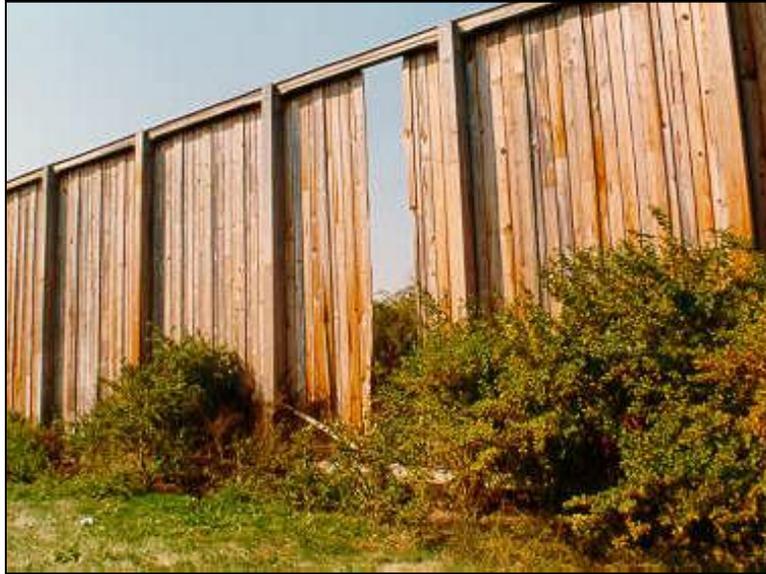
Figure 4.5.4-10: View of Broken and Missing Timber Planks.

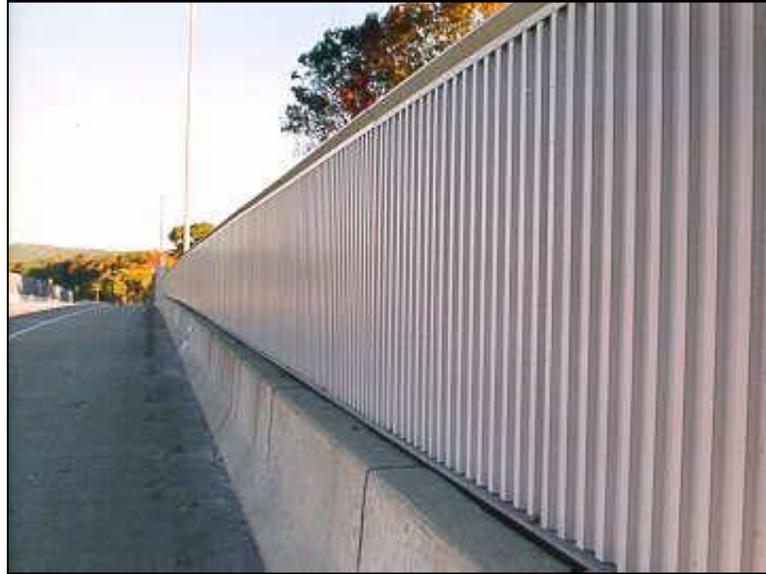
Figure 4.5.4-11: Steel Noise Barrier Wall.

The following is a discussion of different types of material defects that may be found when inspecting metal. Refer to Figure 4.5.4-11 for an overall view of a metal noise barrier wall.

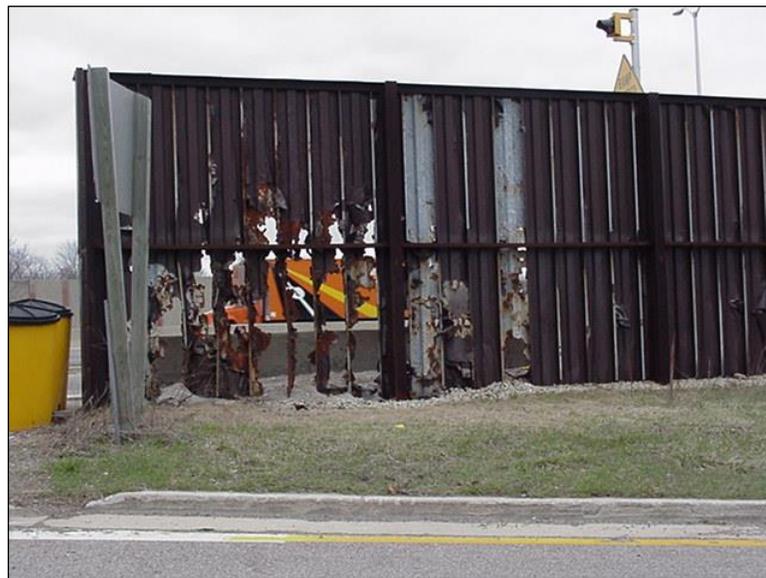
Figure 4.5.4-12: Severe Corrosion of a Metal Noise Barrier Wall.

- **Fatigue Cracking:** Cracks that have formed as a result of cyclic wind loading.
- **Corrosion:** This type of deterioration is the slow, steady deterioration of ferrous material due to exposure of bare metal, moisture and oxygen. Exposure to deicing chemicals act as a catalyst and accelerate metal corrosion. Refer to Figure 4.5.4-12 and Figure 4.5.4-13 for views of metal corrosion.

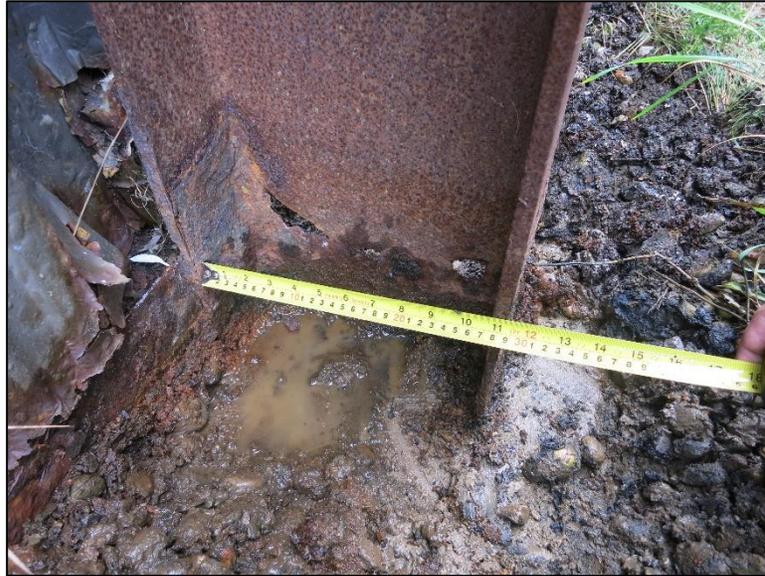
Figure 4.5.4-13: View of Through Section Loss Along the Base of a Post for a Post and Panel Noise Wall.

- **Corrosion:** Corrosion of the steel posts between panels will typically occur along the side facing the roadway spray and especially at the base where debris and deicing agents will accumulate. The inspector should check for scaling, pack rust and section loss. Digging out a few inches of material around the steel posts may be required to fully expose corrosion occurring at the groundline. Refer to Figure 4.5.4-13.

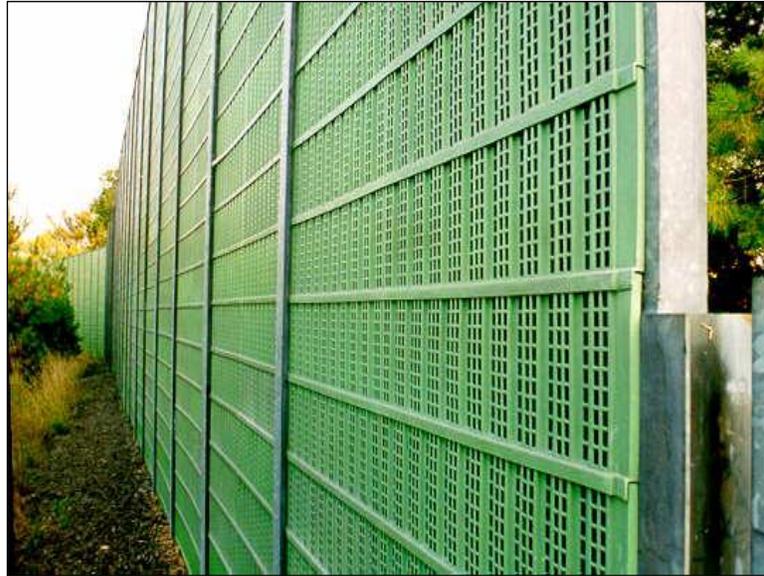
Figure 4.5.4-14: Plastic Composite Noise Barrier Wall.

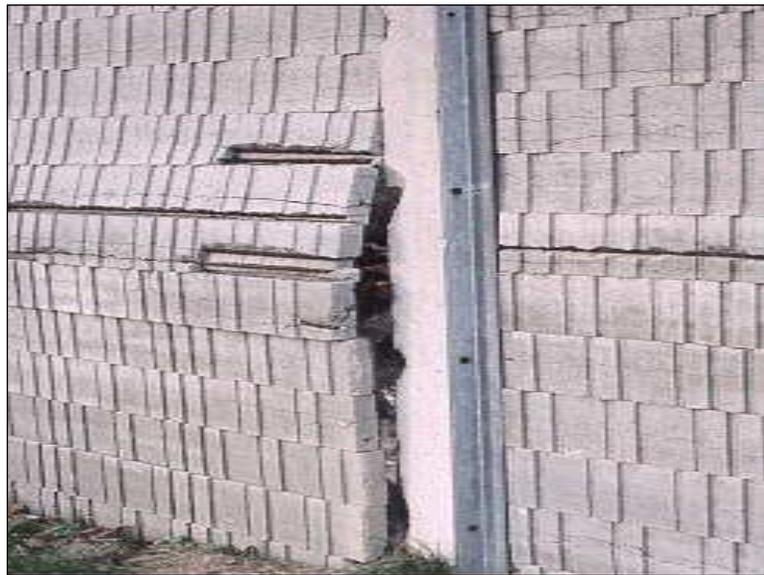
Figure 4.5.5-1: Lateral Movement of a Noise Barrier Wall.

The most common causes of lateral movement are slope failures; seepage; changes in soil characteristics (e.g., frost action and ice); and long term consolidation of the original soil. The most common causes of rotational movement are saturation of backfill due to clogged drains; erosion of the embankment along the front of the wall; and improper design. Refer to Figure 4.5.5-1 for a view of lateral wall movement and its effects on a wall. Refer to Figure 4.5.5-2 for a view of a failed drain tile system resulting in the washout out of material below a noise wall.

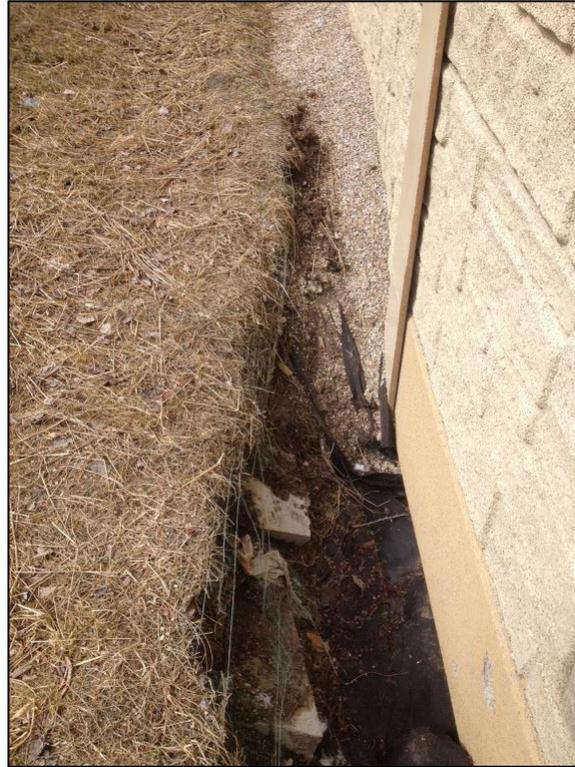
Figure 4.5.5-2: Drain tile system failure below noise wall resulting in loss of material and exposure of noise wall footing.
