# SDD 13C10 Retrofit Dowel Bars

## Standard Detail Drawing 13C10

Retrofit Dowel Bars

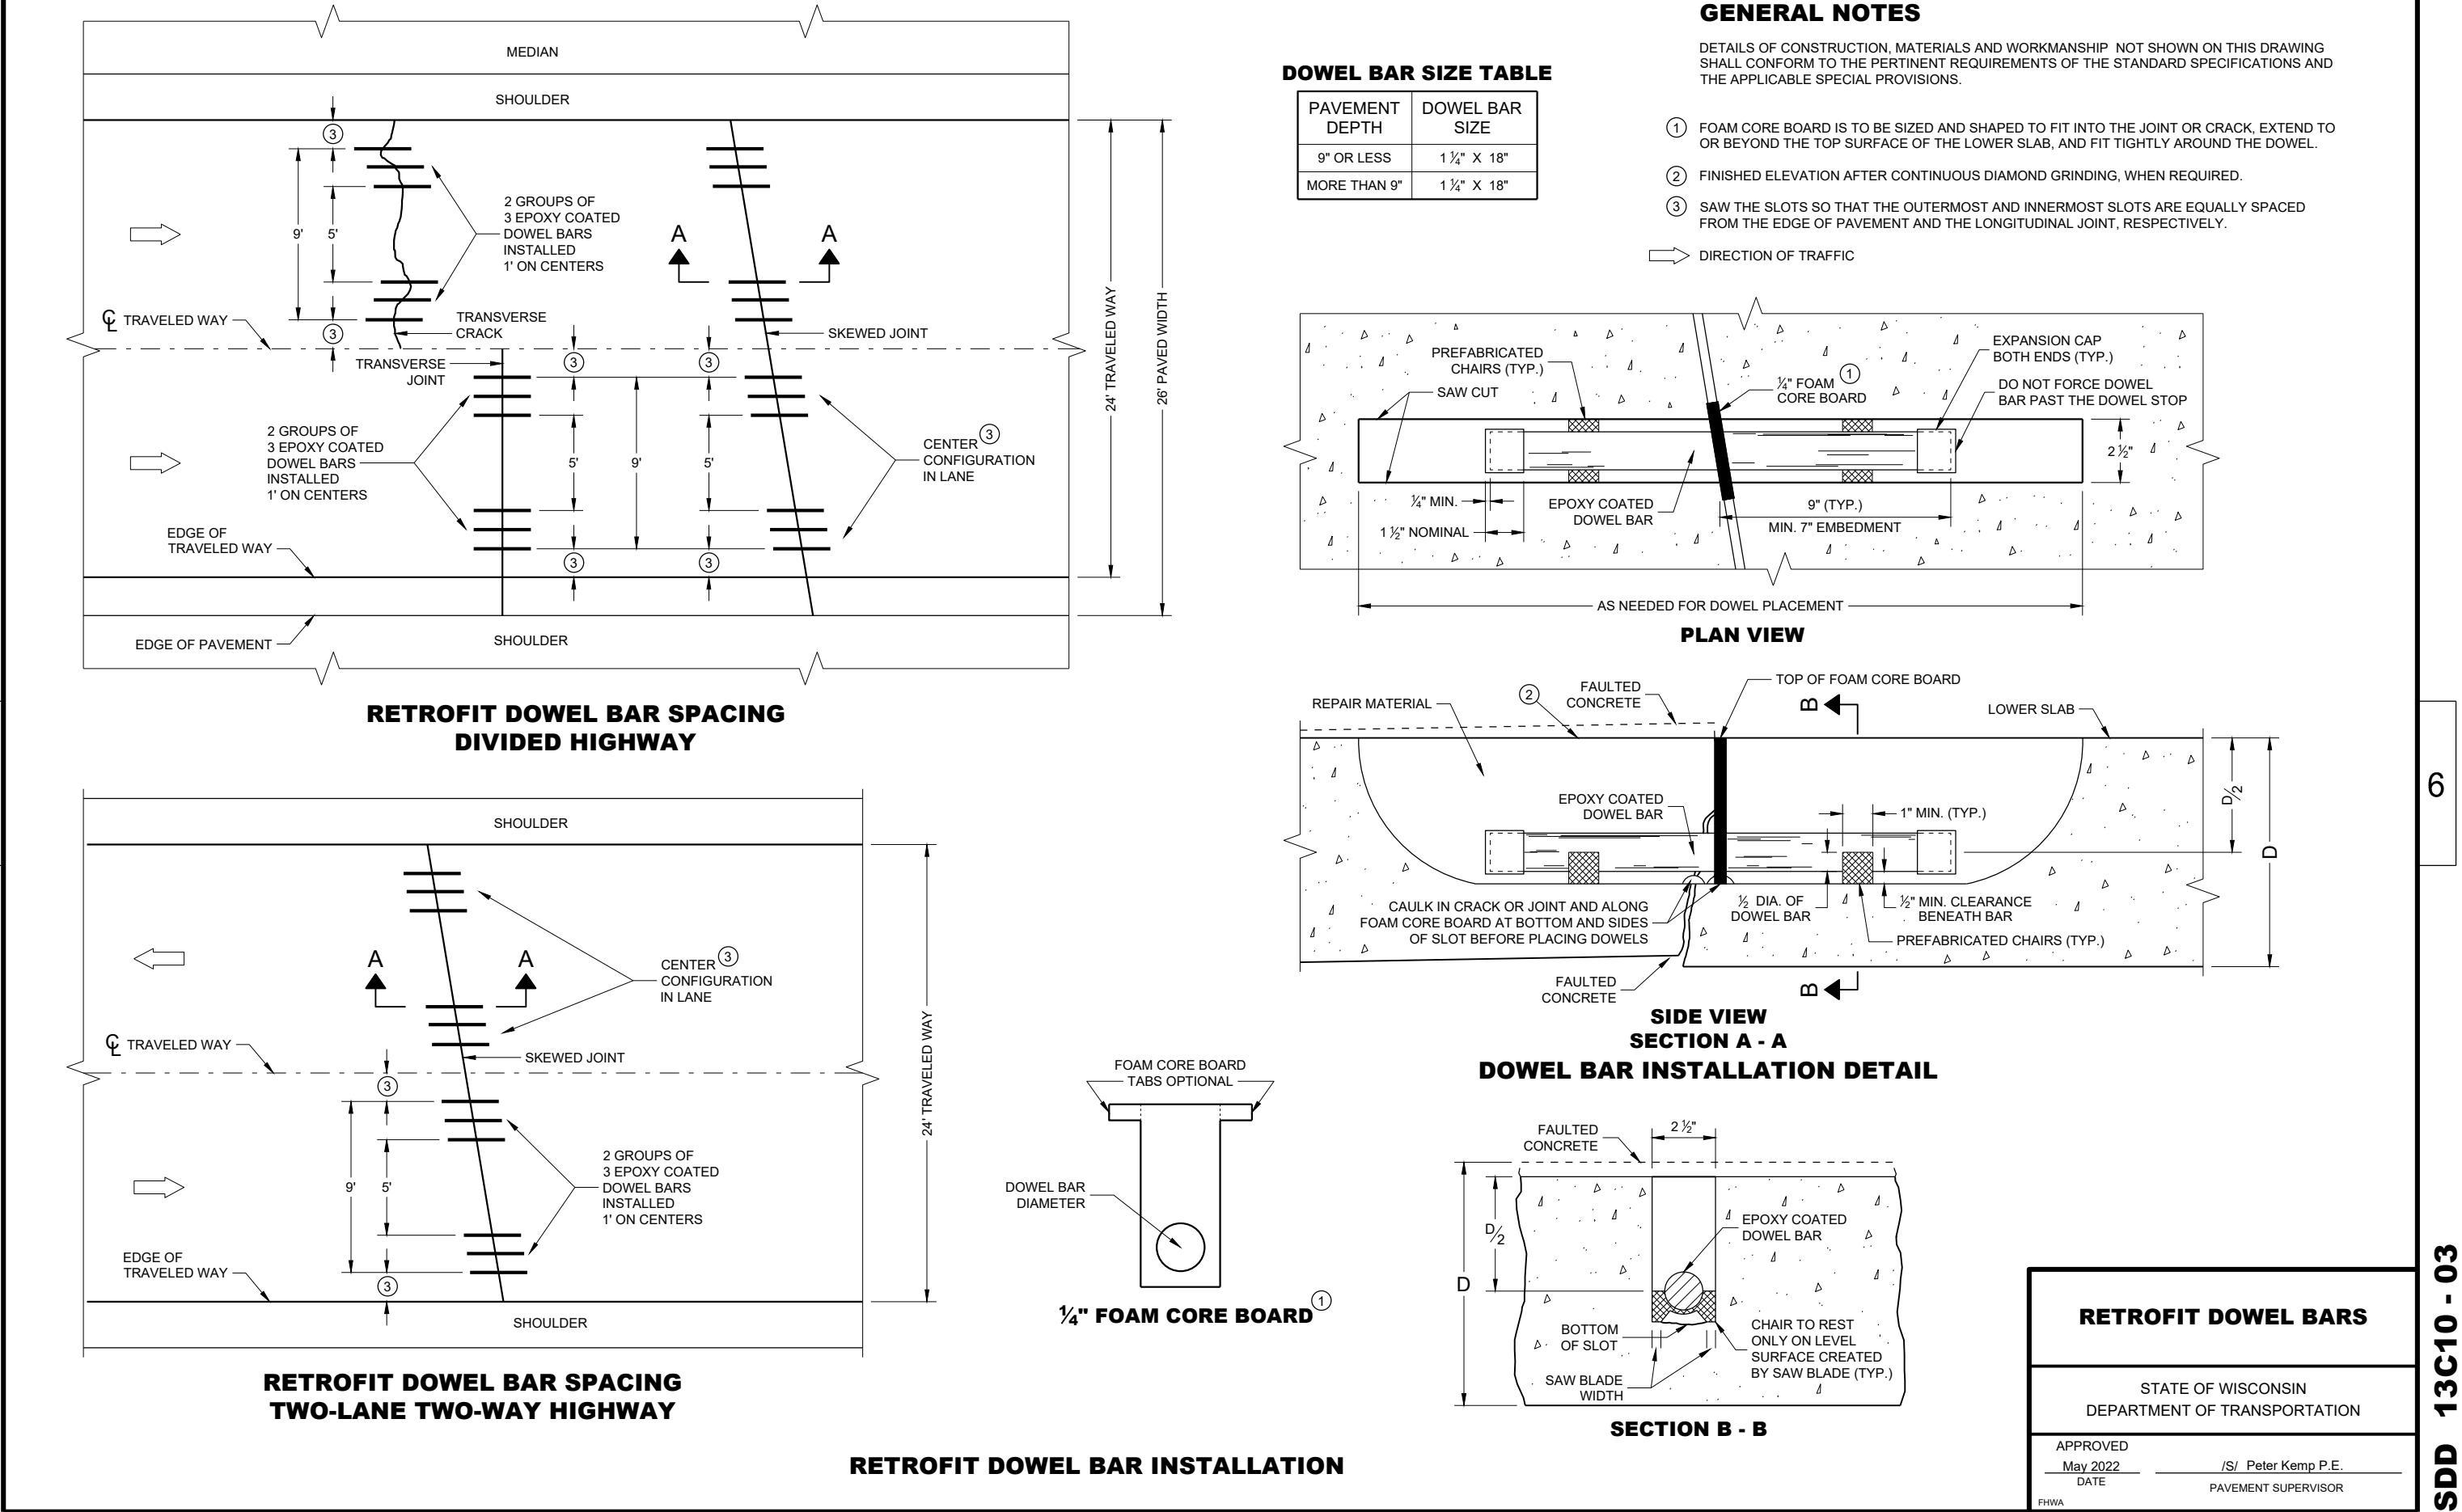
SD Ū 13C 0 03

Use this SDD on jointed plain concrete pavements with or without dowels. Retrofit dowel bars are recommended to restore load transfer at joints and cracks in concrete pavement that are otherwise in good condition.

Use retrofit dowel bars on faulted joints and on cracks that are longer than 4 feet and at least 4 feet from an adjacent transverse joint. Spalled joints should be repaired with partial depth repair (see SDD 13C8 and STSP 416-015). Severely deteriorated joints and cracks should be replaced with full depth repairs; slabs broken into three or more pieces should be replaced (see SDD 13C9). Projects with an excessive amount of additional work are probably not good or cost-effective candidates for retrofit dowel bars.

When faulting is greater than 1/4-inch, continuous diamond grinding under <u>Standard Spec 420</u> is necessary to restore the ride after retrofitting with dowels.
