PURPOSE

NEED

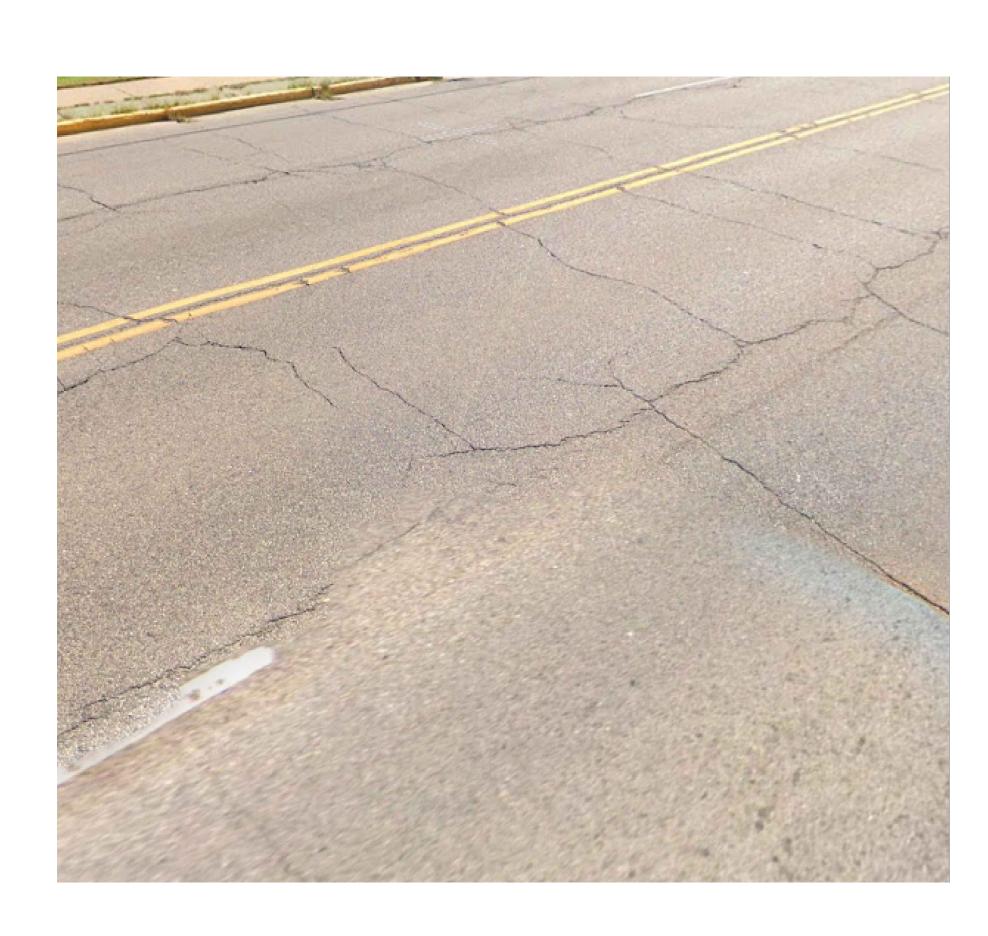
Currently the pavement is in poor to very poor condition.

South - 48
Central - 51
North (NB) - 46
North (SB) - 37

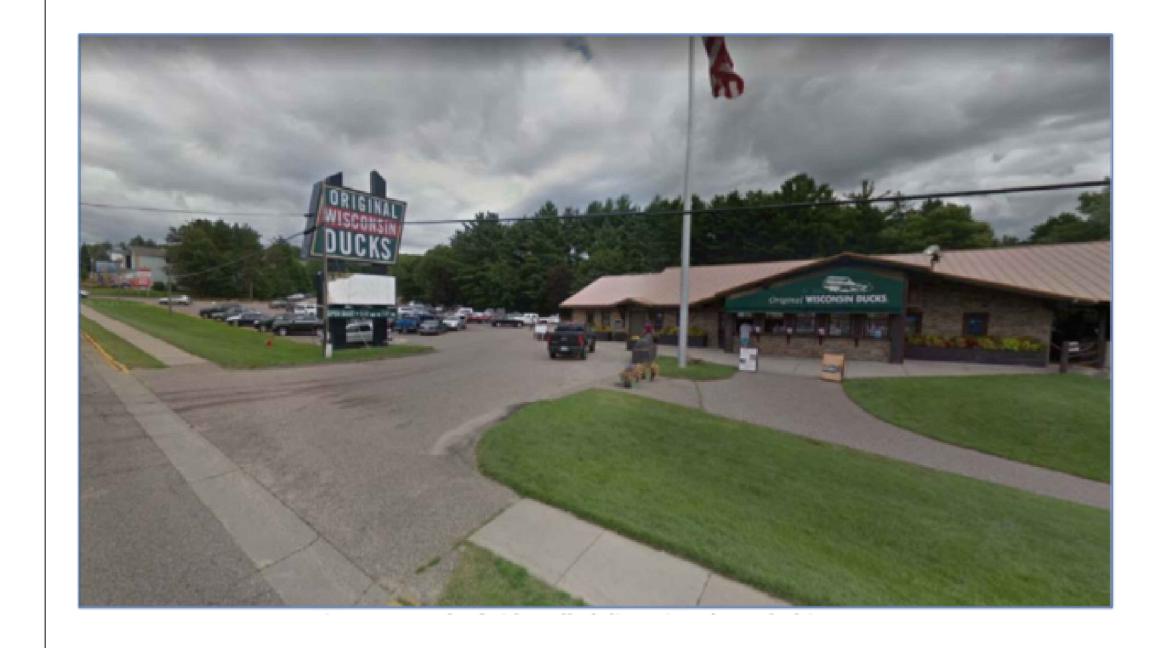
Lack of sidewalk delineation through driveways makes it challenging for drivers to determine the pedestrian path

Existing corridor does not include any on street bicycle accommodations.
