**Division Of State Patrol
Informational Memorandum**

6-99-5

**Tab 4
School Bus Inspection Manual**

TOPIC: Definition of Van Type Vehicle

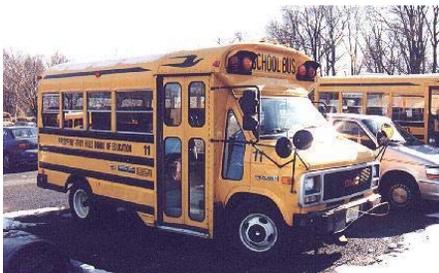
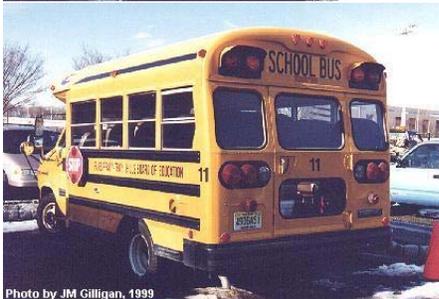
Typical A - II

Background: Terminology in Trans 300.39 refers to a van type vehicle and exempts them from having a lower glass panel in the rear emergency exit doors. The situation arose where the lower panel of a single center mounted emergency exit door did not have a lower glass panel on a typical A-II school bus. Referencing the national school bus standard one will find that the A-II school bus is exempt from the lower glass panel. The question then asked was, "Is the typical A-II school bus required to have a lower glass panel in the rear emergency exit door"?

Decision: The terminology used in Trans 300.39 to exempt the van type bus refers to school buses which have two swing out emergency exit doors hinged on the outside. A window in the lower panel of these doors would place them under the seats and provide no visibility to the driver at all. One can also relate to this type of vehicle as it normally utilizes the original right front door as the service door by connecting a control arm to it. It was the intent of Trans 300 to require this lower panel of glass in the center mounted emergency exit doors to provide a view for the driver to the rear of the bus when backing up. This window is more effective in the smaller A-II school buses than in any other school bus. Therefore it is decided that this window is required and the vehicle in question will have to be retrofitted. **Issued May 1, 1999/BA**
