2024

With 2025 Updates

# STRUCTURE INSPECTION FIELD MANUAL

Wisconsin Department of Transportation

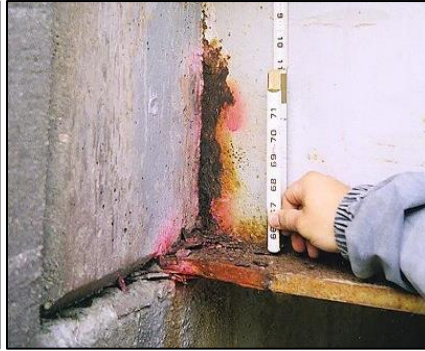
**Corrosion (1000)**

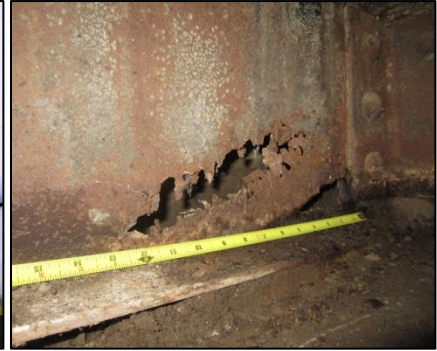
**Condition State 4**

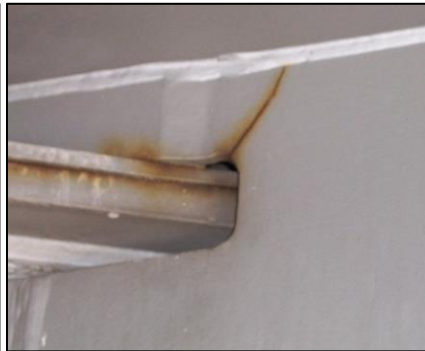
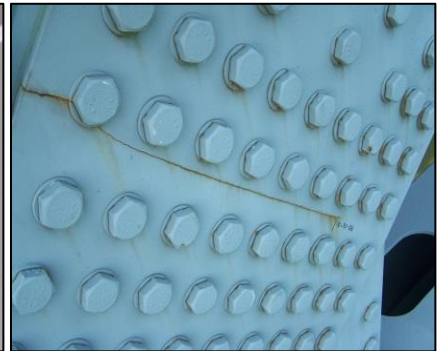
**Cracking (1010)**

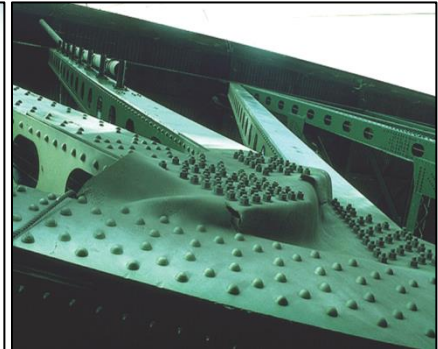
**Distortion (1900)**

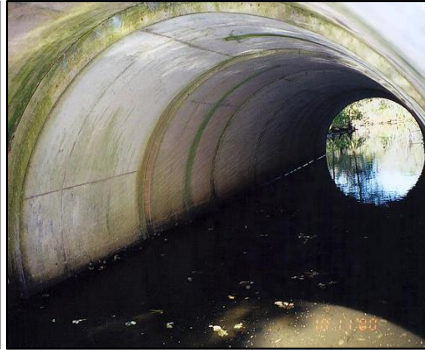
**Settlement (4000)**

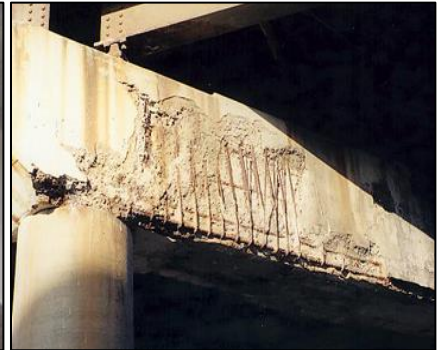
**Spalls (1080)**

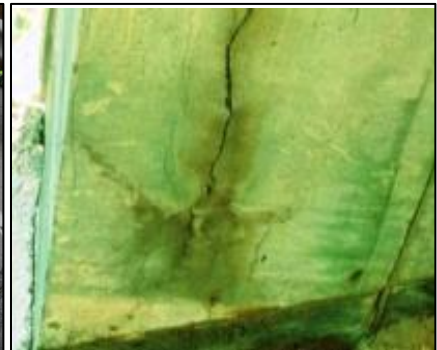
**Cracking – Reinforced Concrete (1130)**

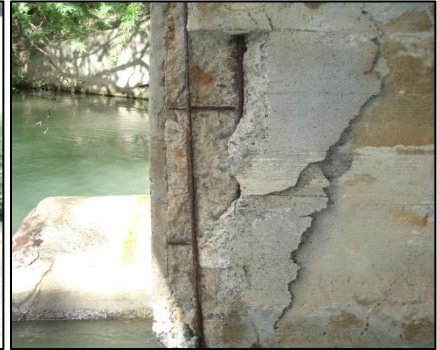
**Delaminations (1080)**

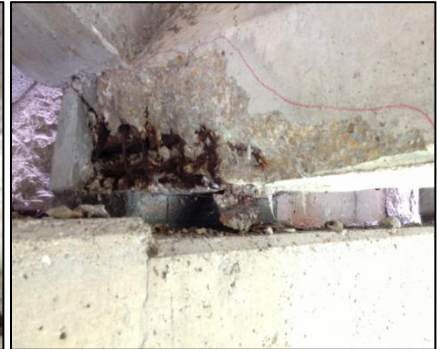
**Spalls (1080)**

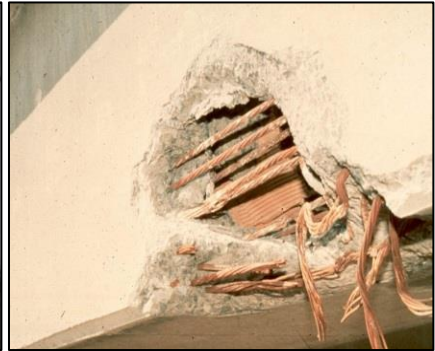
**Exposed Prestressing (1080)**

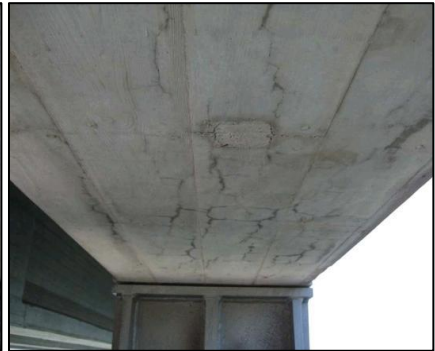
**Cracking – Prestressed (1110)**

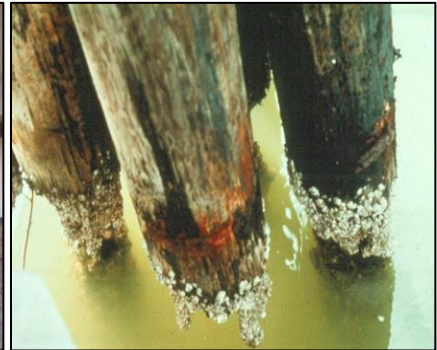
**Decay/Section Loss (1140)**

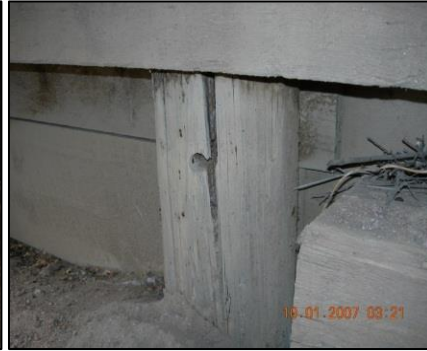
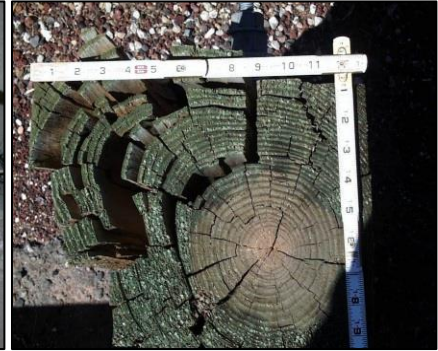
**Checks/Shakes (1150)**

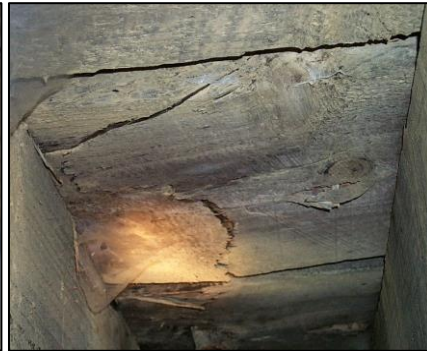
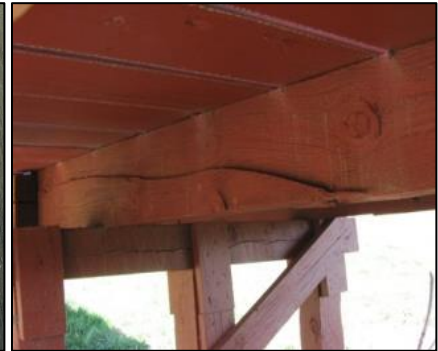
**Cracks (1150)**

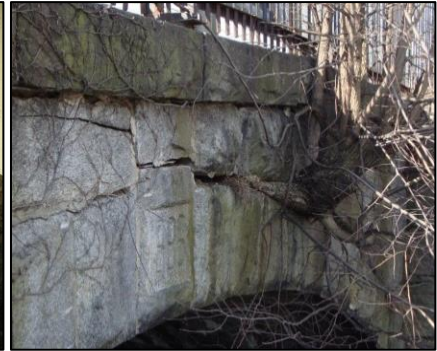
**Mortar Breakdown (1610)**

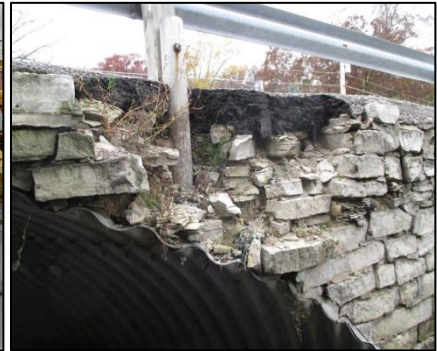
**Split/Spall/Patched Area (1620)**

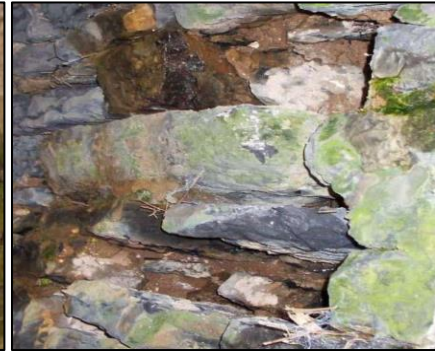
**Masonry Displacement (1640)**

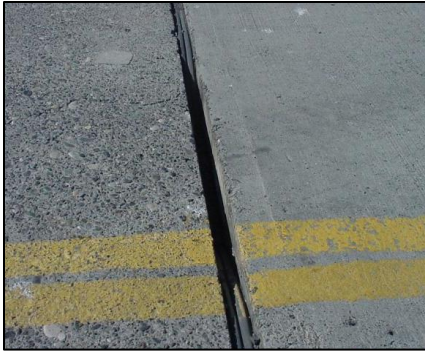
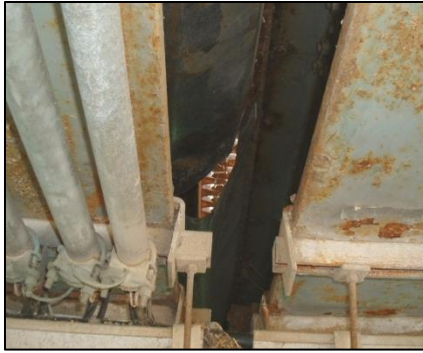
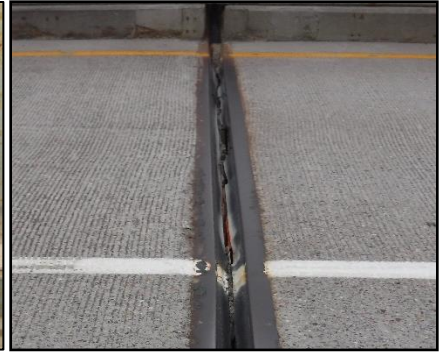
**Leakage/Seal Adhesion/Damage/Cracking (2310)**

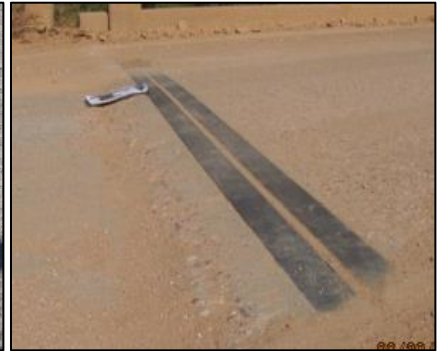
**Debris Impaction (2350)**

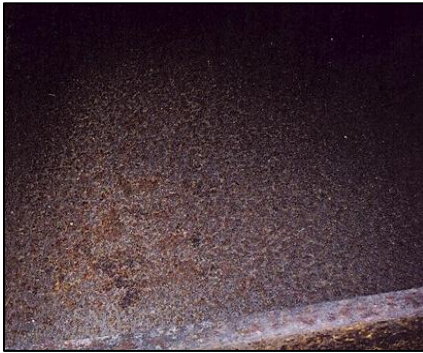
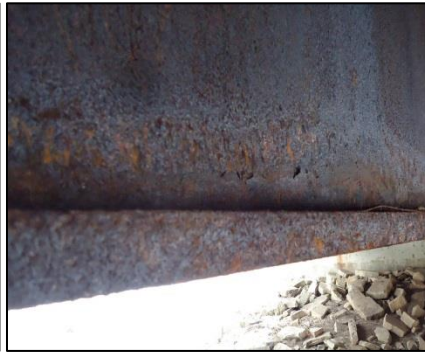
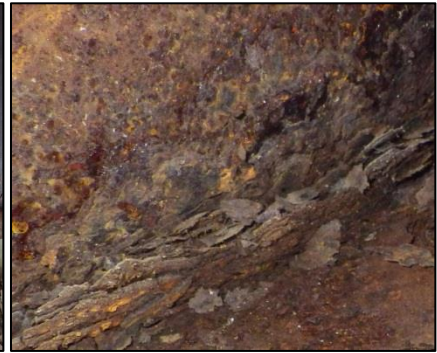
**Oxide Film Degradation/ Texture Adherence (3430)**

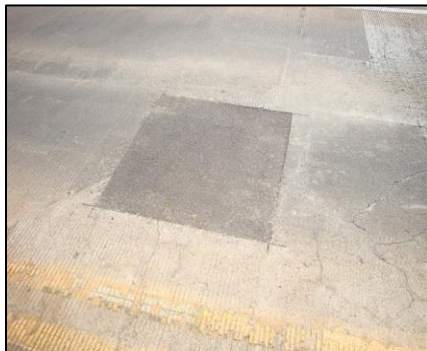
### **Debonding/Spall/Patched Area/Potholes (3210)**

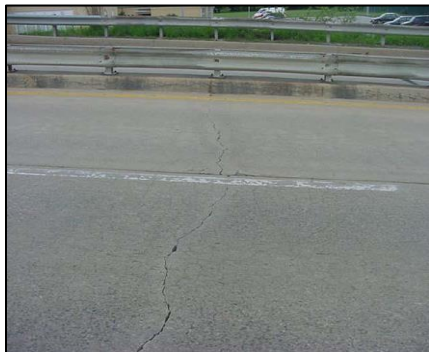
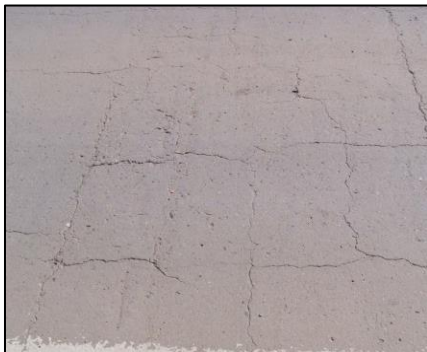
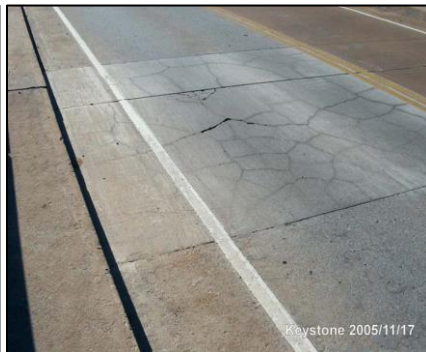
## Cracks, Concrete or Epoxy (3220)

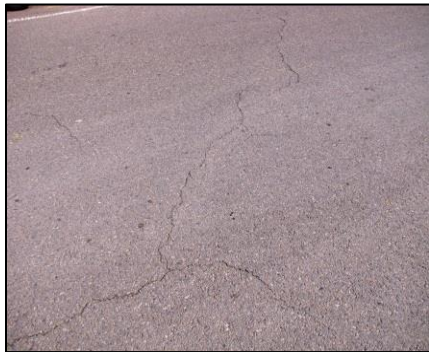
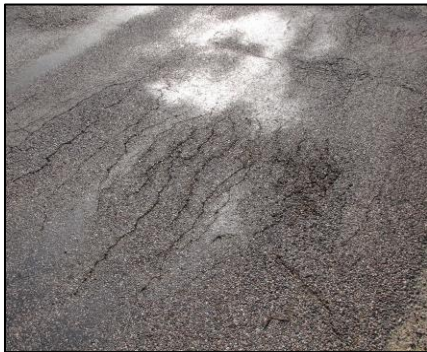
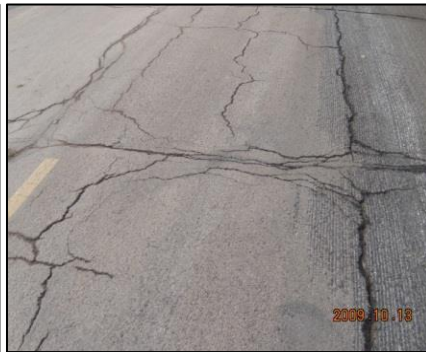
## Cracks, Asphalt (3220)
